CONSERVATION PLAN

OMANAIA MARAE + OMANAIA WESLEYAN CHURCH

BURGESS & TREEP ARCHITECTS 2012

Omanaia Marae + Omanaia Wesleyan Church Omanaia Road Hokianga, Taitokerau

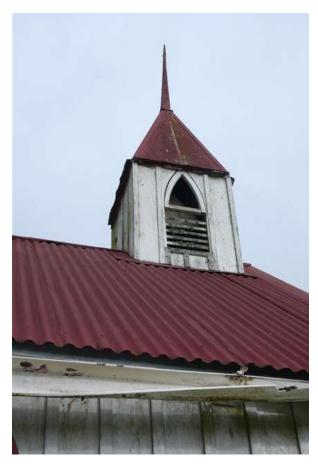
East detail showing condition of bell tower and detached spouting on the main roof. Burgess & Treep 2012

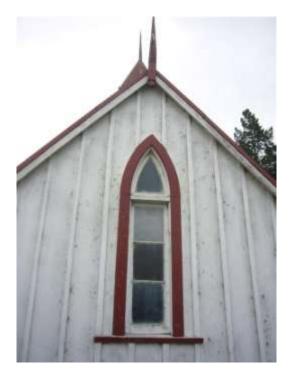
North window showing narrow sill. Burgess & Treep July 2012

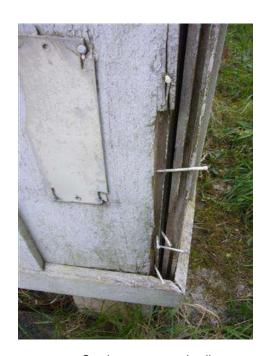
South west corner detail. Boards split and broken.

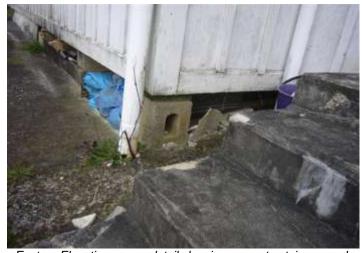
Eastern Elevation corner detail showing concrete stairs poured against cladding and concrete block foundations.

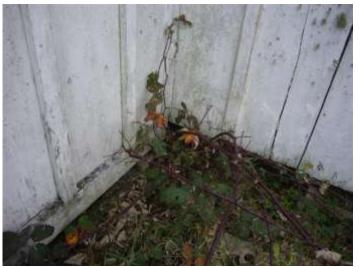
North western porch corner, note split and broken boards Burgess & Treep, July 2012

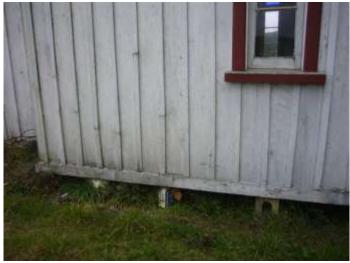
Western facade, note paint cans used for foundations Burgess & Treep, July 2012

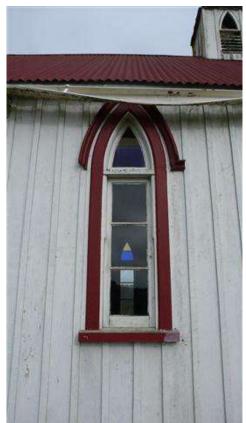
Window with broken hood moulding. Burgess & Treep, July 2012
