REMUERA

RAILWAY STATION + SIGNAL BOX

CONSERVATION PLAN

By Burgess Treep + Knight Architects Ltd,
Graeme Burgess + Lilli Knight
December 2015

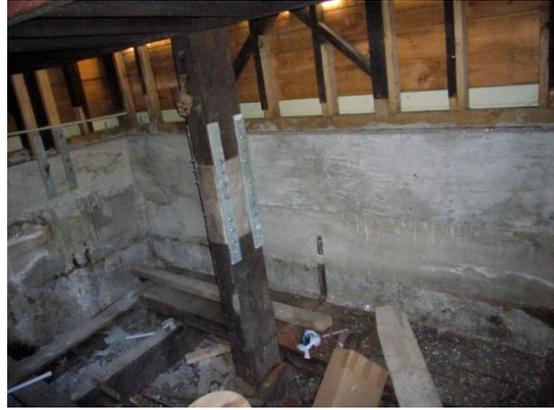
A new concrete foundation wall has been constructed on top of the original foundation wall up to ground level. The original bottom plate has been replaced. Before this change, the box apparently used to rock when the levers were operated.

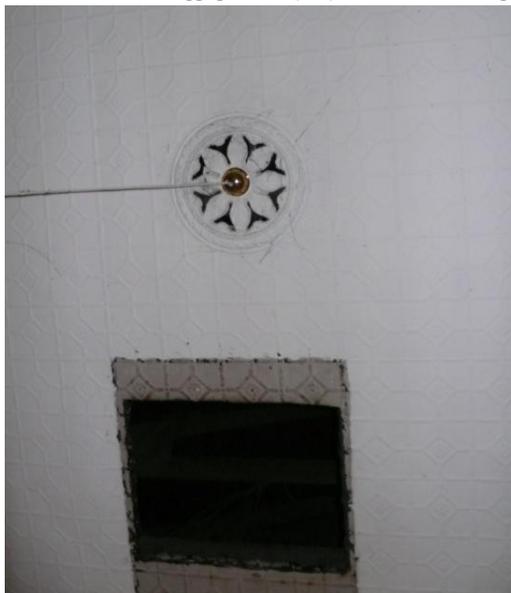
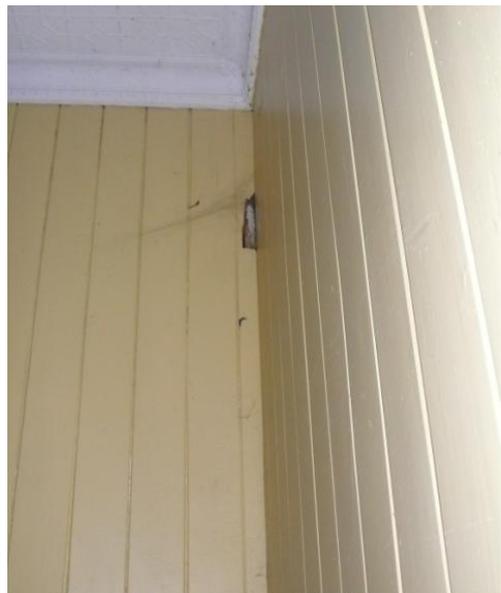
Ceiling rose + hole cut into pressed metal ceiling (left) Damage to t & g wall lining, Images: B, T & K Architects 2015

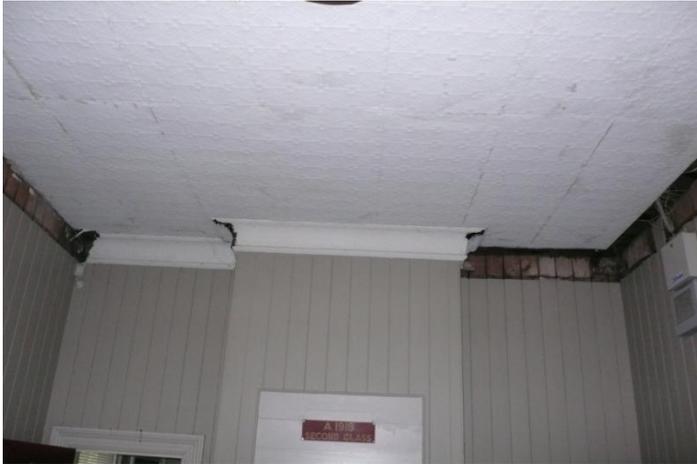
Showing south wall, ceiling with sections of missing cornice (left) missing pressed metal cornice

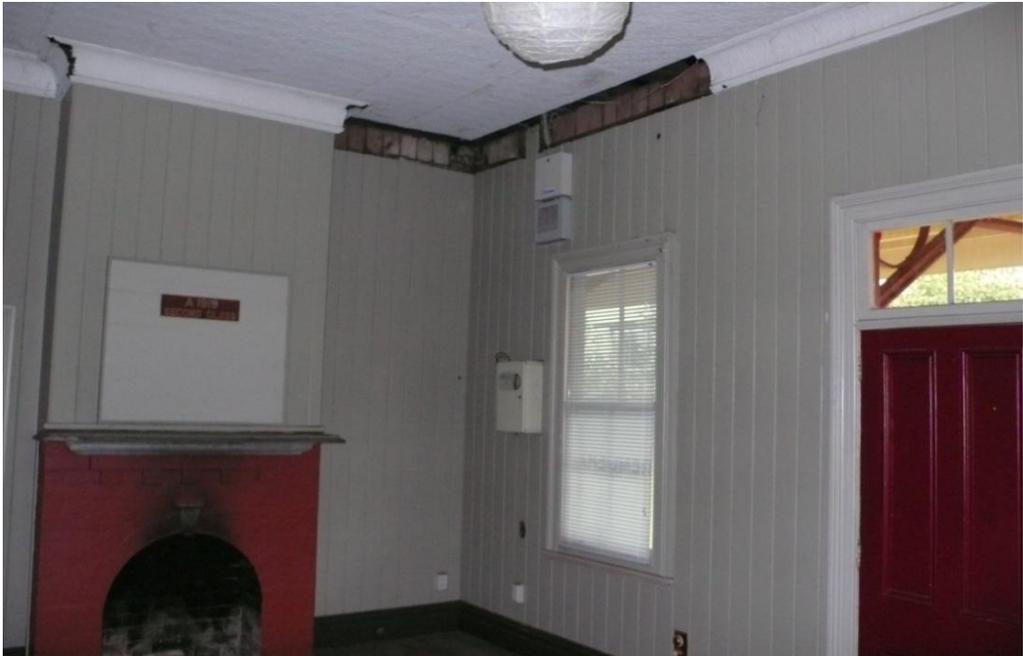
South west corner of the Station master & Booking Office, note large section of cornice missing, Images: B, T & K Architects 2015

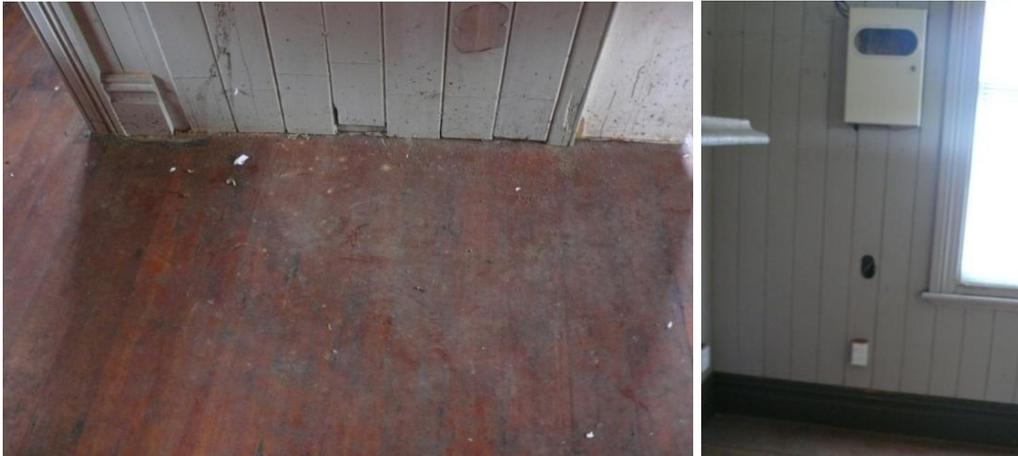
Section of missing skirting board (left) Distribution board on west wall, note hole in t & g lining

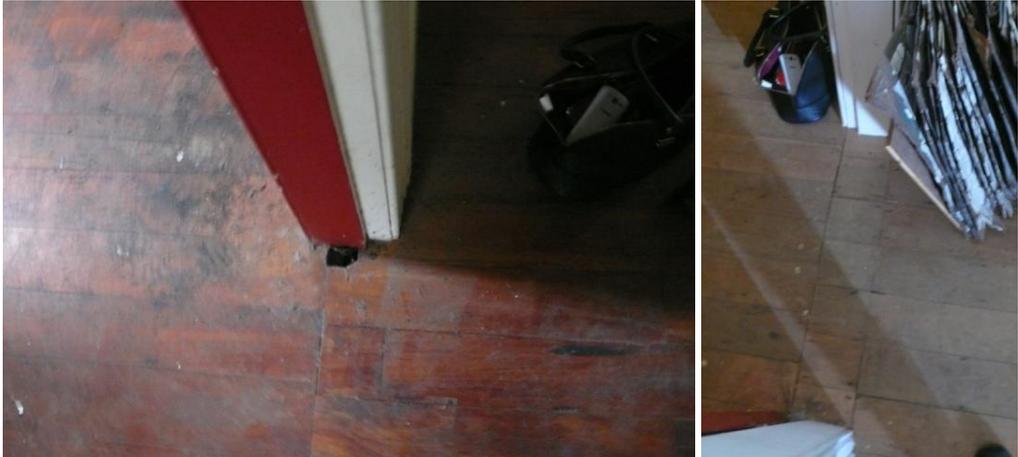
Hole in floor at doorway (left) new doorway into evidence in floorboards of where wall previously ran through

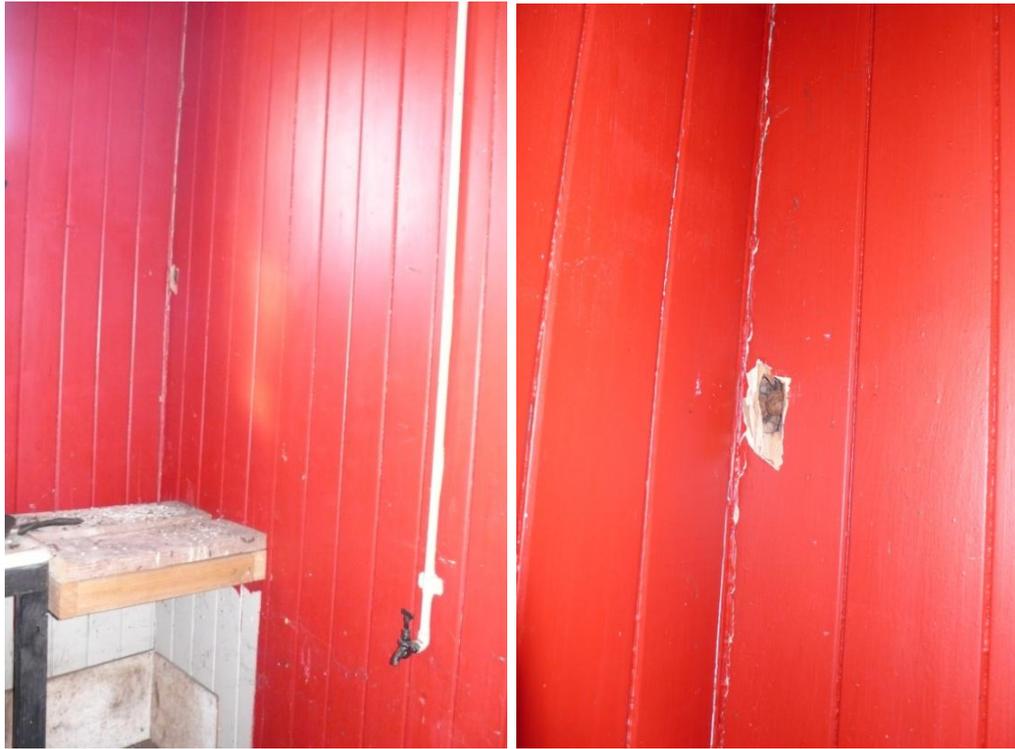
Showing north east corner of kitchen area + wall mounted tap (left) damage to t & g wall lining

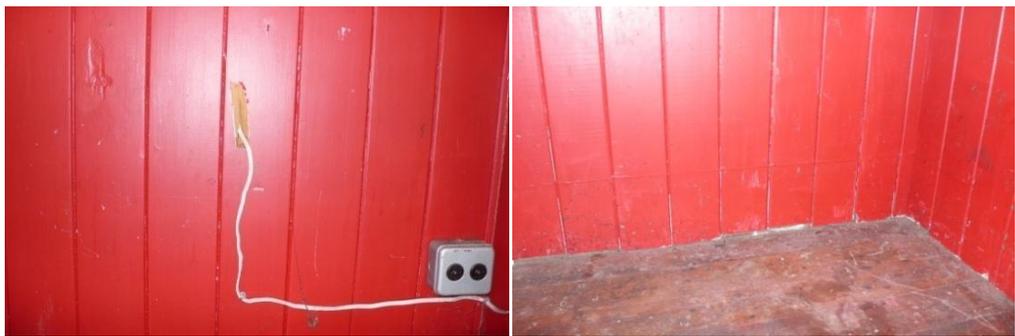
Exposed wiring (left) missing skirting board in kitchen

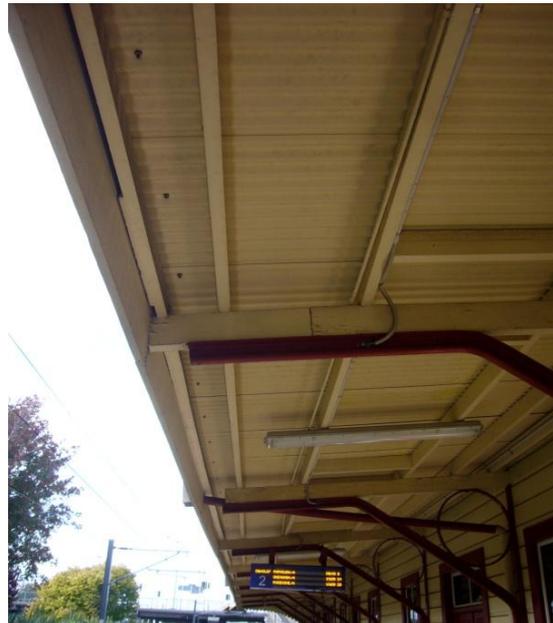
The verandah roofing was replaced in 1996. The flashing between the roof and the wall has not been properly fixed. This is loose on the southern side and this intersection has been leaking. Daylight can be seen from below. Two horizontal bars have been fitted along the verandah roof as safety markers following electrification. These elements affect the flow of water down the roof. These roofs need a full clean down and painting.

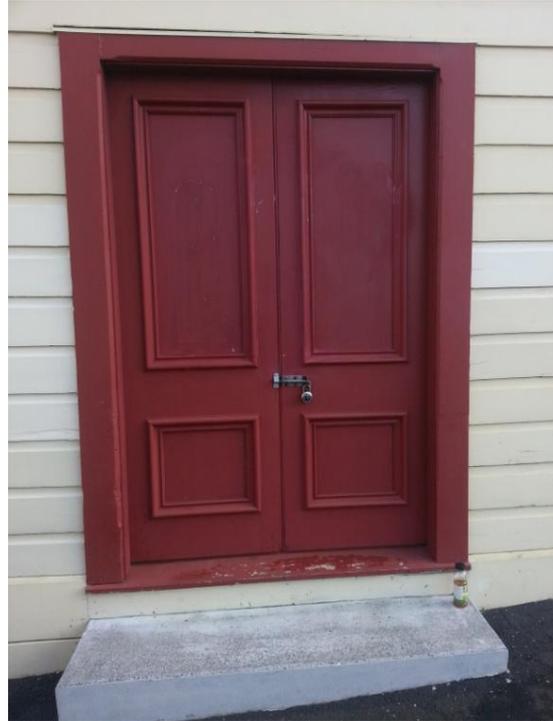
The doors have not been fully repaired. Many of the rails are damaged, some by general use and this may be considered as 'patina'. The panelling on some doors is split and broken and all the lock/hardware areas are heavily damaged.

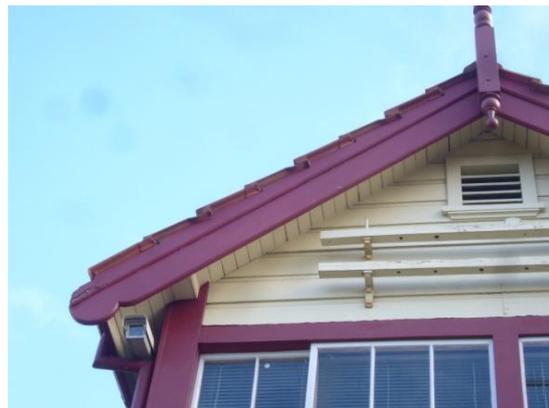
SOFFITS	The soffit is narrow tongue & groove board. In several areas it is badly damaged. There is a large hole in the soffit at the north western corner of the entry porch gable. At the north west corner of the main roof the fascia is pulled away from the soffit, and nesting material has spilled out of the gap. The nesting material has been painted to match indicating that this problem is long
----------------	---
