REMUERA

RAILWAY STATION + SIGNAL BOX

CONSERVATION PLAN

By Burgess Treep + Knight Architects Ltd,
Graeme Burgess + Lilli Knight
December 2015

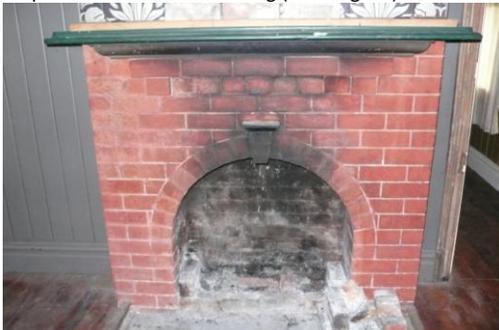
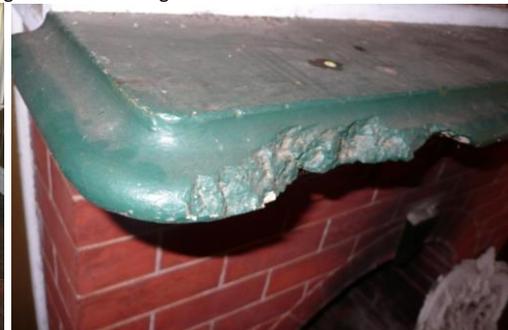
Fireplace on north wall (left) close up of damage to edge of concrete mantle, Images: B, T & K Architects 2015

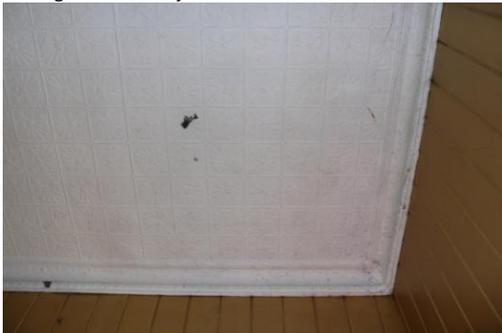
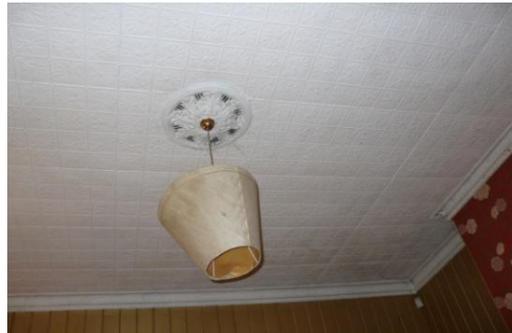
Damage to pressed tin ceiling tiles (left) ceiling rose

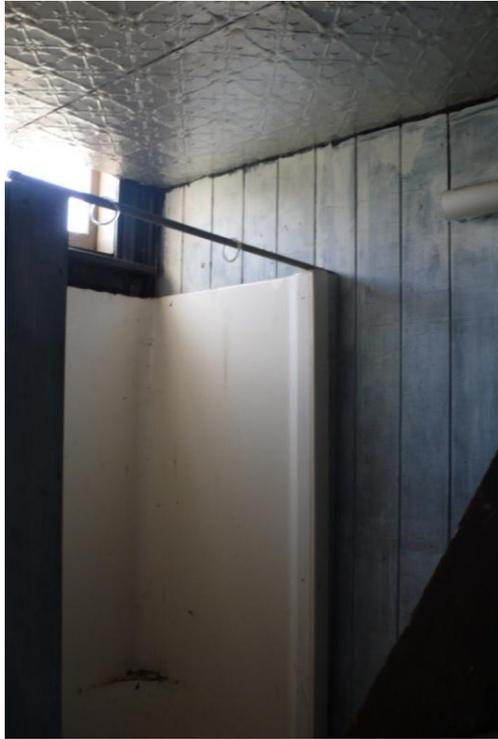
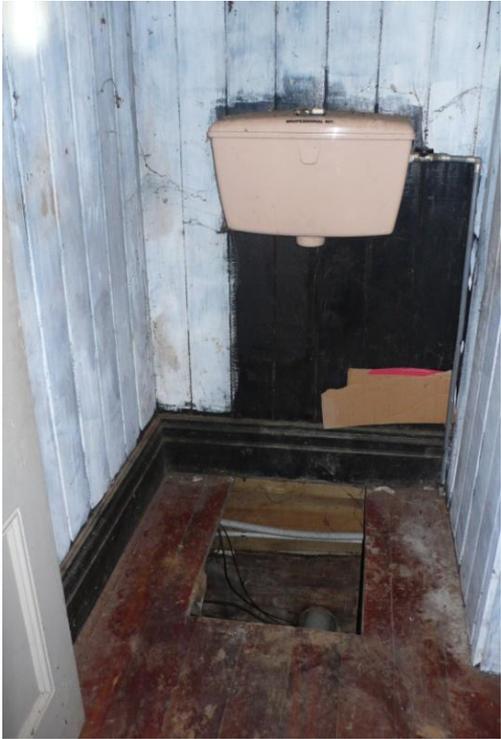
Showing shower unit fitted to existing toilet cubicle (left) hole in floor where toilet has been removed

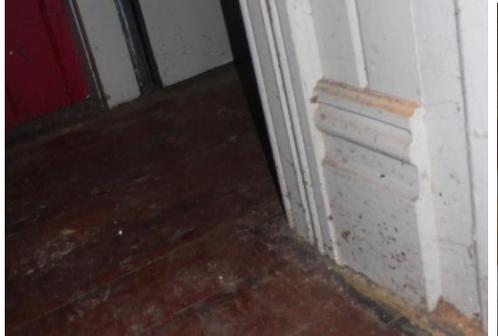
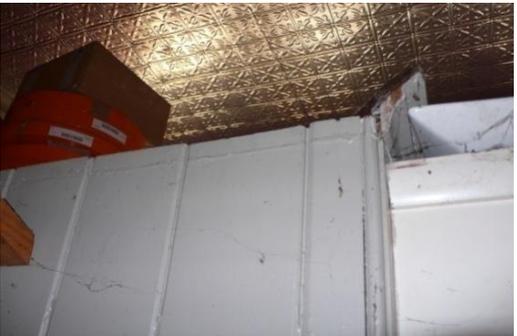
Toilet partition wall, section of skirting missing (left) section of cornice missing, Images: B, T & K Architects 2015

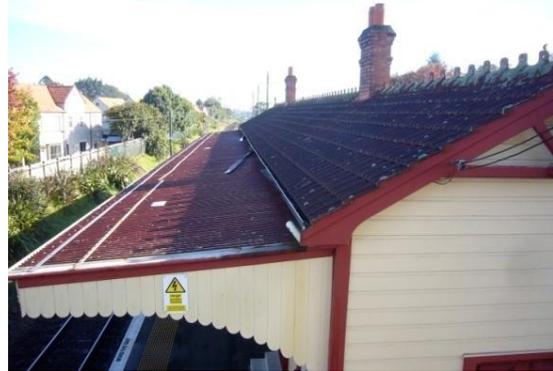
Marseilles tiles, crenellated ridging, terminals
Roof Repaired in 1996. New terracotta finials installed. The roof is in reasonable condition but has lichen growth and needs cleaning and checking.

The spouting needs to be cleared and checked regularly.

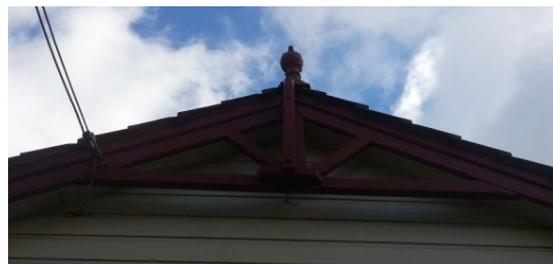
EXPOSED GABLE TRUSS- EACH END

Good condition

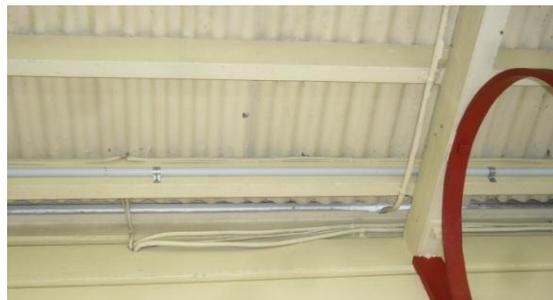
EXPOSED VERANDAH ROOF STRUCTURE

Exposed timber framing is in a reasonable condition. Check all timbers and repair as required.

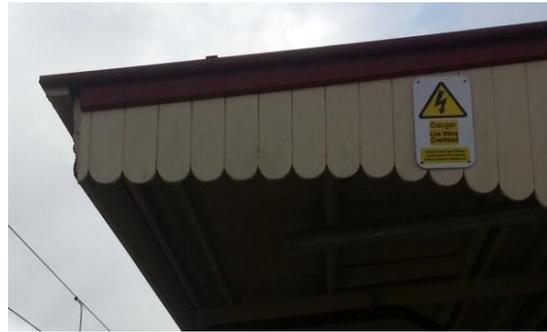
VALANCING TO VERANDAH

Valance boards broken at the northern end of the eastern platform. Repair/replace to match detail and profile.

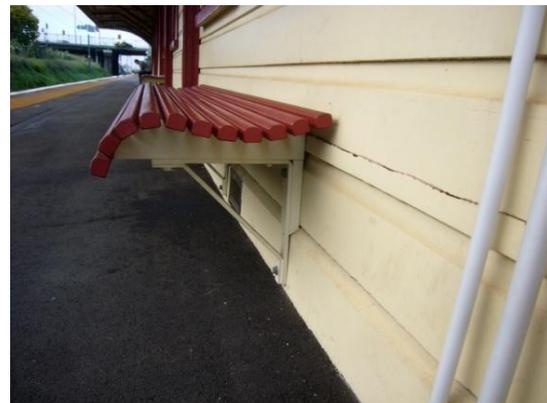
SEATS

Where the seat brackets have been fitted along the northern and southern sides of the building the weatherboards have split and cracked as the brackets are not fitted to structure they are hung on the weatherboards and have caused substantial damage.

The seat support bracket system is causing damage to the cladding. The seats are in good condition.

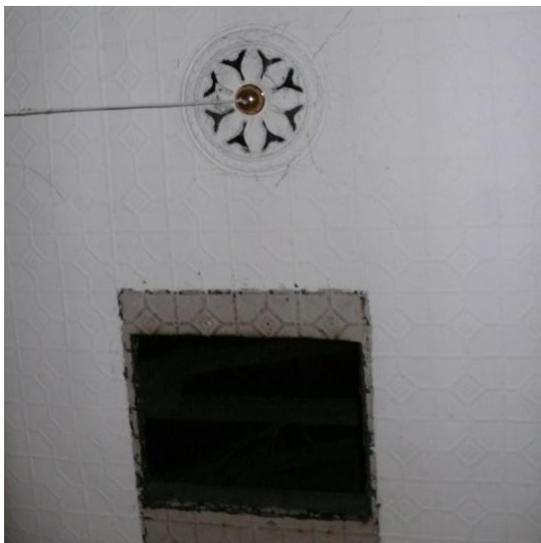
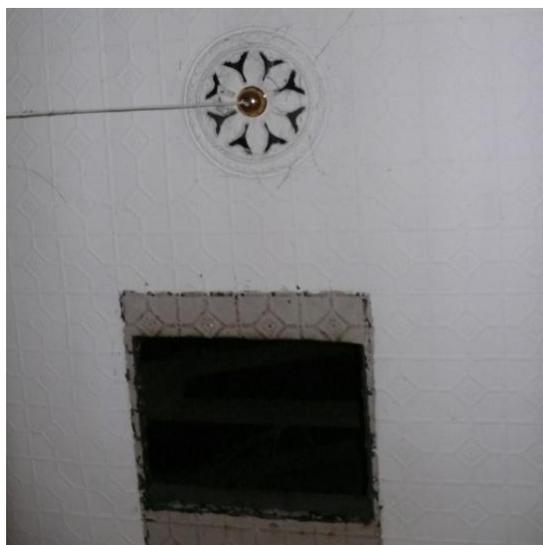
CEILING & CORNICE	Ceiling in poor condition with sections missing and extensive rust evident.
	Large access hole cut into ceiling above double doors on south wall

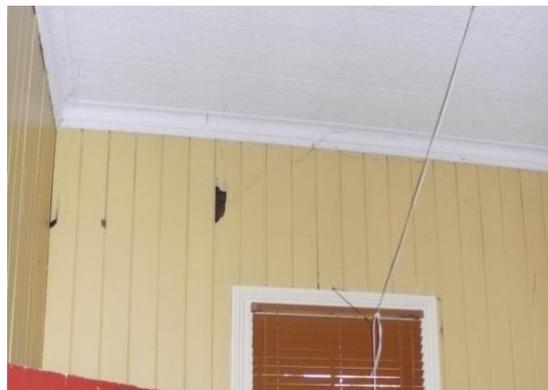
Vertical tongue and groove wall linings are in generally reasonable condition although there are several large holes + split boards (location of damage indicated on plans)

Hole in south wall covered by metal plate (evidence of location of basin which has been removed since 1992)

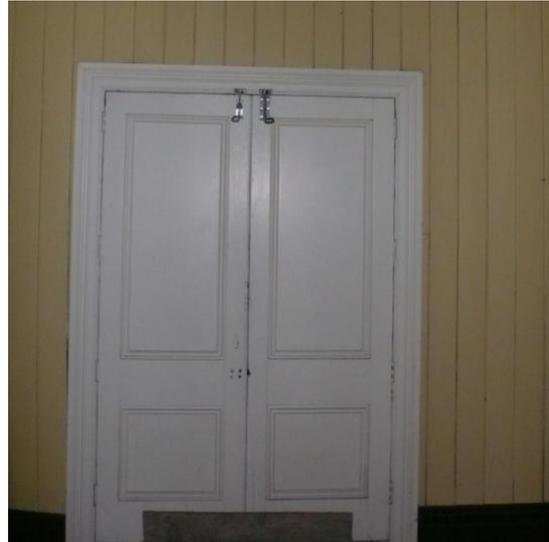
Double doors on south wall in reasonable condition, original hardware is missing. Both doors fastened at top with padbolts (1992 report states that all exterior doors were badly

vandalised with door sill and original hardware missing) Door sills are all intact.

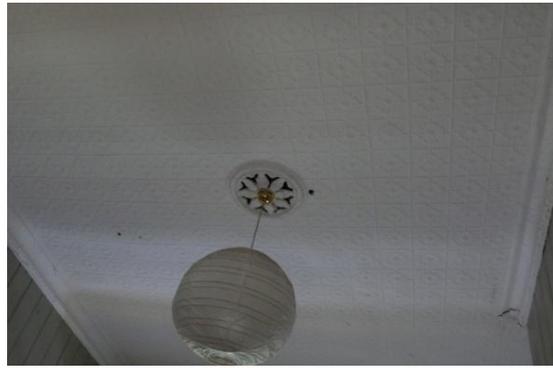
Pressed metal ceiling panels in reasonable condition.

Some holes that require repair.

Some significant rusting to cornice along east wall with some sections rusted out entirely. (Roof was leaking at the time of the 1992 report causing rust to the ceiling panels & cornice. The building has since been re roofed).

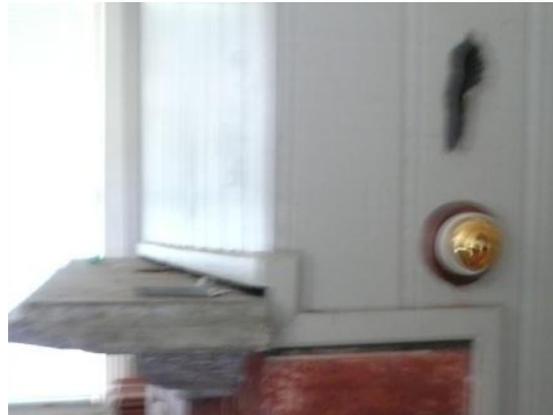
Vertical tongue and groove wall linings in reasonable condition with the exception of several holes in the boards as noted on plans.

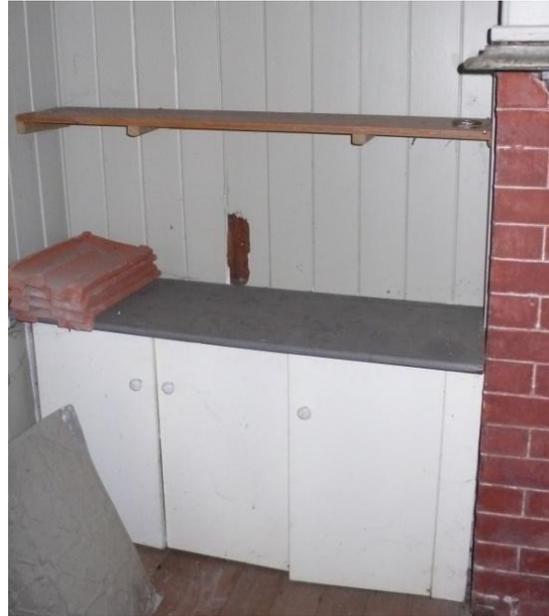
Joinery is in generally in good condition (various repairs/ replacements have been made since 1992, where it was noted that glazing bars were missing from east window and one fanlight. Sash cords were broken and the bead was missing from below the sill to the west window. (Panels were cracked on the east door)

There is a non original timber cabinet unit and wall mounted shelf fitted into the alcove to the west of the fireplace. This should be removed.

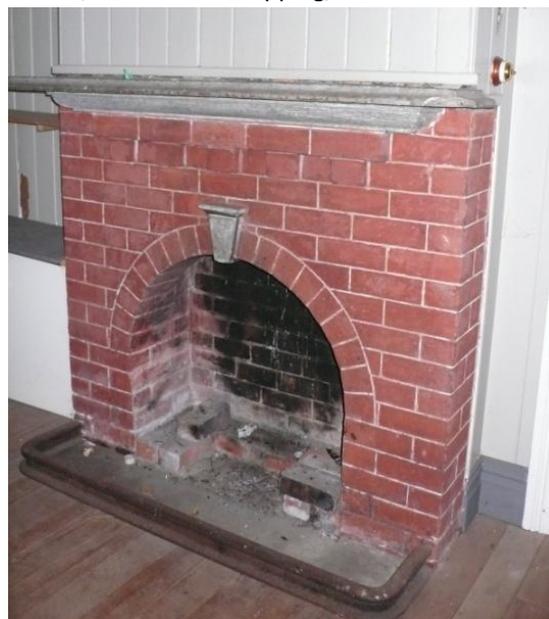
FIREPLACE + FIRE SURROUND

Fireplace is in reasonable condition. Iron fire grate is missing. The corner has been broken off the concrete mantle piece. The steel railway line fireplace fender around the hearth remains in place. Gap between timber cover bead and mantle, evidence of dropping/movement.

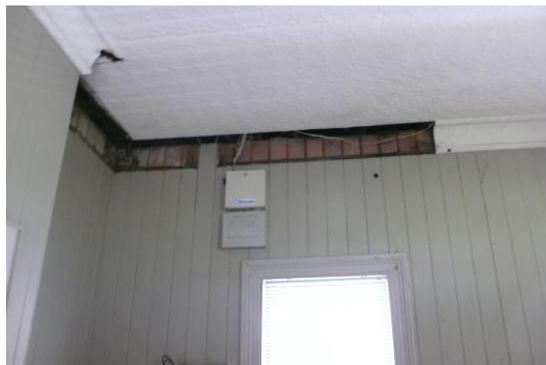
CEILING & CORNICE

Ceiling in poor condition, cornice in very poor condition missing along the entire east wall and in the south west corner.

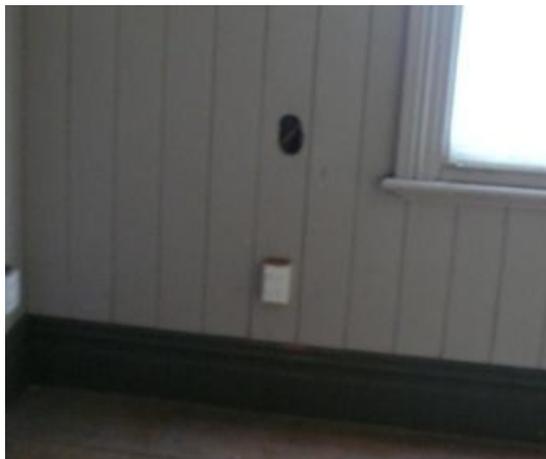
WALLS

Vertical t&g boards. Minor damage to some boards, holes and splitting. Holes in the areas where services have been re-run or fitted.

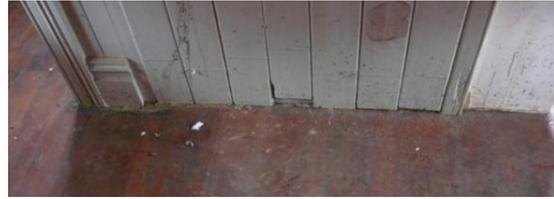
SKIRTING & ARCHITRAVES

The skirting boards have been taken off at some stage and have not been fitted back in places.

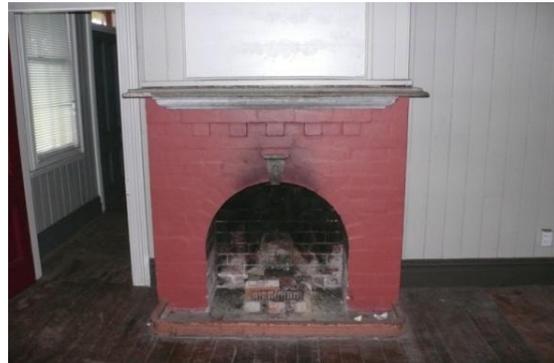
FIREPLACE + FIRE SURROUND

Fireplace is in reasonable condition. Iron fire grate is missing. The concrete mantle is in good condition. The steel railway line fireplace fender around the hearth remains in place. Gap between timber cover bead and mantle, evidence of dropping/ movement.

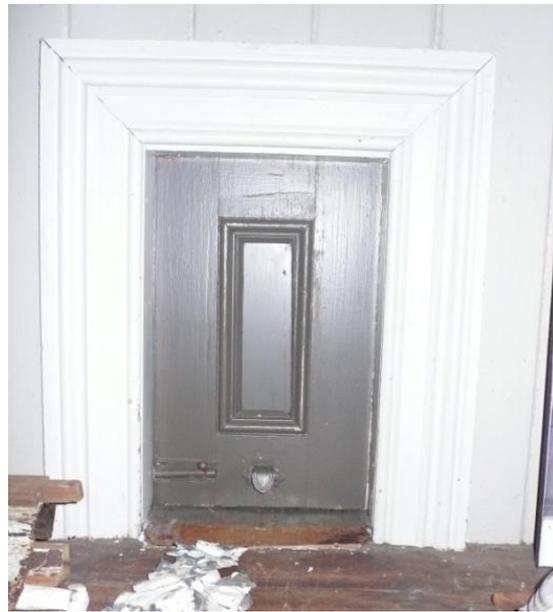
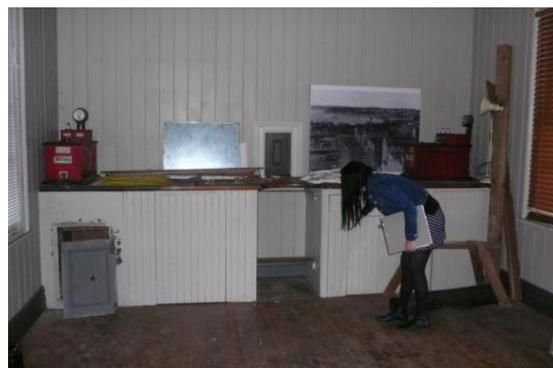
TICKET HATCH AND COUNTER

The original ticket hatch, a vertical sliding timber panel in the wall, remains in place and is in working condition. The Kauri wall to wall counter also remains in place across the northern wall of the room. It is in good condition. To the left hand side is the original concrete encased safe within the general vertical t & g cupboard unit. The door of the safe, blown off in the 1940s, has been kept and is in the room. The cupboard and drawer unit under the bench is in two sections, split by the seating recess beneath the centred ticket hatch. This in-situ built unit has solid timber drawers and t&g cupboard doors flush with the finished surface. The entire unit is in reasonable condition, and would benefit from general repair and maintenance.

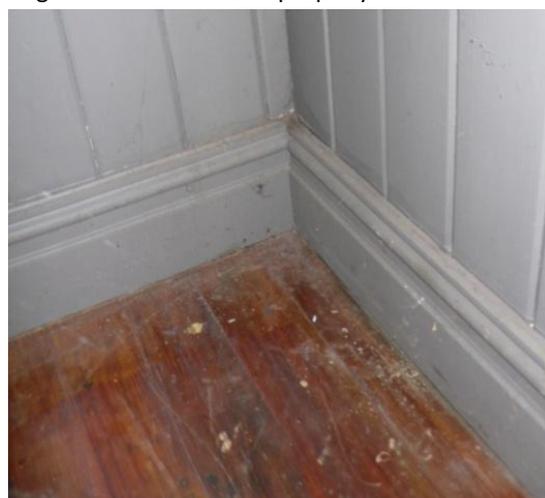
SKIRTING & ARCHITRAVES

The skirting boards have been taken off at some stage and have not been properly refitted.

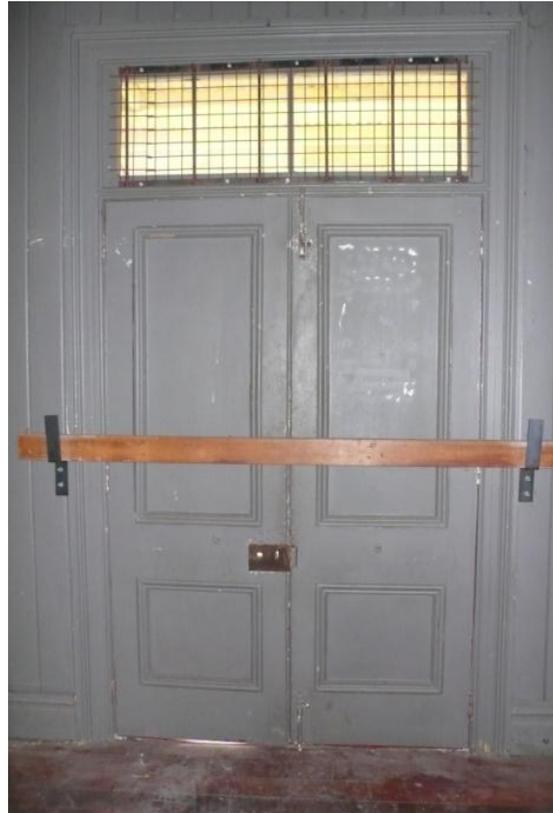
Refer to previous notes. Wire mesh security panels are fitted to the inside of all window

openings in this room. These are not original and should be removed. A metal bar on simply formed steel brackets is fitted across the double doors on the western wall.

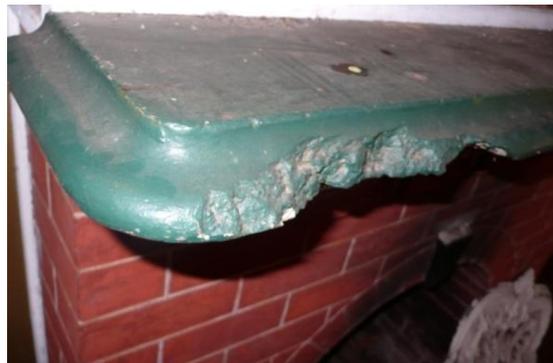
FIREPLACE + FIRE SURROUND

Fireplace is in reasonable condition. Brickwork within the hearth is missing. The concrete mantle is chipped. The steel railway line fireplace fender around the hearth remains in place. Some evidence of dropping/movement.

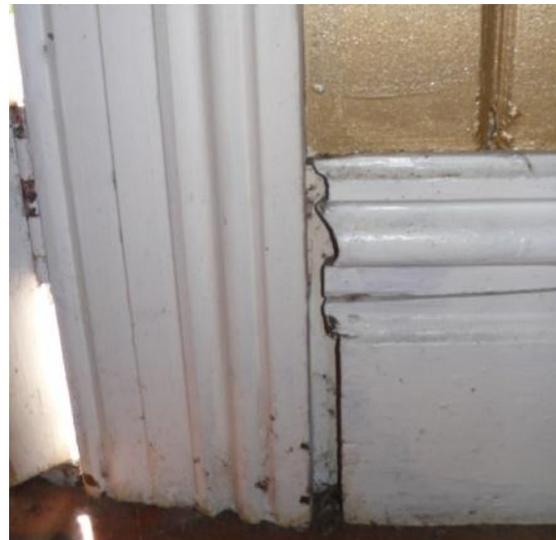
SKIRTING & ARCHITRAVES

The skirting boards have been taken off at some stage and have not been properly refitted.

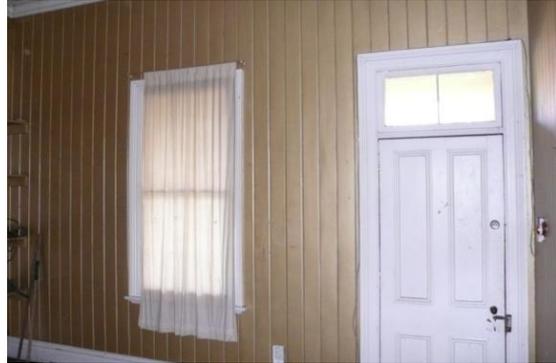
JOINERY

Refer to previous notes. Security mesh has been fitted over the inside face of the window openings on the western side of the room.

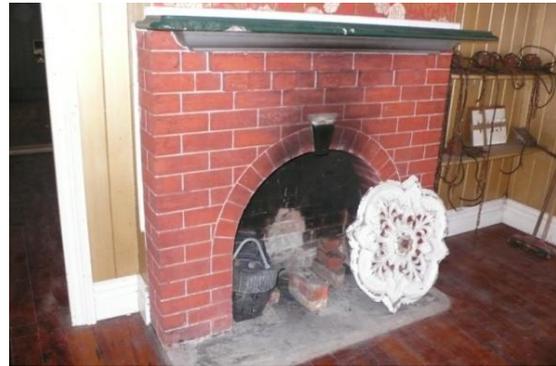
FIREPLACE + FIRE SURROUND

Fireplace is in reasonable condition. The 'key stone' element is broken. The concrete mantle is broken at the front left edge. The steel railway line fireplace fender around the hearth is missing. Gap between timber cover bead and mantle, evidence of dropping/ movement.

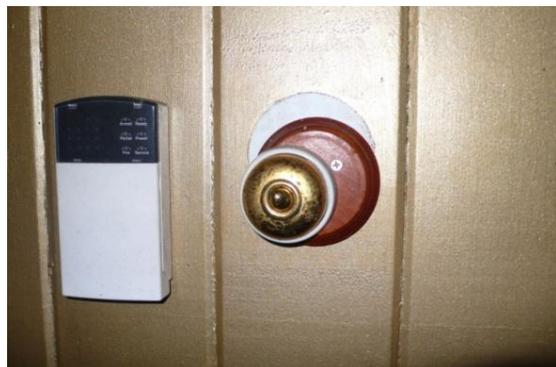
SERVICES

New power points and switches have been fitted. Apart from the light switches, that are period styled, these elements tend to clash with the overall aesthetic of the interior. Some wiring has been run exposed. This should be concealed or removed.

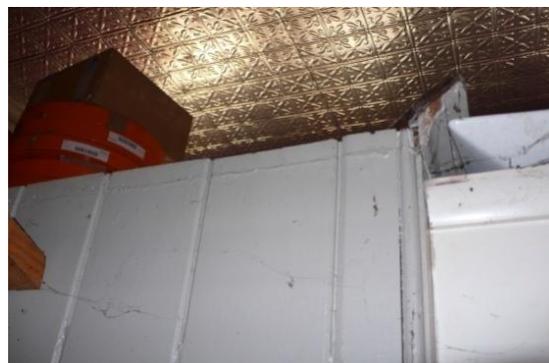
CEILING & CORNICE	Ceiling panels have been replaced using new pressed metal ceiling panels sourced by the Trust. The plain metal cornice generally in good condition with some sections rusted and in need of repair or replacement. The ceiling fitted over the toilet cubicle areas is poorly constructed and distracts from the space. This should be removed.
------------------------------	---

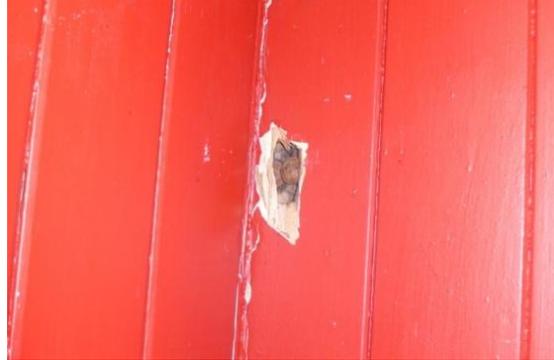
WALLS	Vertical t&g boards. Minor damage to some boards, holes and splitting. Holes in the areas where services have been re-run or fitted.
--------------	--

A new opening has been formed in the southern wall on the eastern side of the fireplace through to the Public Lobby. The door has been removed from the doorway on the southern wall of the room, opening into the Ladies Waiting Room.

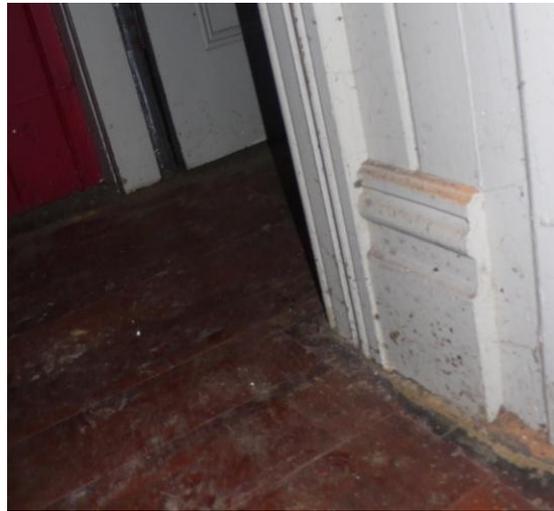
SKIRTING & ARCHITRAVES

The skirting boards have been taken off at some stage and have not been properly reinstated. Sections of the skirting remain in place under the bench.

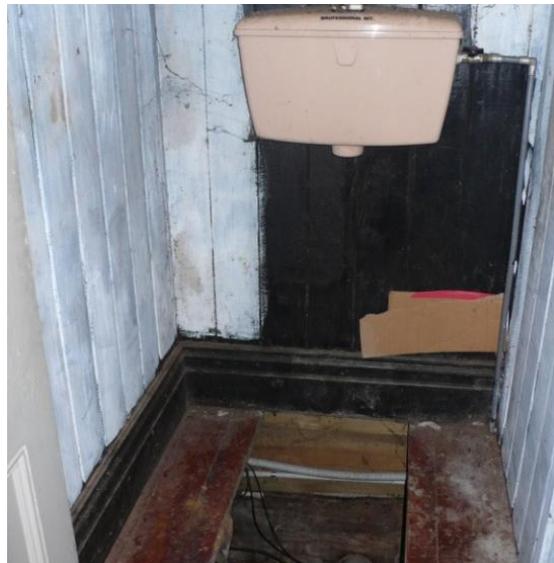
FLOOR

Refer to previous floor notes. In this area a large hole remains in the floor in the toilet area. This should be repaired and a floor access created for future repair and maintenance.

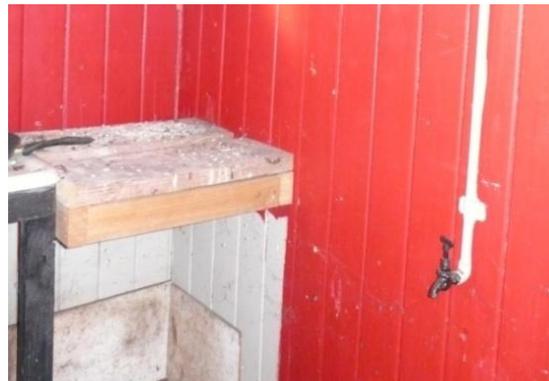
SERVICES

New power points and switches have been fitted. Apart from the light switches, that are period styled, these elements tend to clash with the overall aesthetic of the interior. Exposed wires have been run through the space. These should be removed or concealed. All the new plumbing services fitted in the 1990s are prosaic and detract from the appearance of the space. There is a surface mounted period tap on the east wall. This element should be disconnected and retained.

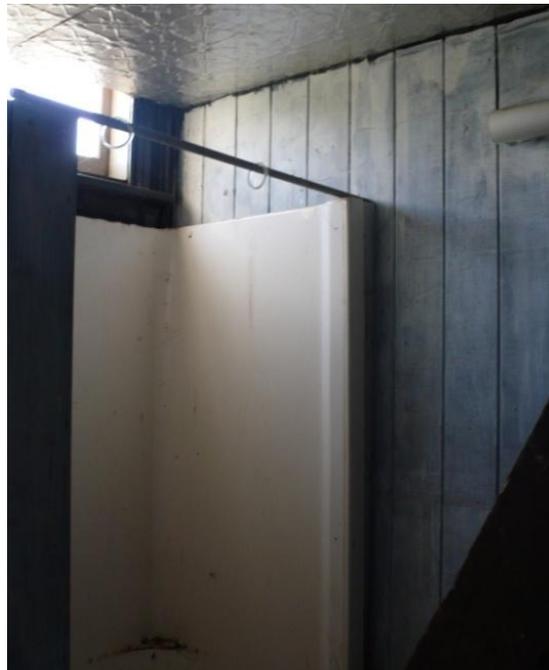
CUBICLES

Vertical t & g with timber cornice and panelled doors. Sections of the cornice are missing. The openings have been altered and a ceiling constructed over part of the cubicle area. All the recent changes should be undone.

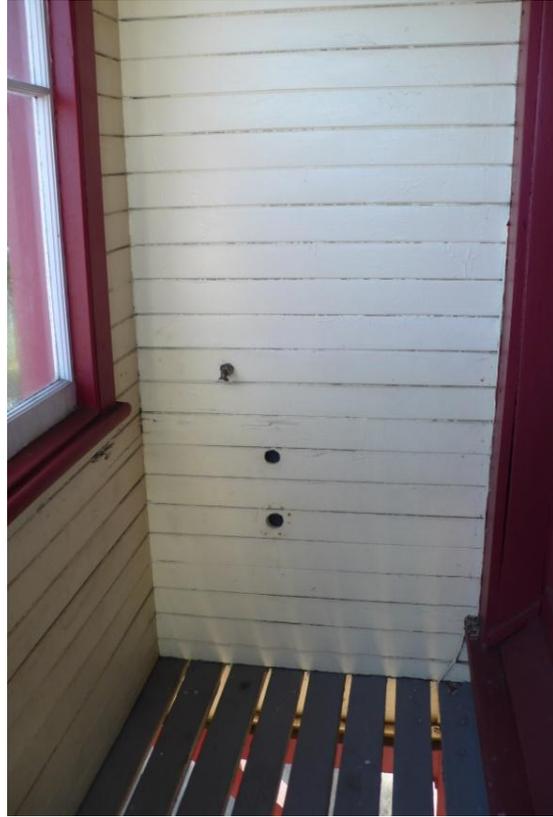
SOFFITS	The soffit is narrow tongue & groove board. In several areas it is badly damaged. There is a large hole in the soffit at the north western corner of the entry porch gable. At the north west corner of the main roof the fascia is pulled away from the soffit, and nesting material has spilled out of the gap. The nesting material has been painted to match indicating that this problem is long
----------------	---

groove boards. The walls are in reasonable condition. There are some holes where services have been removed at the eastern end.

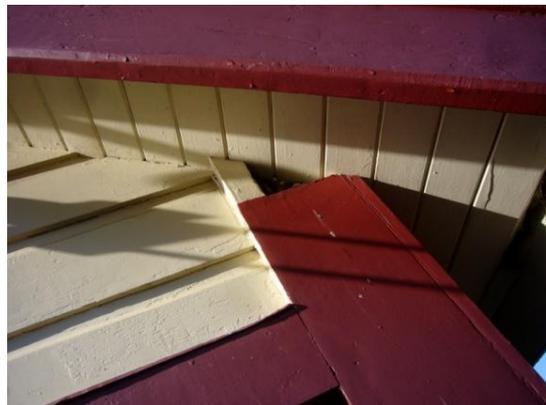
FACINGS

The facings around the joinery openings are plain flat section boards. Simple flashings are fitted over the openings. The corner facings are also plain flat section boards in a larger profile. The corner facings are cranked around the base of the cantilevered porch, framing the wall edges of the east wall and the porch itself. The corner facing at the south eastern corner is not a whole length. There appears to be a flashing over the vertical junctions. The facing board at the north west corner has a triangular gap at the intersection with the soffit. Elsewhere this gap is filled by a boxed beam end. All intersections need to be checked and made watertight.

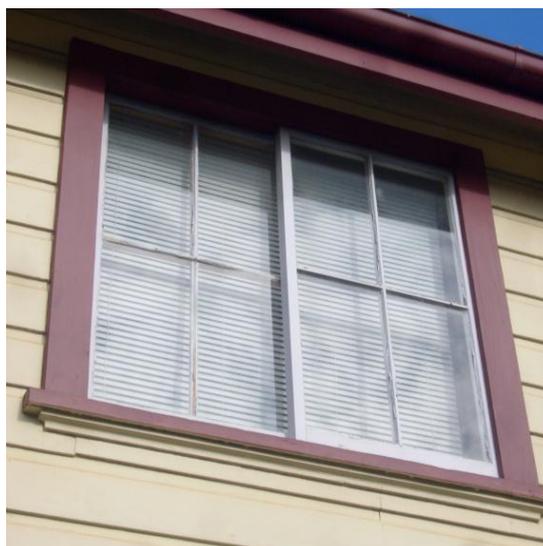
JOINERY

At the lower level of the building there is a door beneath the cantilevered porch, two small fixed window in the eastern wall, and three fixed windows on the western wall. The door is a solid timber door made up of flat finished vertical boards. It is in good condition. The windows are also in good condition.

The northern wall of the porch has a four paned fixed window. This window is in reasonable condition.

The door into the signal box is a four panelled inward opening door. The panels are sunk solid timber with bolection mouldings. The base of the door has an angled drip moulding to weather the cill. This door is also in reasonable condition.

The window joinery of the signal room on the upper floor consists primarily of sets of fine sliding paired sash units. There is a single unit centred on the east wall, two sets of uneven sash units facing south the full width of the wall, three joinery units the full width of the west wall, sliding units at each end with a fixed sash between, and a single unit, in three parts, at the western corner of the northern wall. These units appear to have been repaired, and are in good condition. The cills of these units project further out from the face of the cladding than the standard windows. The cills are supported by a coved timber bead.

Check all joinery at regular intervals to ensure condition and ease of movement.

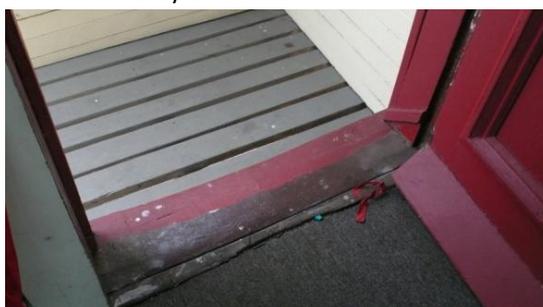
ENTRY PLATFORM

The entry platform is an open deck supported by triangular framed timber brackets at each end and at the centre. The stair stringers also provide support to the exposed deck framing. The eastern corner of the entry platform is semi-enclosed by the small projecting gable/porch that gives cover to the doorway. The exterior finishes of the porch are as previously described under, roof, cladding, joinery & porch lining. The decking is open slat decking and appears to be new. The handrail follows the detail and profile of the stair handrail. In addition to the post and handrail there are diagonal crossed rails within the handrail panels on each side. The handrail has pulled away from the building at the North West corner, indicating that the original alignment of the deck and main building is out of line. Public safety is a concern as the stair is easily accessed.

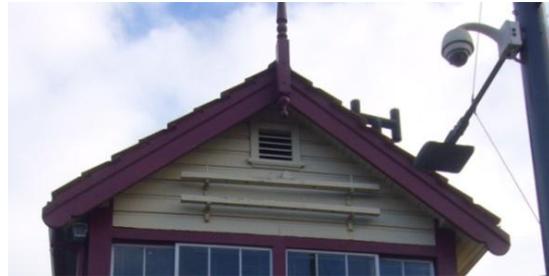
LOUVRE PANELS IN GABLE ENDS

At each end of the main gable at the top of the wall is a square louvred opening. The louvres are horizontal fixed timber boards in a frame with full cill and facings. The cill is supported by a covered moulding. These should be checked, and if necessary, made bird and insect proof.

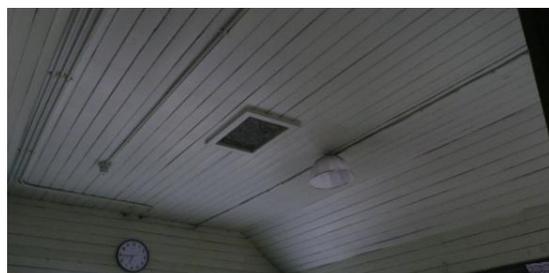
CEILING LINING

strip timber t & g lining running the length of the room, with a single framed metal ceiling vent. Surface fixed conduit. Ceiling linings are generally in good condition. All original conduiting should be retained, all recent conduit should be removed.

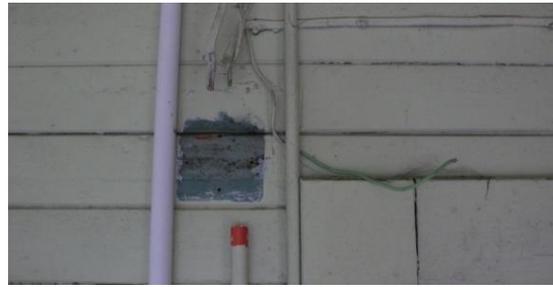
WALLS LINING

Matching horizontal strip timber lining. Generally in good condition. Some minor holes where services penetrate or have been removed. Remove redundant services. Repair to match.

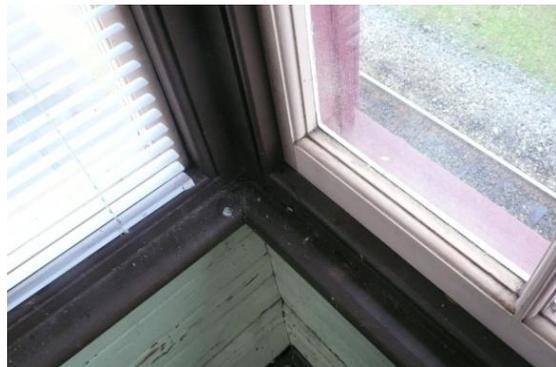
ARCHITRAVES

Plain flat board architraves and cill, all in good condition.

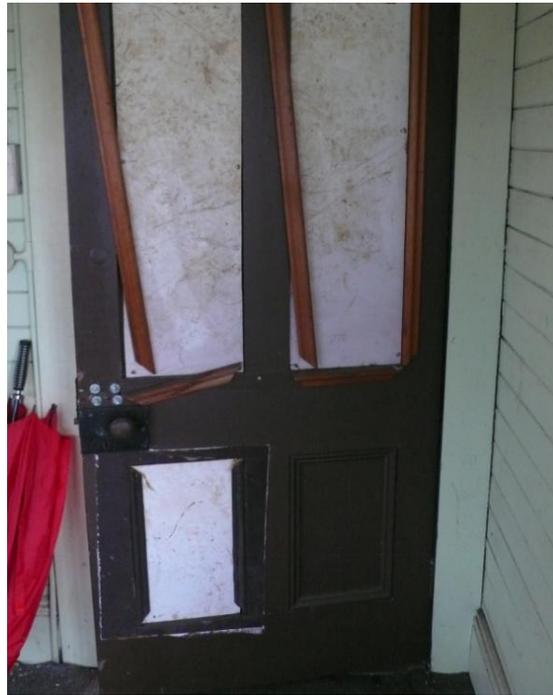
DOOR

The inside face of the door is in very poor condition. Most of the mouldings are loose or broken, and the panels appear to be temporary replacement panels. The door stop is a planted piece of wood.

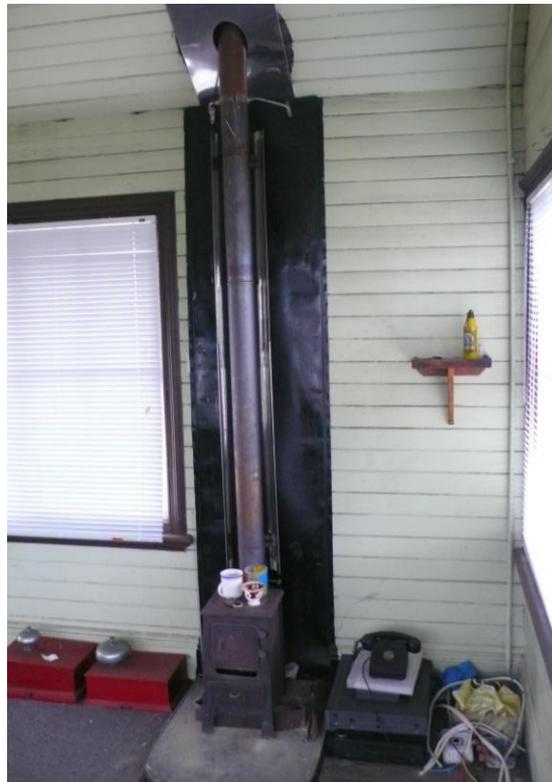
STOVE

The original wood burning stove unit has been removed. A replacement unit has been installed by the Trust. The fire was a free standing small 'pot belly'. The replacement is similar in size and form. The concrete base remains. The heat shield flashing to the wall appears to be a replacement. The Heat shield flashing to the ceiling is new as the trace of the former circular plate remains on the ceiling. The fire area is in good condition. The fire is not used.

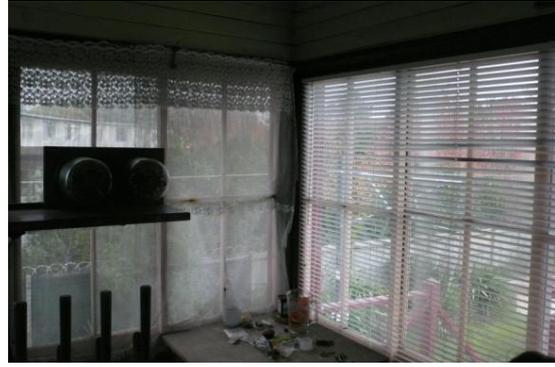
BENCH

Bench top at the north west corner, plain timber slab bench top, in good condition.

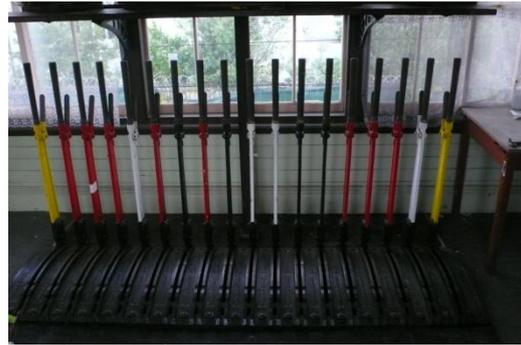
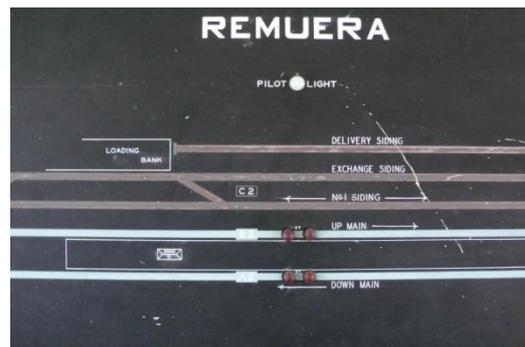
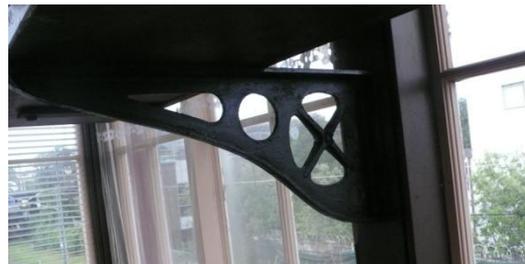
EQUIPMENT

The signal equipment remains in the room. This unit runs across the west side of the room. A slab timber bench supports the signal panel and associated electrical equipment. This is supported on cast iron brackets. In front of the bench is an array of levers fitted into a floor panel. The equipment is no longer used. As artifacts related to the history of the station and the rail network this equipment is of tremendous value. Some of the glassware covering the signals equipment is missing. These missing elements should be re-instated.

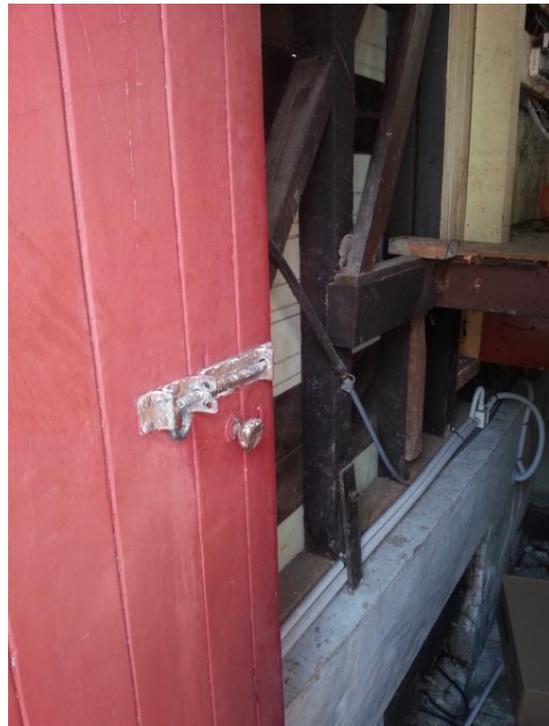
ENTRY DOOR & PLATFORM	The entry door is set on the concrete base of the building. The base has been raised as part of the lifting works. The platform remains at the lower level, making this a dangerous threshold. If the area is to be used in future a new platform will have to be constructed and the access restored to the working platform and possibly closed to the sub-floor area.
----------------------------------	--

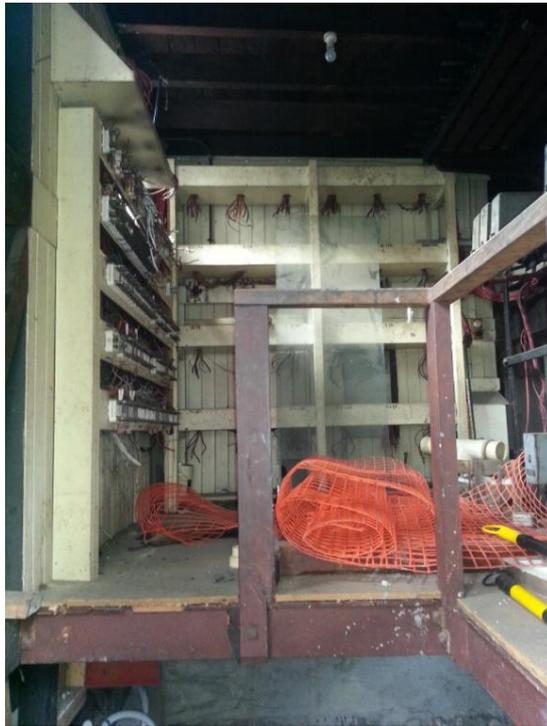
WALL FRAMING	The interior walls are unlined. The full structure of the building is visible. There are heavy beams each side of the lever unit and across the northern wall to provide support for the deck brackets. The framing appears to be in very good condition.
---------------------	---

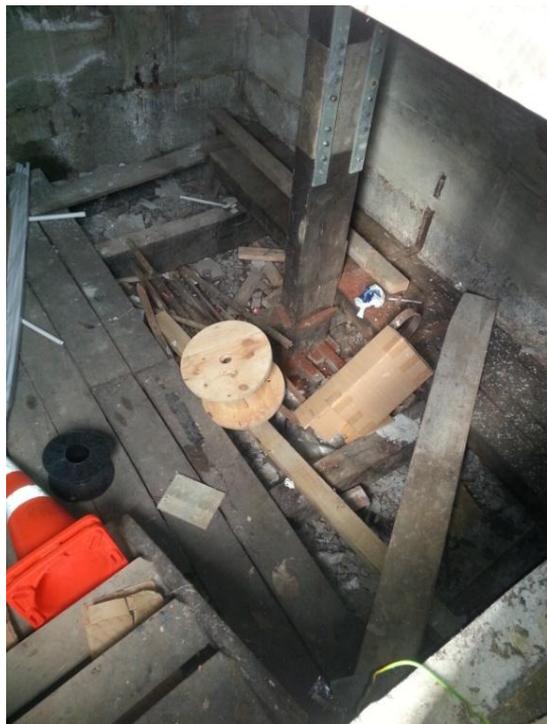
SUBFLOOR FRAMING

The entire base of the building has a concrete foundation wall. The subfloor wall and framing are in very good condition. There is some rubbish in the area. This should be removed.
