BLUMENTHAL HOUSE

317 St Heliers Bay Road, Auckland, New Zealand. Built in 1958,
Architect: Vladimir Cacala

CONSERVATION PLAN

Prepared By Burgess + Treep Architects Ltd, Graeme Burgess + Lilli Knight
April 2015

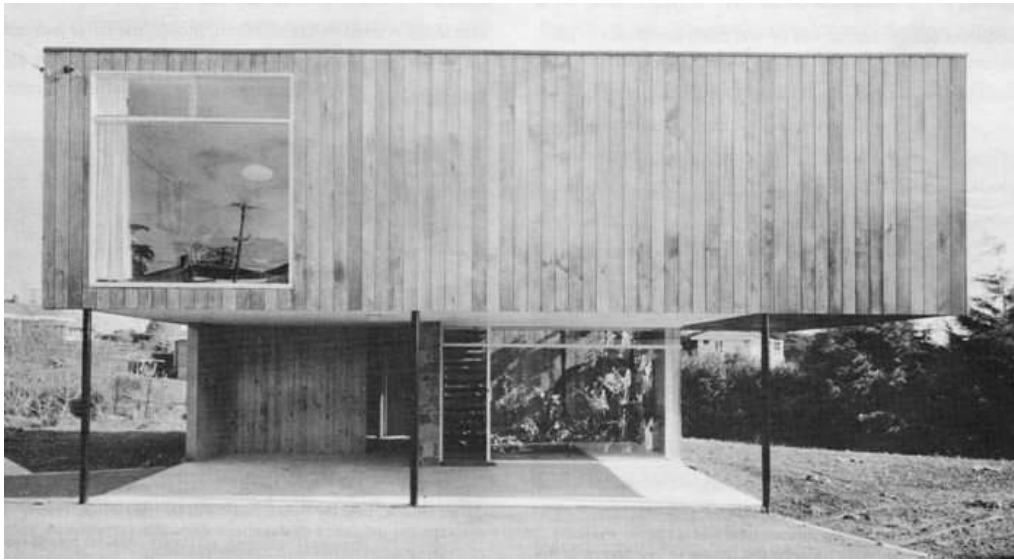
East Elevation of the Blumenthal House, Image: *Home & Building* ACP media 1950's edition, www.lostproperty.org.nz

The first impression of the Blumenthal house is of the hovering eastern wall, the living room on the upper floor, extended out over the carport/entry area, lightly held by four CHS steel columns. The plain rectangular geometry of the house is immediately striking. The living room wall, with wing-walls, is a single plane of vertical t & g boards broken at the southern end by a square, floor to ceiling joinery frame. The joinery frame is divided horizontally into two uneven sized fixed panels, a large panel at the bottom and a narrow top panel.

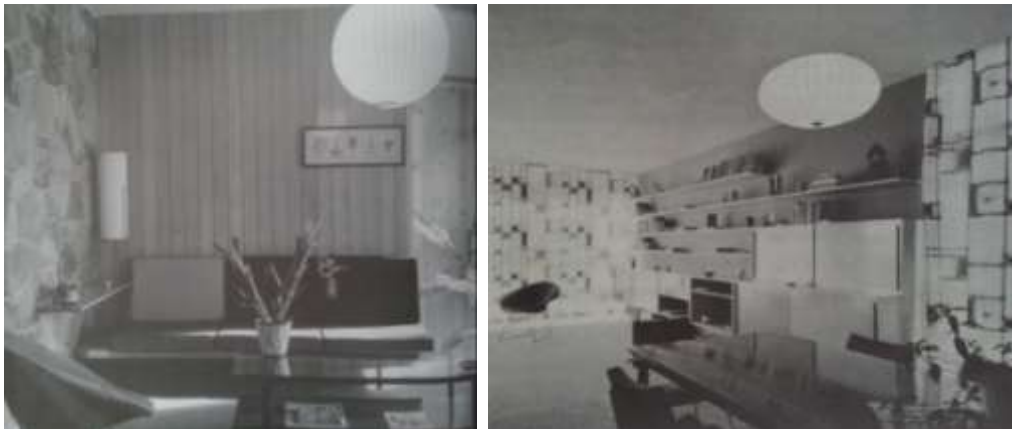
"The sparse interior is furnished with Bertioia chairs imported from New York and fabrics from Germany" as published in Domus magazine 1960, Image: Long Live the Modern, pg 88 (left) Image: NZ Home and Building – Souvenir Edition, the 1950s Show, Auckland City Art Gallery (right)

A hanging staircase goes up past the foliage to a glass sliding door opening onto the hall. Dividing the house and supporting it structurally is a wall of dark stone with white pointing which becomes a decorative feature in the living area. Cacala believed this stone created a 'centre of power' for the house, and related it to European Bauhaus prototypes, gesturing to the marble walls of Mies van der Rohe.¹¹

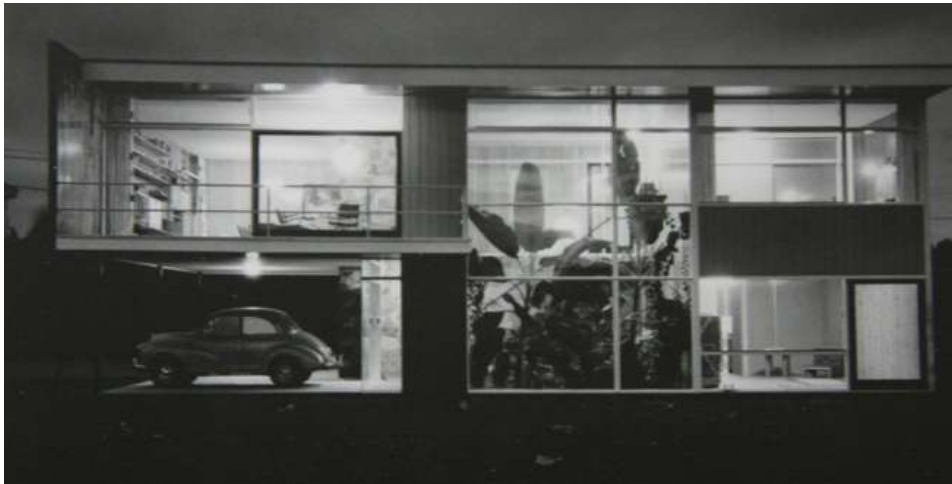
Northern façade of the Blumenthal House as published in *Domus* magazine 1960, Image: www.lostproperty.org.nz

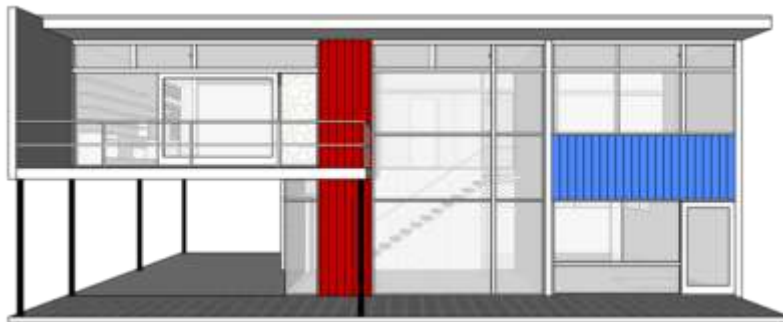
Blumenthal House, North Elevation: LK Burgess & Treep Architects 2014

The void of the carport is an essential component of the overall geometry of the house. The effect of the carport void is a key component of the overall design and sculptural form. This space is clearly a major element on the eastern side, and from the north looking at the house the effect of the void heightens the sense of interplay between inside/outside, solid/void that underpins the overall form, mass and design of this side of the house. The 1960 photograph of the house, published in *Domus* magazine, was taken at night. The sense of hovering forms and dissolved space is heightened by the stark contrast between the glowing house and the darkness of the foreground.

The joinery is divided horizontally in a grid that reduces from bottom to top, and vertically into a rhythm (from left to right based on the upper floor) of wide (A), wide (A), narrow (B), wide (A), narrow (C), wide (A), narrow (C). The joinery elements are white. The narrow (B) panel is a vertical panel of t & g boards finished in red. The central horizontal panel at the right hand side of the wall is also finished in vertical t & g boards and painted blue. The doors are large sliding panels contained by the grid, one (A width) at the right hand side of the living room on to the deck, and at the lower level from the living room of the independent flat at the right hand side (C width). The remaining panels appear to be fixed glass, as Cacala has used a cabinetry sliding glass system to create opening glass panels within sections of the grid that are in the bedroom and living areas. These sliding panels (one in the left hand upper panel of the living room, both left hand panels in the upper floor bedroom, and one within the left hand upper panel of the independent flat living room) are a magnificent example of lateral design. The central section, the garden room/entry, is full height, and the glass is fixed. The garden room glazing protrudes beyond the red wall into the carport space.

The roof plane extends out over the wall giving shelter to the deck and adding to the sculptural form of the house. The soffit of the overhang and the side wall of the deck are stained timber. The vertical face of the right hand corner is finished in a white painted facing board that rises from the base of the house up to the soffit. This is painted white.

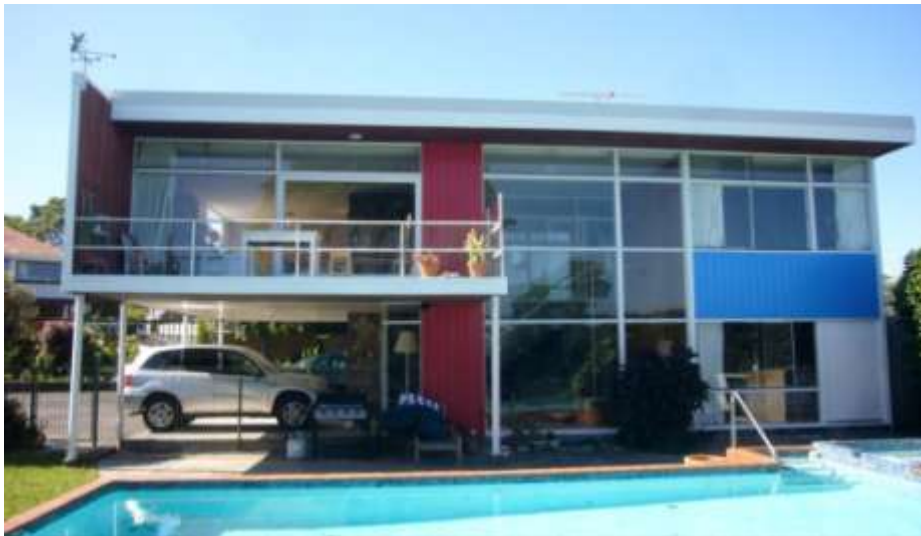
North Elevation, Image: B&T Architects 2014

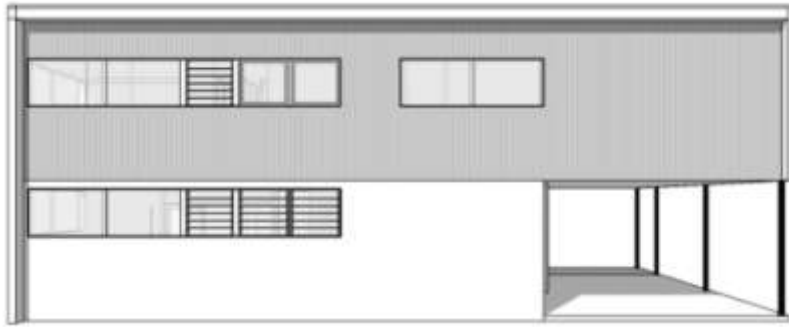
Blumenthal House, South Elevation: LK Burgess & Treep Architects 2014

The southern wall of the house is the service side of the building. This side of the building has also been treated as a sculptural form. The roof and side walls project out to frame the walls. There is no visible spouting. The fascia and the facings of the end walls are on the same plane and create a line around the contained wall surface. The upper floor is finished in vertical tongued and grooved boards. The bottom line of the weatherboards forms a strong line across the solid plastered base wall and beyond at the edge of the carport soffit. The boards sit hard to the plastered surface of the ground floor, keeping the wall surface as close to a single plane as possible. The change of material gives emphasis to the long horizontal of the upper floor.

The wall of the lower floor is solid plaster, on chicken mesh, on fibrolite with 'sisalcraft' paper behind. This lower wall is painted white. The wall extends out beyond the wall of the laundry/storage room behind and finishes in line with the right hand side of the kitchen window above.

The joinery openings are carefully articulated. At the western end of the wall there is a long horizontal panel of joinery on each floor. The vertical panel divisions match at each level. At the left is a wide panel with sash-less sliding glass panels, next are three panels. At the upper level the two right hand panels are sash window in the bathroom, with a louvered panel to the toilet. At the lower level all the right hand panels are louvre windows. The kitchen window is a sash-less sliding glass window. This window sits within the horizontal band of the main window.

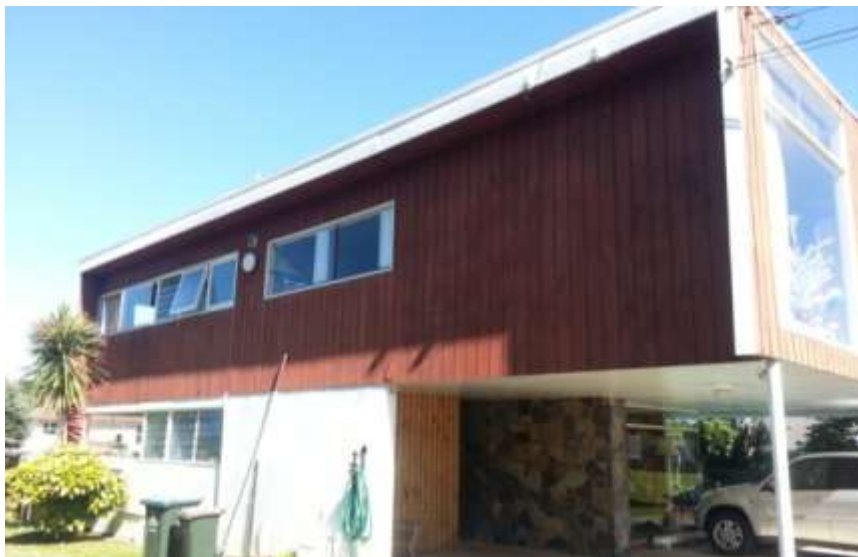
South Elevation, Image: B&T Architects 2014

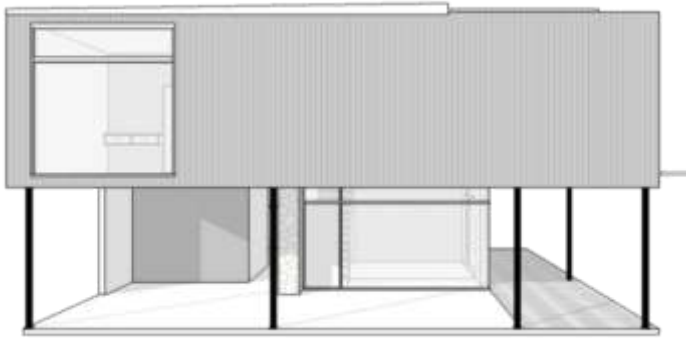
Blumenthal House, East Elevation: LK Burgess & Treep Architects 2014

The parking platform is a stage for the cars, with the carport as the porte-cochere. The entry to the house is not immediately obvious (there are two entries in the carport, the deeply recessed entry to the independent flat to the left of the central stone wall, and the entry to the house at the right of the stone wall).

The solid door is set within a fully glazed wall. The joinery unit is a single frame. There is a glazed panel above the door and this line runs back across the fixed window and returns back on the northern frontage of the building to the side wall. The corner is open with butted glass. The ceiling of this area is finished as a smooth plastered surface of pure form. A white painted timber wheel stop sits out from the glazed panel.

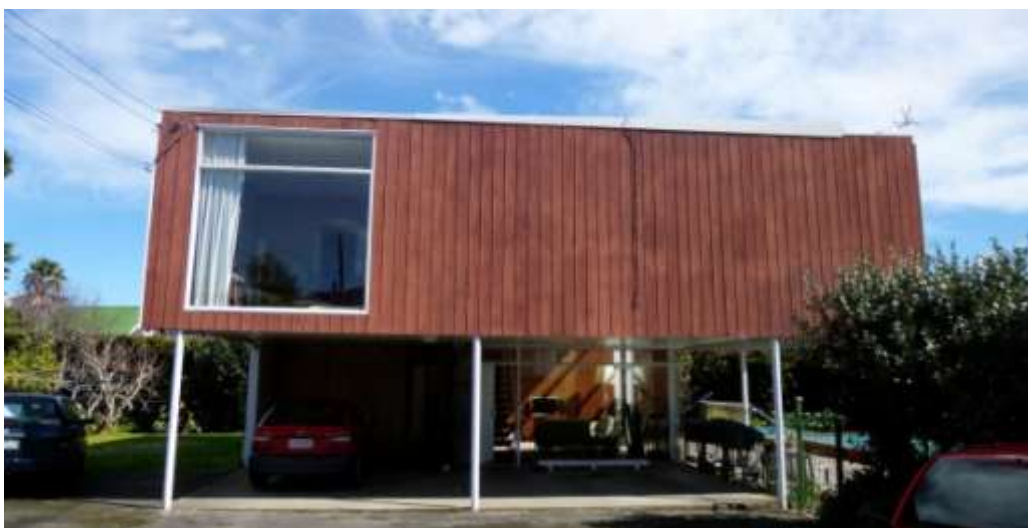
East Elevation, Image: B&T Architects 2014

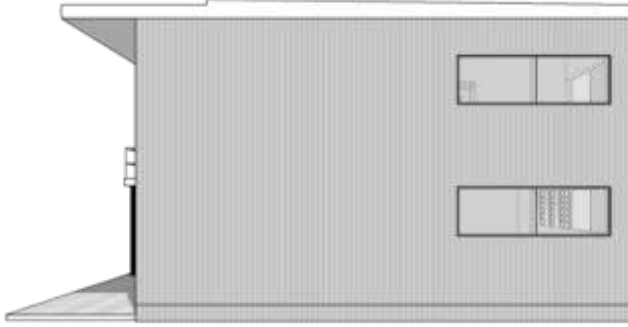
Blumenthal House, West Elevation: LK Burgess & Treep Architects 2014

The western wall of the house is very plain, a rectangular surface with the roof edge expressed as a narrow cantilever at the northern top corner. The wall projects beyond the south face of the building in order to frame that southern elevation. The wall is clad in vertical tongued + grooved boards down to a horizontal base board above the concrete foundation. The wall is finished as much as possible as a plane, with no extruding or recessed elements. There are two windows in the wall, one on each level. Both are at the southern end, and vertically in line. The windows are detailed to be as close to flush with the wall surface as possible. The windows have sash-less sliding glass panels.

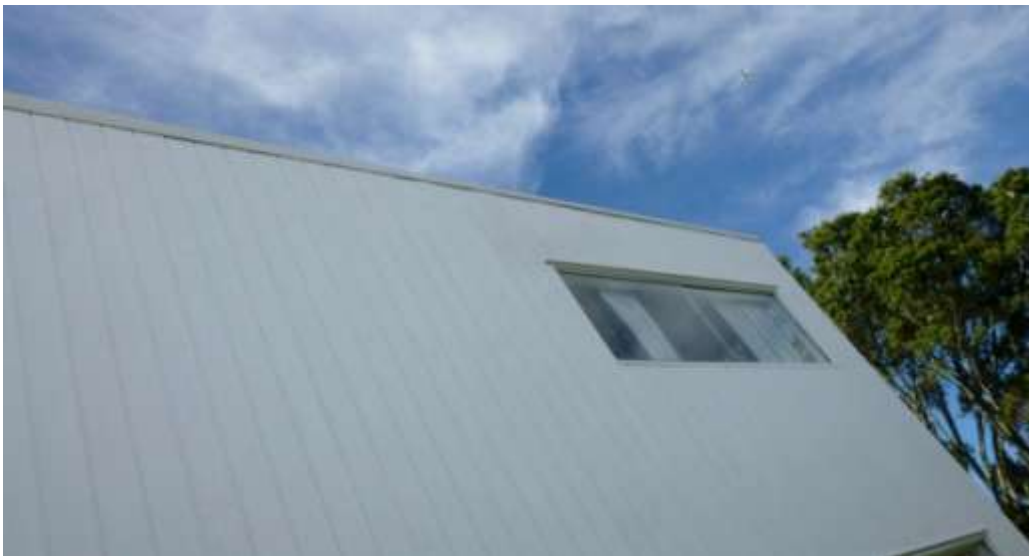
West Elevation, Image: B&T Architects 2014

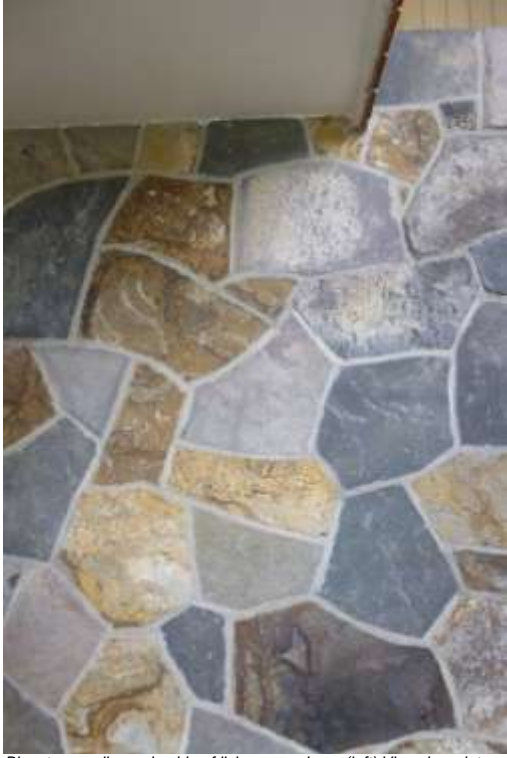
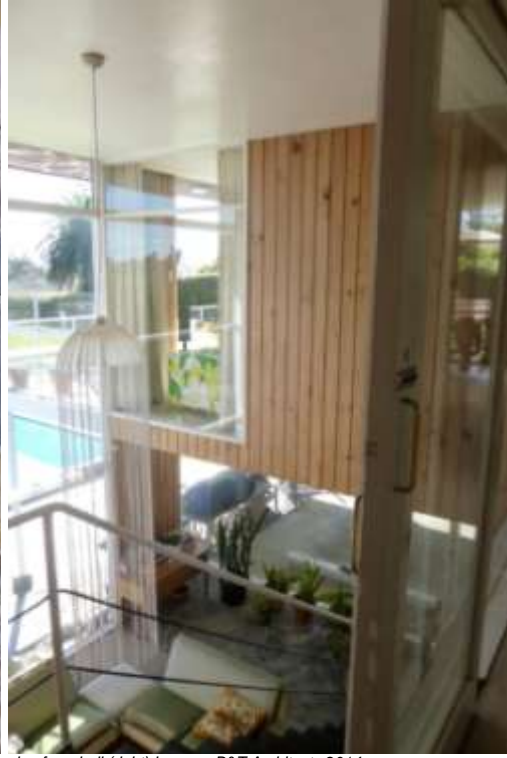
Bluestone wall + underside of living area above (left) View down into garden from hall (right) Images: B&T Architects 2014

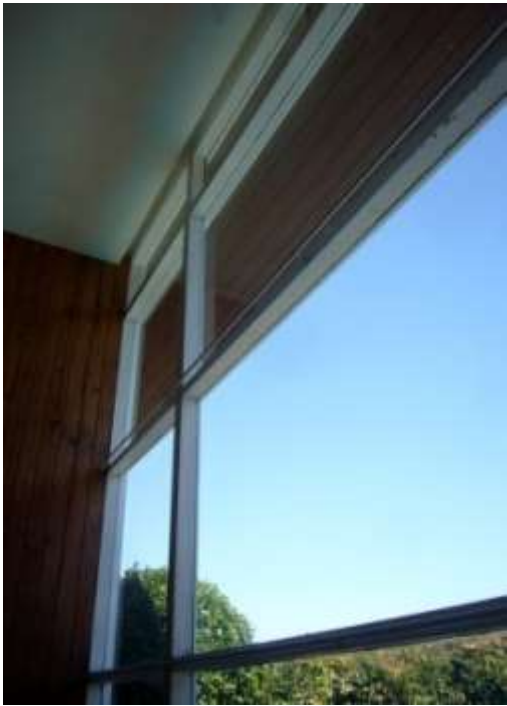
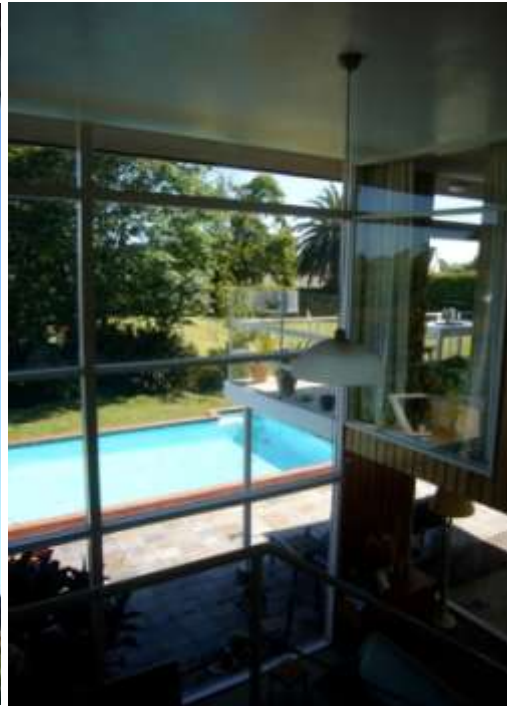
Double height joinery unit with structural steel rods (left) View across garden room from top of stair (right) Images: B&T 2014

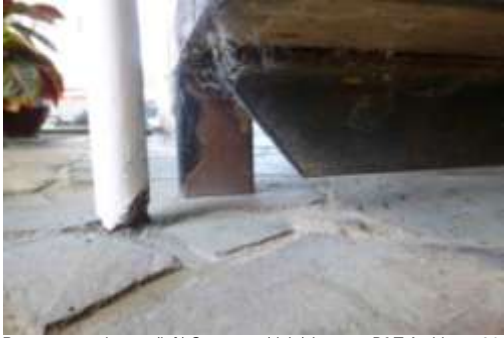
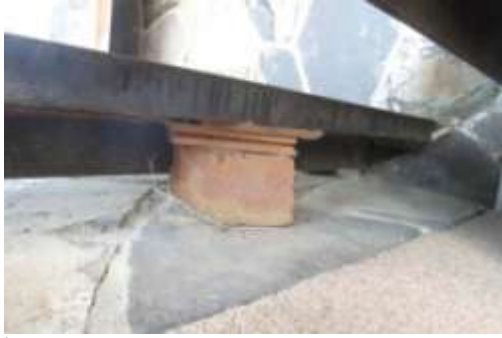
Post rust + stair prop (left) Step prop (right) Images: B&T Architects 2014

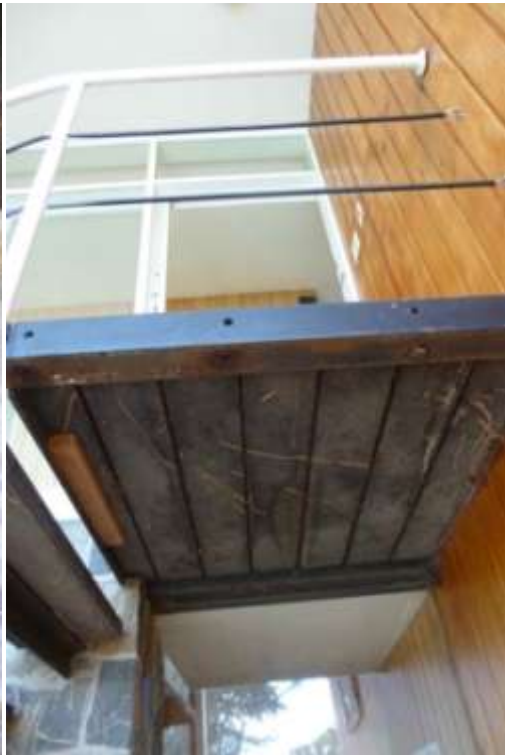
Underside of stair tread (left) Underside of landing showing glazed partition wall (right) Images: B&T 2014

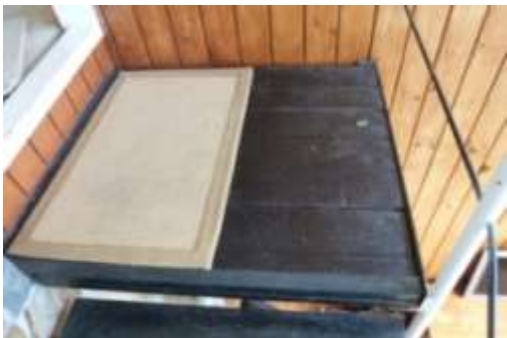
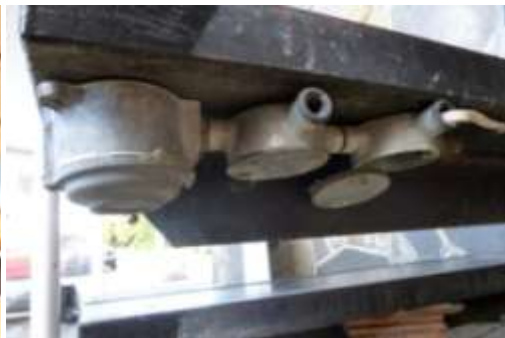
Stair landing (left) Garden irrigation system mounted under stair treads now defunct (right) Images: B&T 2014

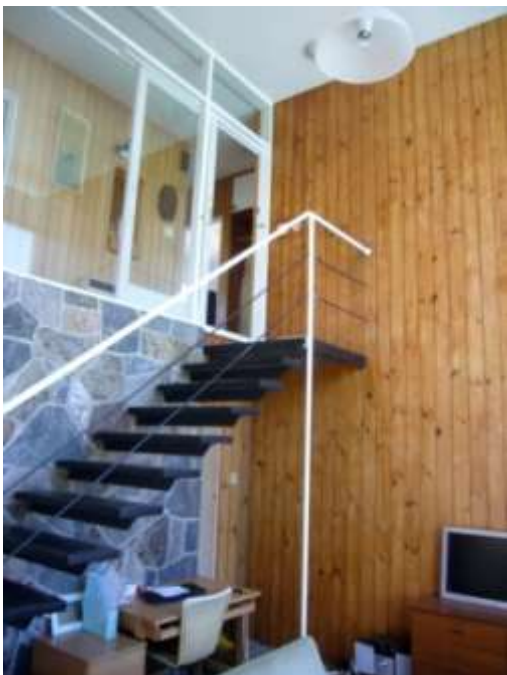
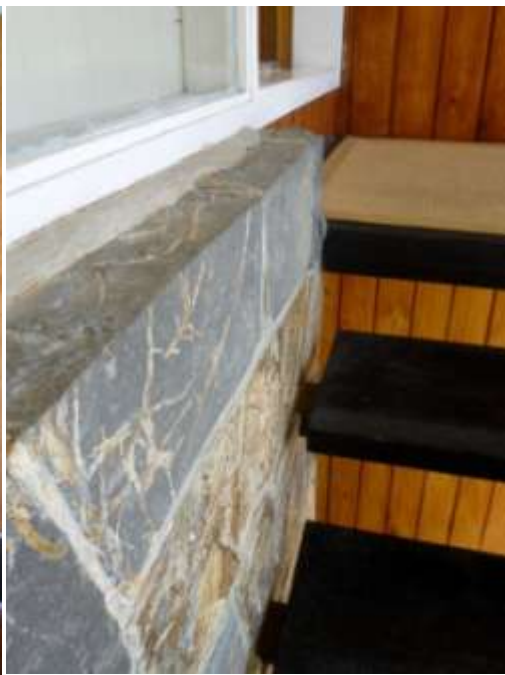
Showing stair and pipe hand rail (left) Stair tread connection to bluestone wall (right) Images: B&T 2014

The entry to the house is direct into the garden room. The floor of the living room above cantilevers over the entry/eastern side of the room compressing the entry. The stair to the upper floor is directly ahead of the door and is formed of treads cantilevered out of the central stone wall. At the time Malcolm Walker Architects worked on plans for extensions to the house in 2000, the area of the room beneath the living room was finished in stone “crazy paving”, the remaining area was an internal garden with tropical and subtropical plants, some very large. The garden was removed in 2012.

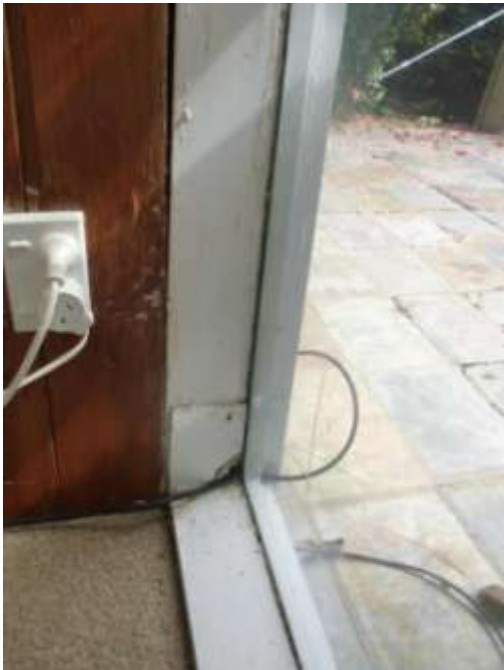
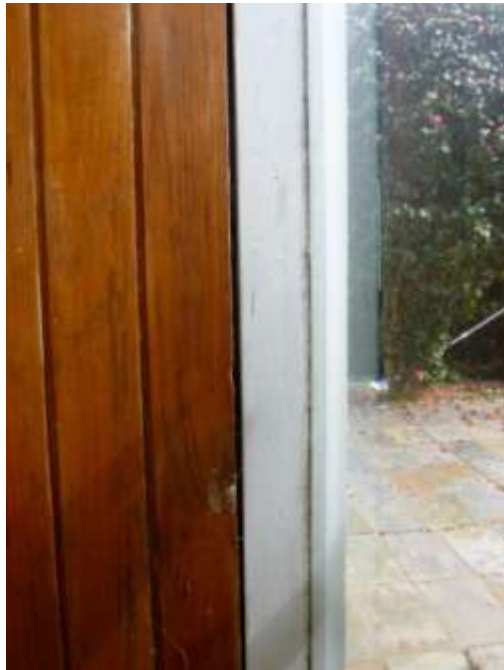
Base corner of joinery frame (left) Panel + joinery intersection (right) Images: B&T Architects 2014

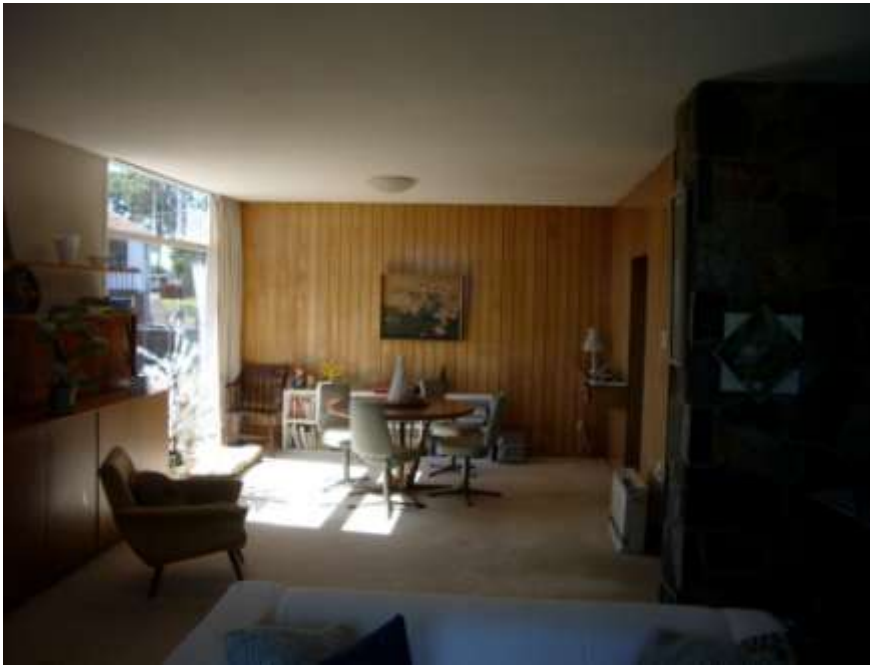
Looking through to dining area from lounge, Image: B&T Architects 2014

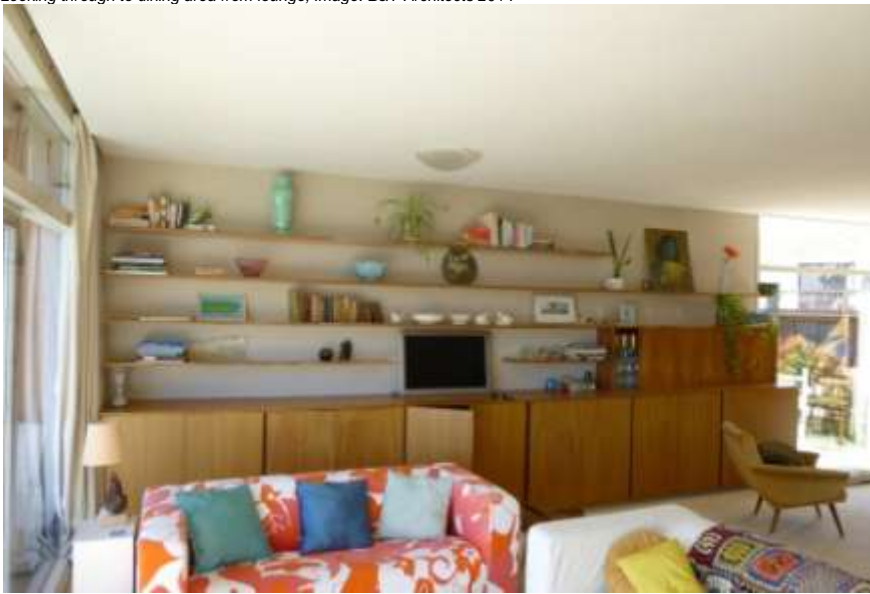
Built in cabinetry unit on east wall, Image: B&T Architects 2014

At the south end of the eastern wall is the square joinery panel hard to the corner. The ceiling across the opening is recessed to provide a reveal for the curtain track. The south wall to the right of this is solid and finished in vertical t & g panelling, as are the walls of the kitchen that face the dining room. The eastern wall to the left of the opening is taken up entirely by a sculptural rectilinear shelf and cupboard unit set against a painted fibrous plaster wall surface. The shelves, supported on steel rods drilled into the wall framing, are impossibly thin. The cupboard unit below the shelves, that runs right across to the edge of the window opening has a similarly thin timber surface. The cupboard units have been modified. Period photographs show the units hovering above the floor.

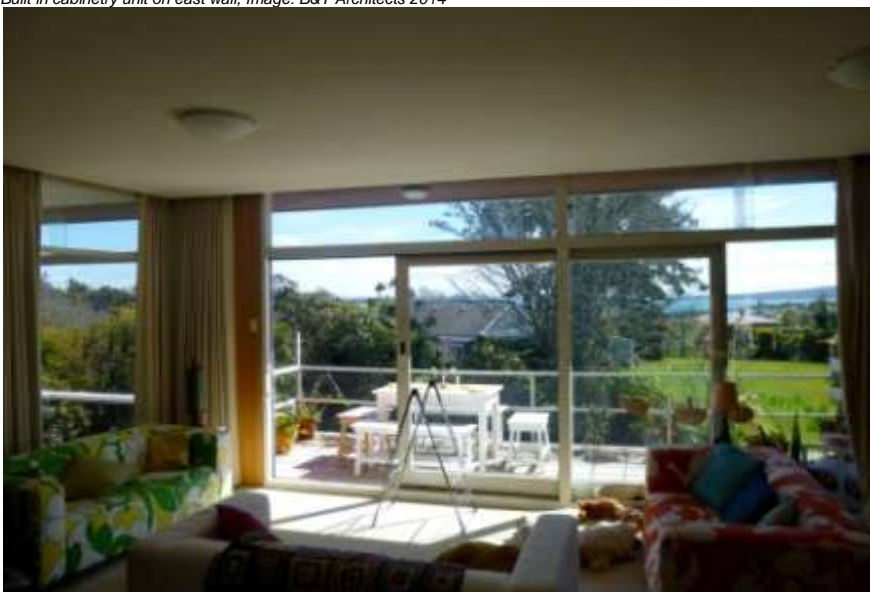
View north to balcony from living area, Image: B&T Architects 2014

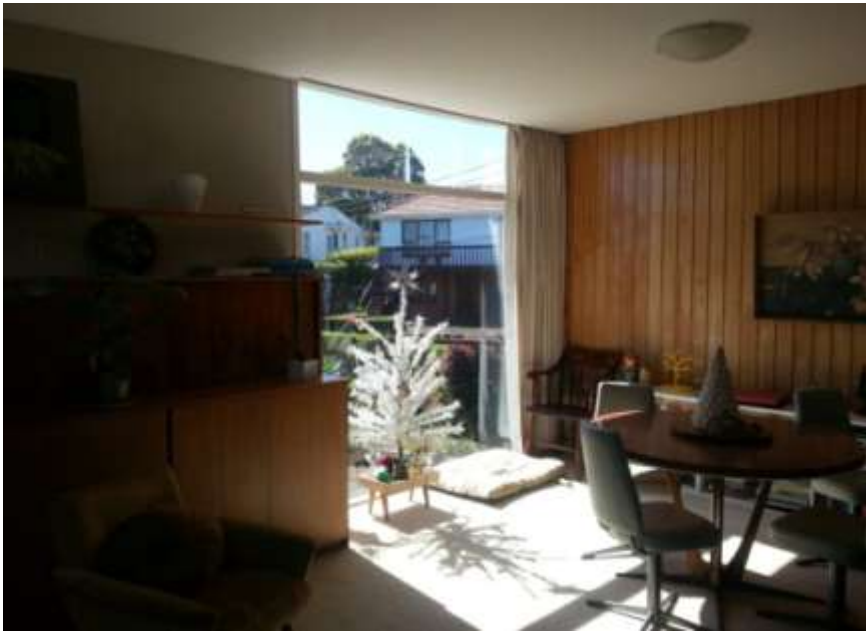
South east corner of living area, Image: B&T Architects 2014

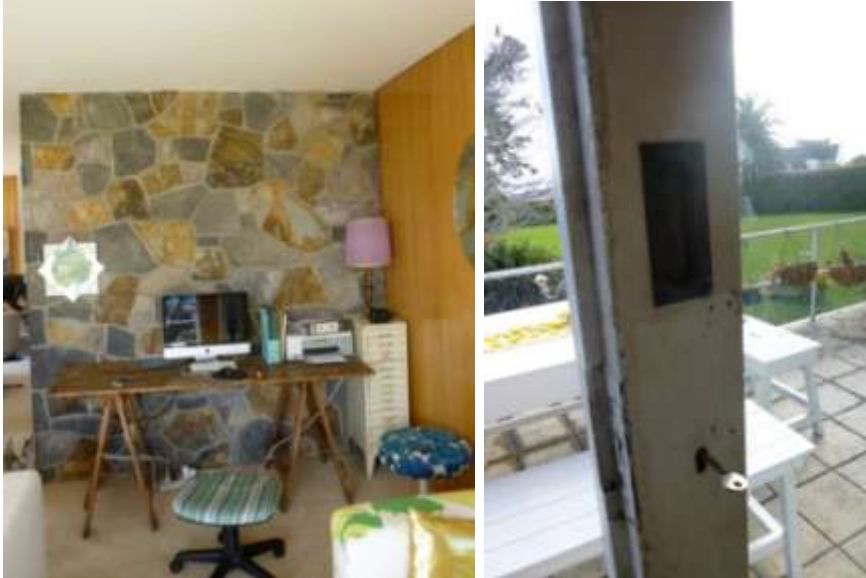
Stone wall in living (left) Sliding door detail (right) Images: B&T Architects 2014

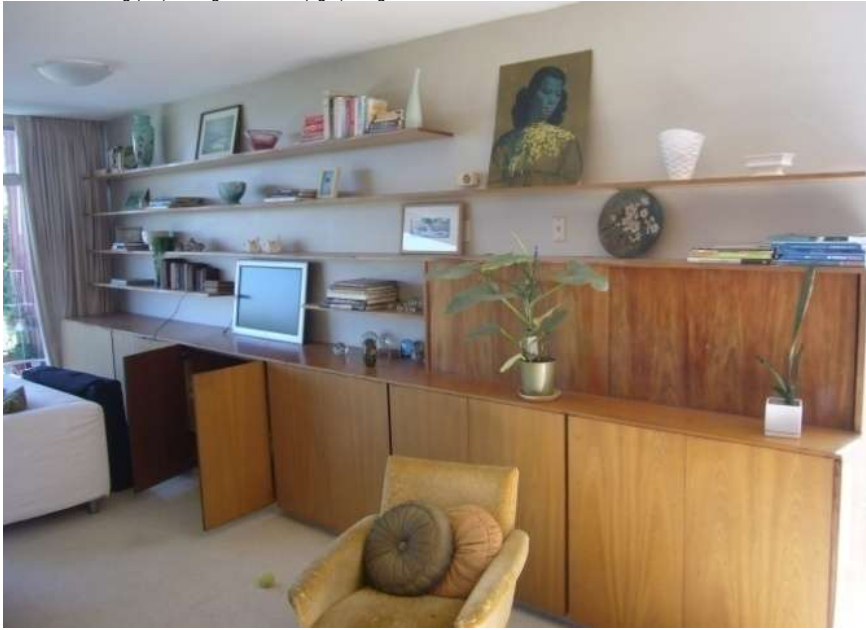
East wall cabinetry unit, Image: B&T Architects 2014

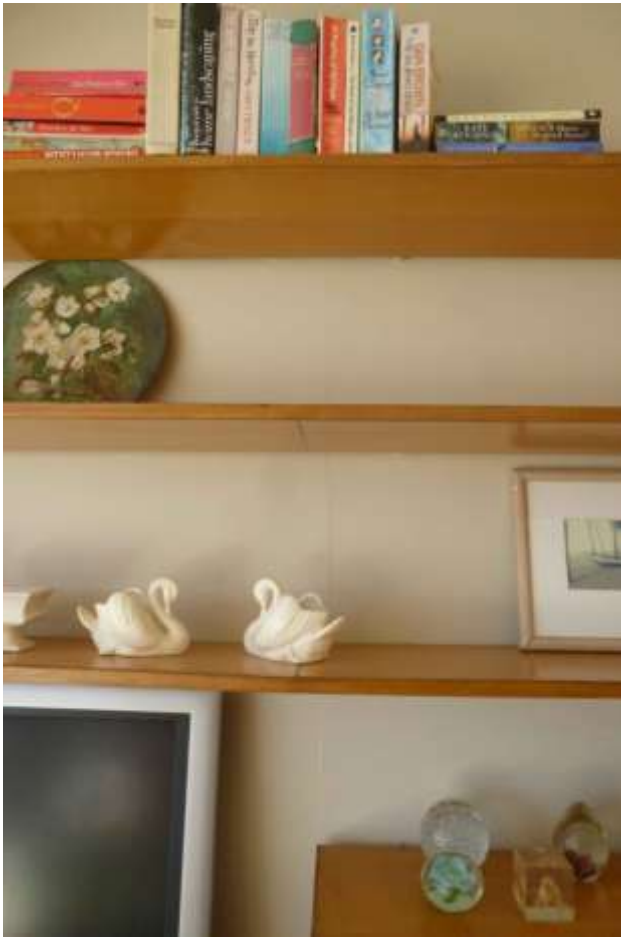
Shelving detail, Image: B&T Architects 2014

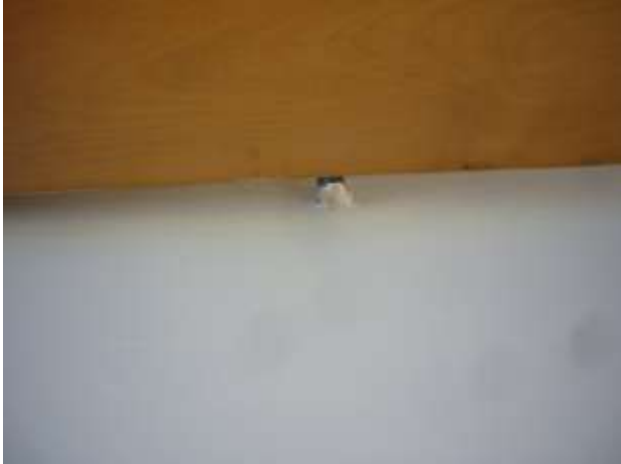
Shelving detail, Image: B&T Architects 2014

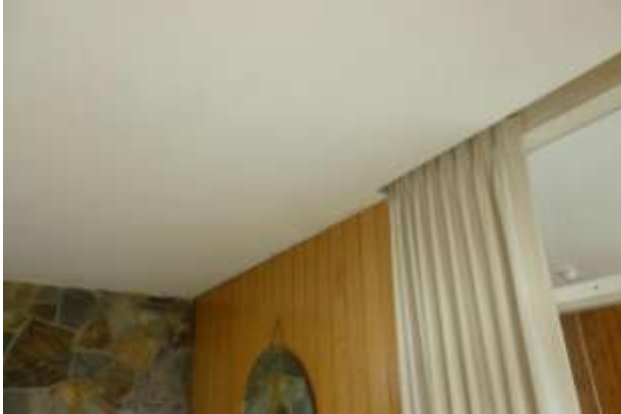
Ceiling at North West corner, Image: B&T Architects 2014

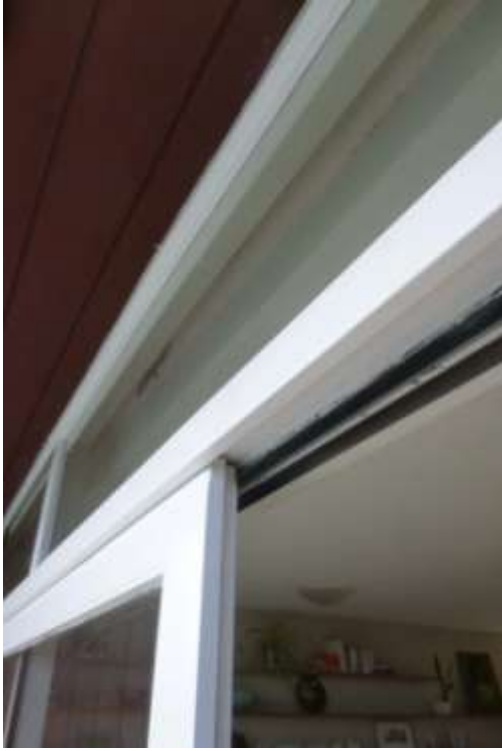
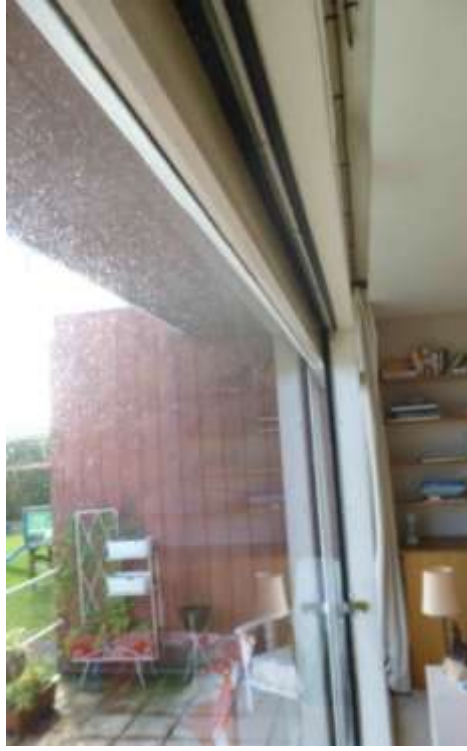
Exterior of sliding door (left) North wall across (right) Image: B&T Architects 2014

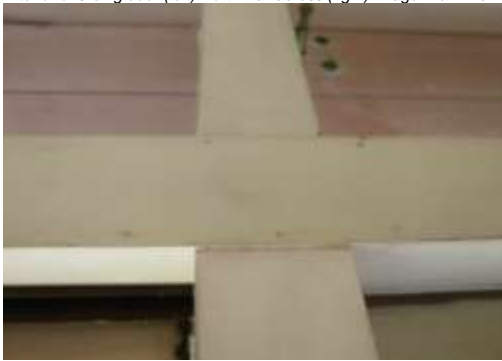
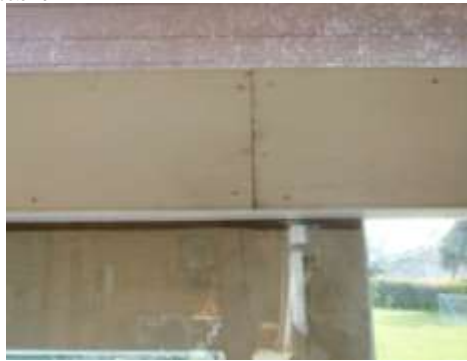
Joinery frame detail (left) Veneer detail on joinery frame (right) Images: B&T Architects 2014

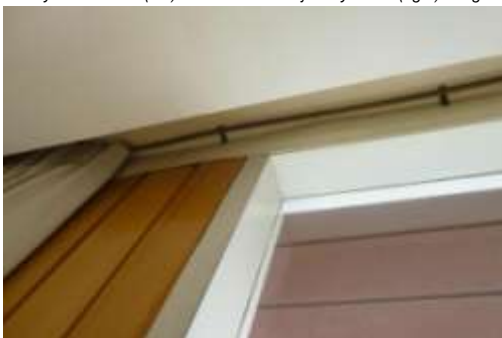
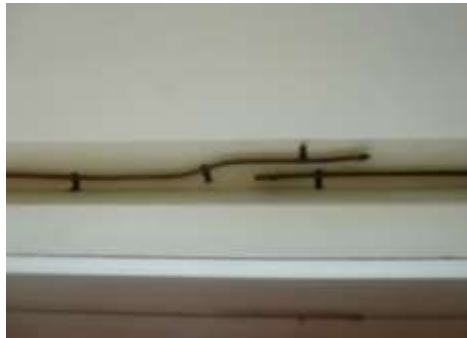
Recessed curtain tracks (left) Curtain track reveal detail (right) Image: B&T Architects 2014

The cabinetry unit stops short of the northern wall to allow for curtains. The ceiling has a deep recess right across the north wall for the curtain track. This recess runs across the face of the solid panel at the left hand side of the wall and returns across the fixed window unit on the west wall looking into the garden room. The fixed panel at the left hand side of the north wall is finished in t & g vertical boards, as is the solid section of the west wall between the internal window and the stone wall. On the north wall the joinery is divided by the external grid into two equal sections horizontally and two sections vertically, a lower panel to door height with the remainder a top light up to ceiling height. The horizontal rail runs through each of the joinery units in the room, all the detail is in line. The left hand lower panel is a large timber framed external slider. The top light panel above this is fixed. The panel to the right at the eastern end is fixed. The top light above this has sliding frameless glass panels.

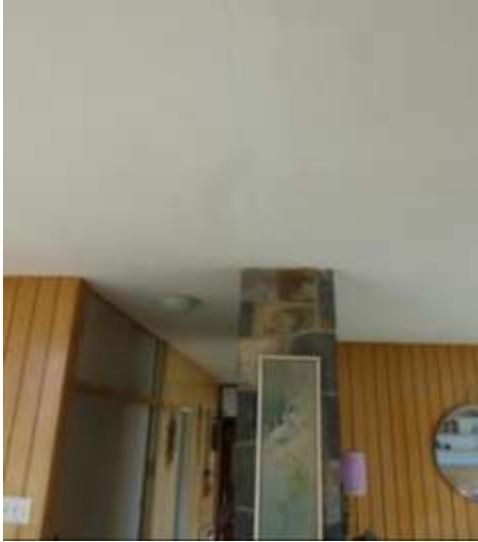
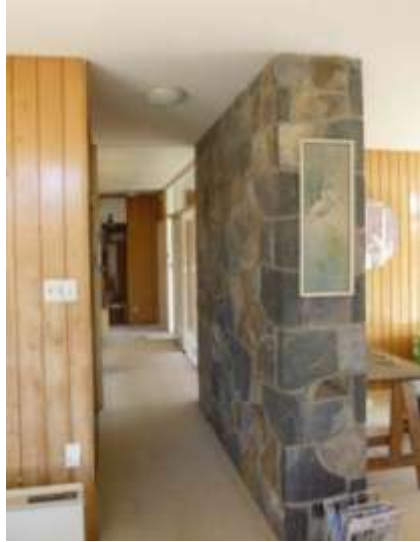
Hall ceiling (left) Ceiling across from hall (right) Image: B&T Architects 2014

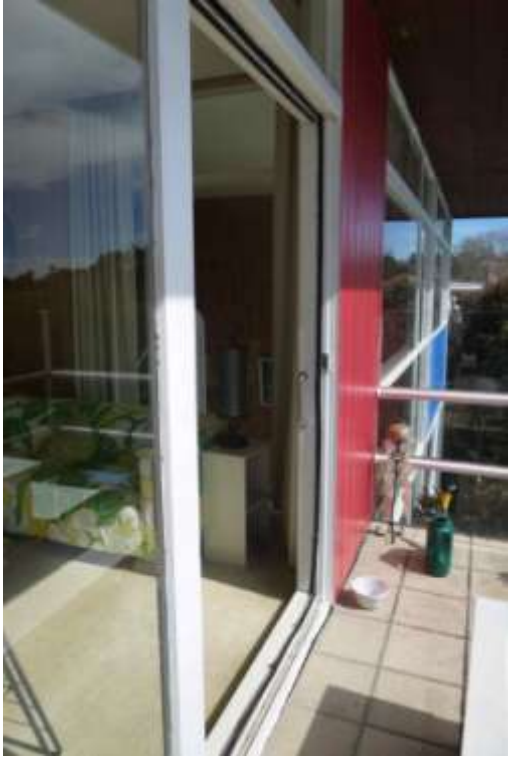
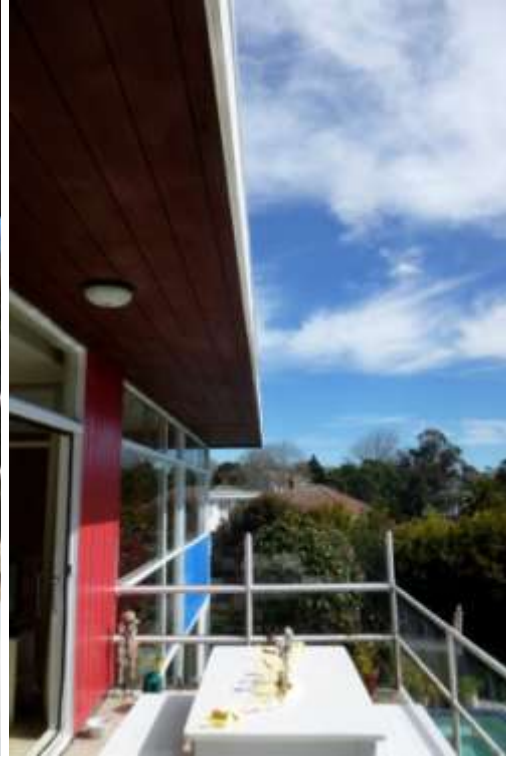
West end +door (left) View west showing glass balustrade (right) Images: B&T Architects 2014

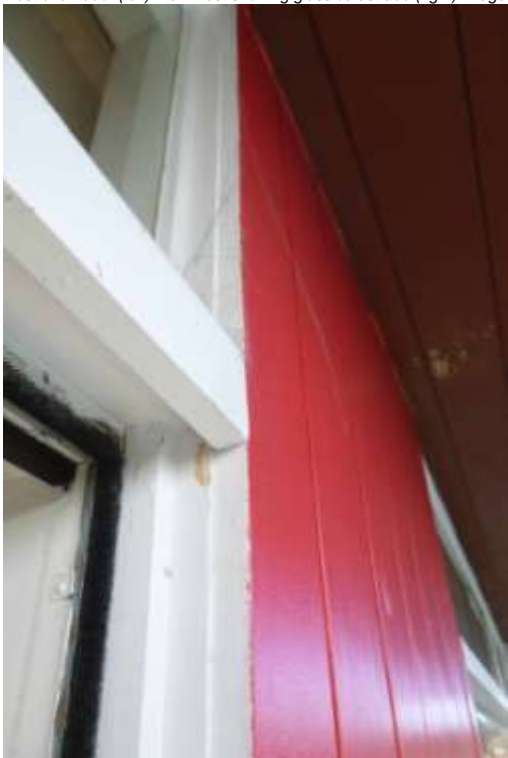
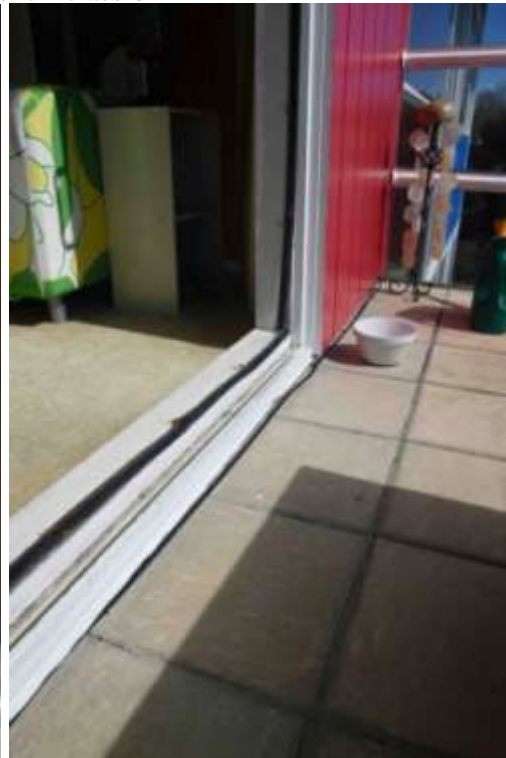
Panel + joinery junction (left) Sliding door track & deck pavers (right) Images: B&T Architects 2014

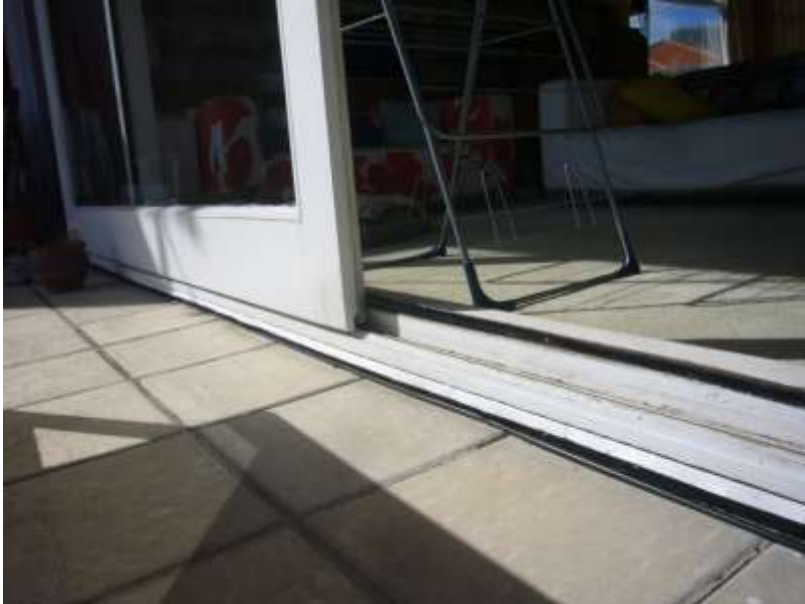
Sliding door opening, Image: B&T Architects 2014

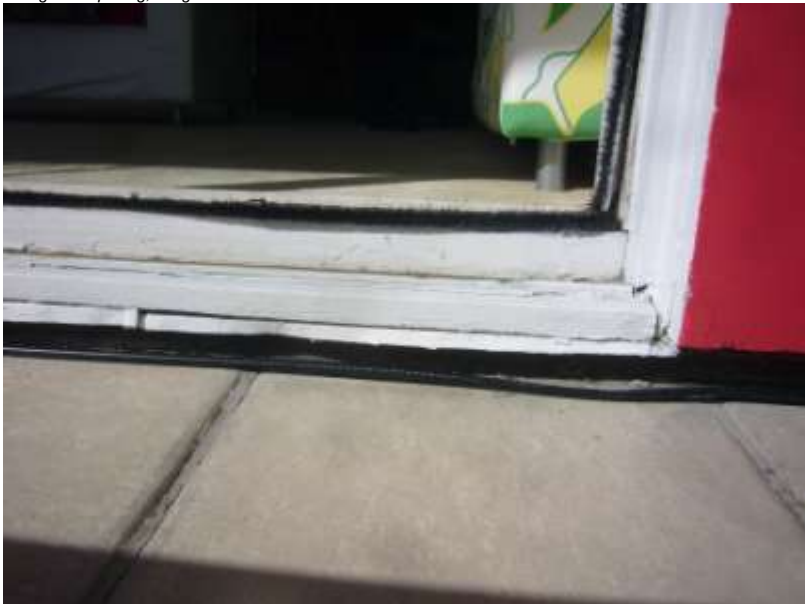
Sliding door threshold, Image: B&T Architects 2014

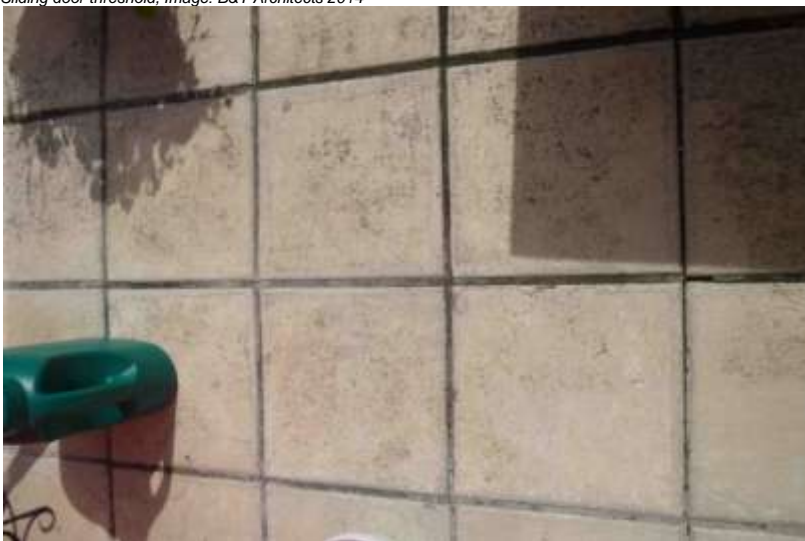
Deck pavers, Images: B&T Architects 2014

The sliding door opens onto a deck terrace the full width of the living room. The deck is 2.5 m deep. The deck surface is finished in square tiles. The deck surface is described on the 1958 drawings as “Asbestos tiles” on “one layer 15lbs asbestos felt in hot bitumen”. The deck has a 175 PFC frame supporting the outside edge. The deck was originally fully cantilevered. The deck rail is fabricated of pipe rail. It is very open.

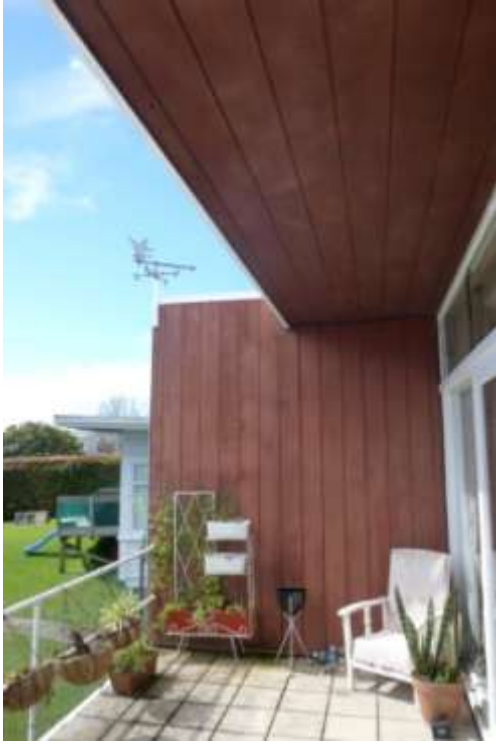
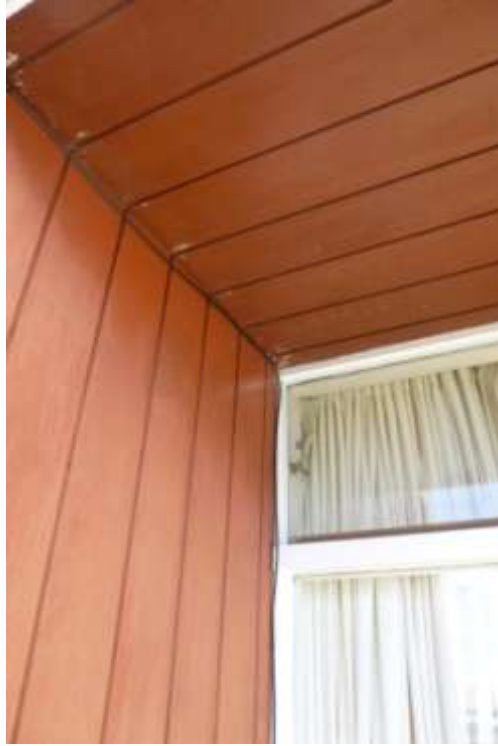
Eastern wing wall on balcony (left) Wall, soffit + joinery intersection (right) Images: B&T Architects 2014

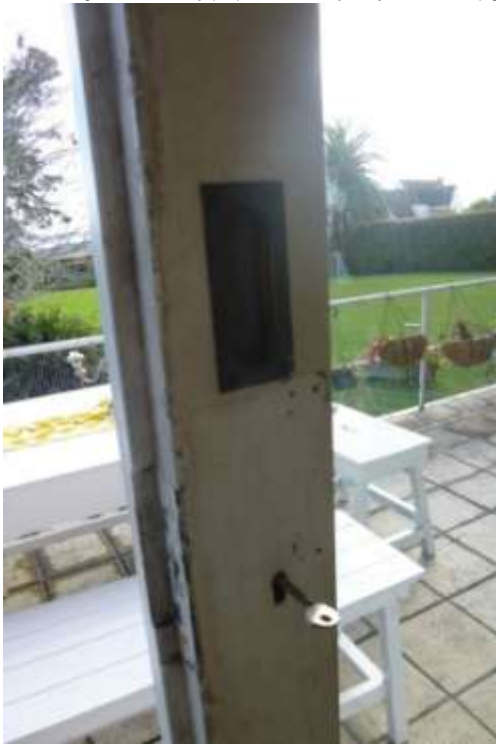
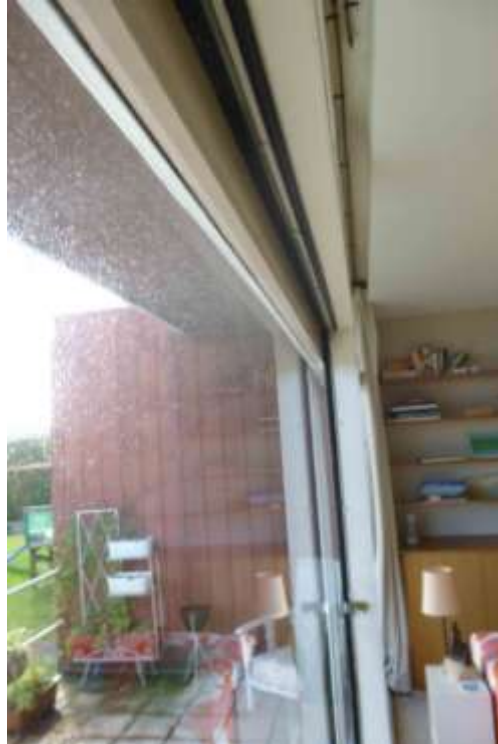
Sliding door lock + recess handle (left) Doors and deck viewed from inside living (right) Images: B&T Architects 2014
