BLUMENTHAL HOUSE

317 St Heliers Bay Road, Auckland, New Zealand. Built in 1958,
Architect: Vladimir Cacala

CONSERVATION PLAN

Prepared By Burgess + Treep Architects Ltd, Graeme Burgess + Lilli Knight
April 2015

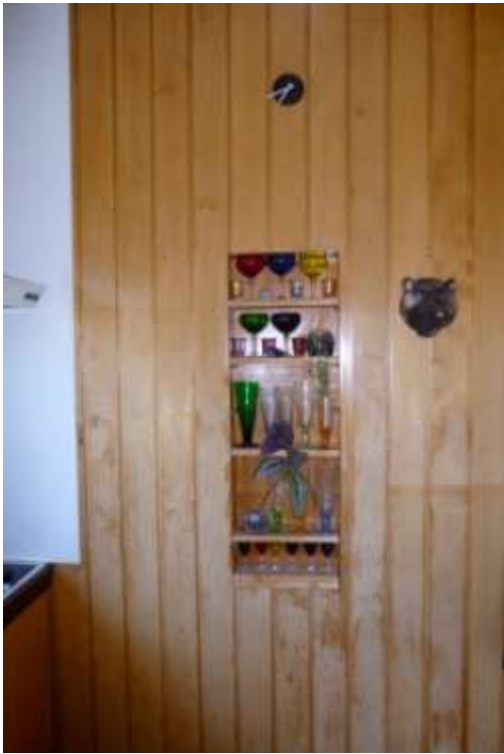
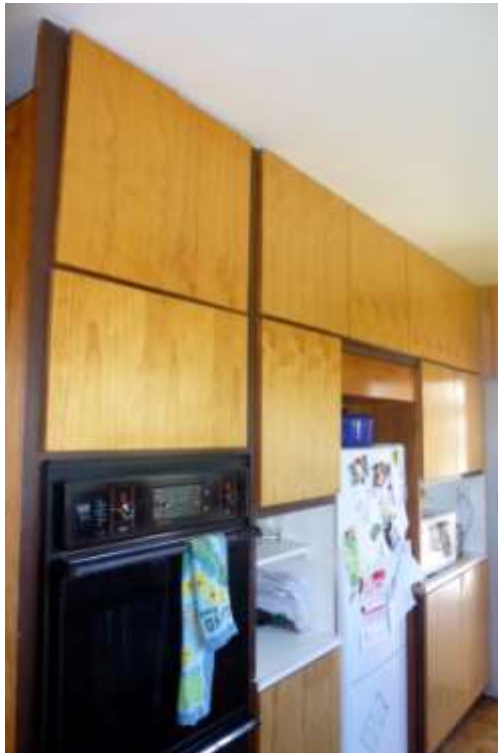
Built in spice shelf, west wall (left) Kitchen cabinetry + fridge recess, north wall (right) Images: B&T Architects 2014

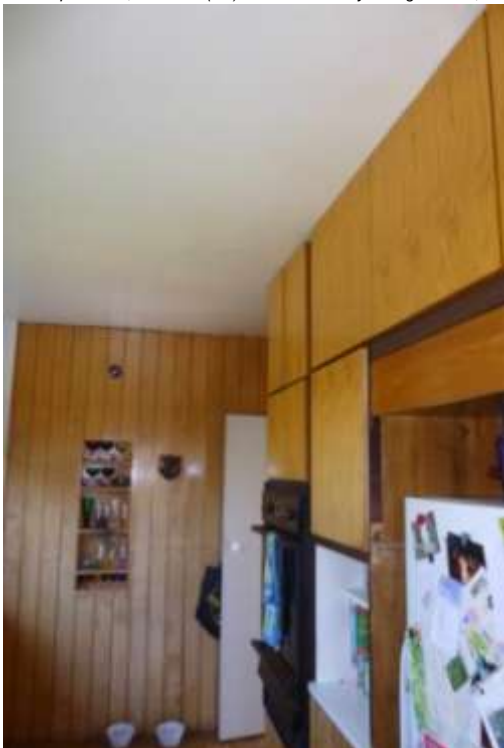
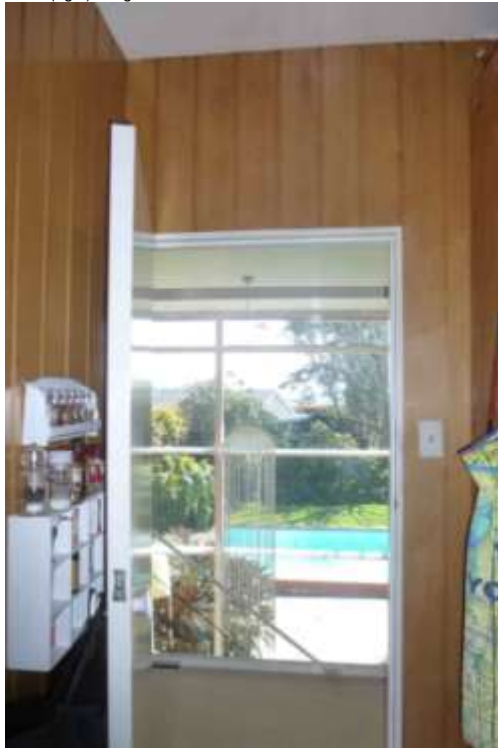
North West corner of kitchen (left) View from kitchen through hall to garden room (right) Images: B&T Architects 2014

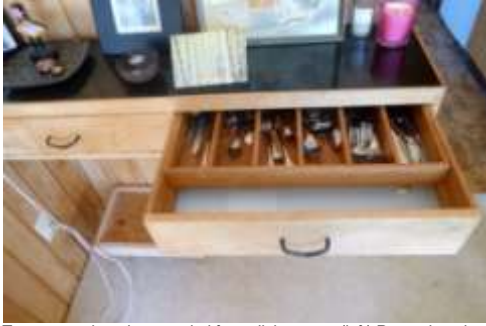
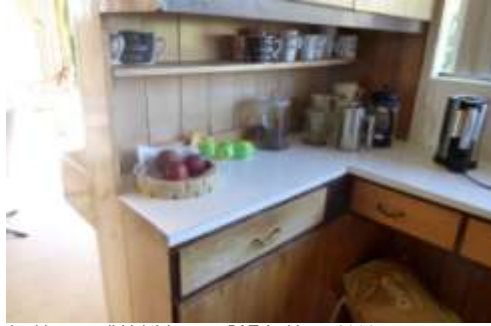
Two way cutlery draw as viewed from dining room (left) Return bench and cabinetry wall (right) Images: B&T Architects 2014

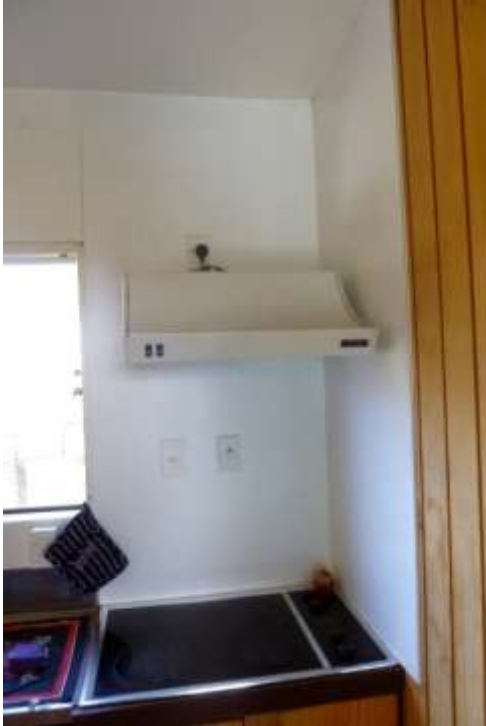
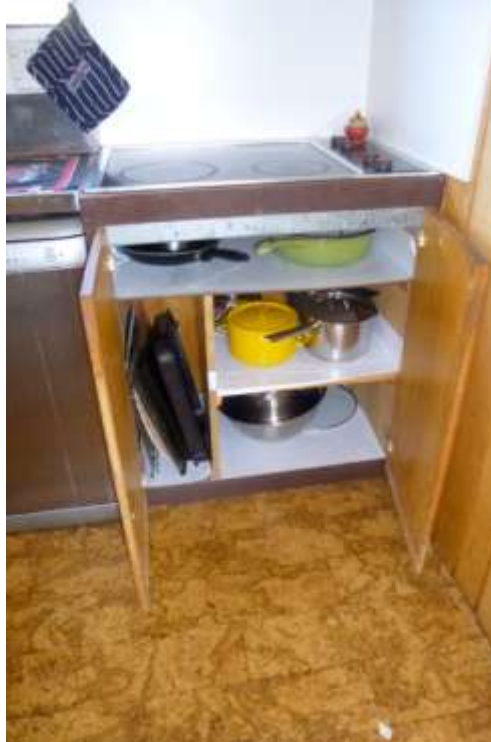
Stove (left) Cabinetry beneath hobs (right) Images: B&T Architects 2014

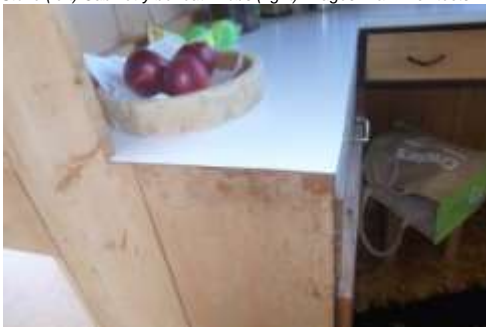
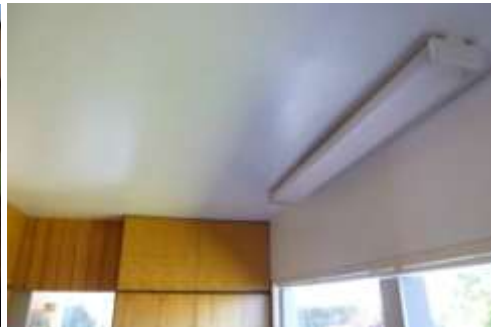
Side panel detail on return bench (left) Kitchen ceiling looking east showing light fitting (right) Images: B&T Architects 2014

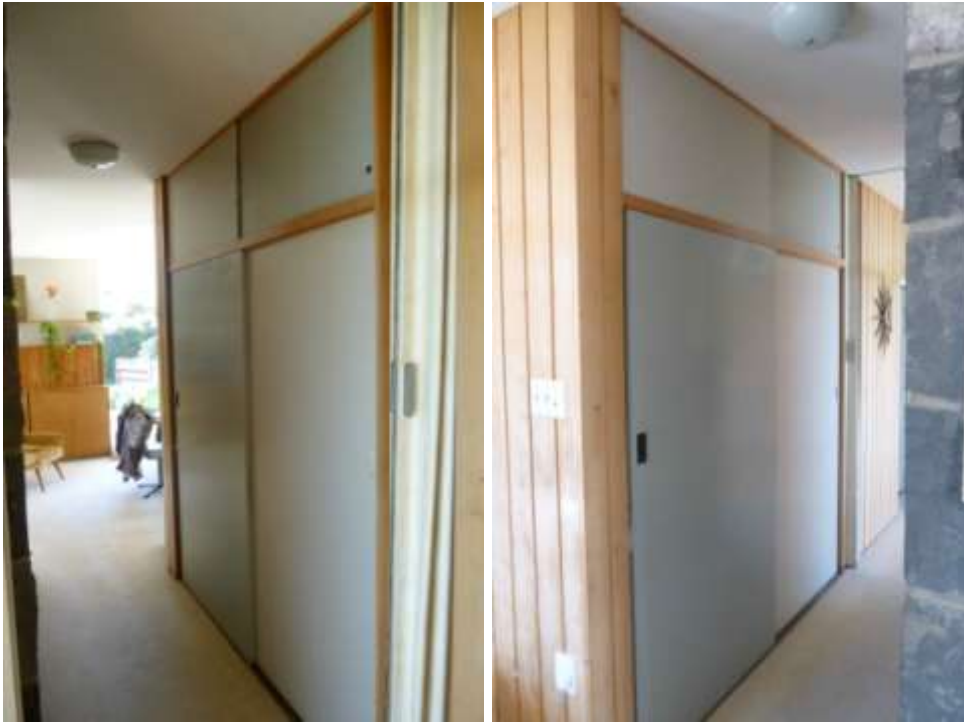
East end cupboards (left) Sliding door top track detail (right), Images: B&T Architects 2014

The upper floor hall is visually open to the garden room, and is part of that space. The hall runs across the house from the living room through to the bedrooms. The wall directly ahead from the landing is clad in vertical t & g boards. A mirrored recess with a single projecting drawer is fitted into the wall. Above the recess is a fixed metal lamp. To the left of this is the door to the kitchen. The door frame, painted white, is finished flush with the wall. The eastern end of the hall narrows. At this end the central stone wall rises up from the entry area below to the ceiling.

The bedroom end of the hall is plain, the walls are finished in t & g boards. The hall has a short leg to the left, creating a small lobby space for the bathroom, toilet and second bedroom. To the right, in line with the main north wall of the hall, is the door to the primary bedroom. At the western end of the hall there is a cupboard recess in line with the wardrobe of the second bedroom behind. The upper section of the cupboard has a flush painted door, the lower section is open, with a single shelf and coat rail. The cupboard recess is solid timber.

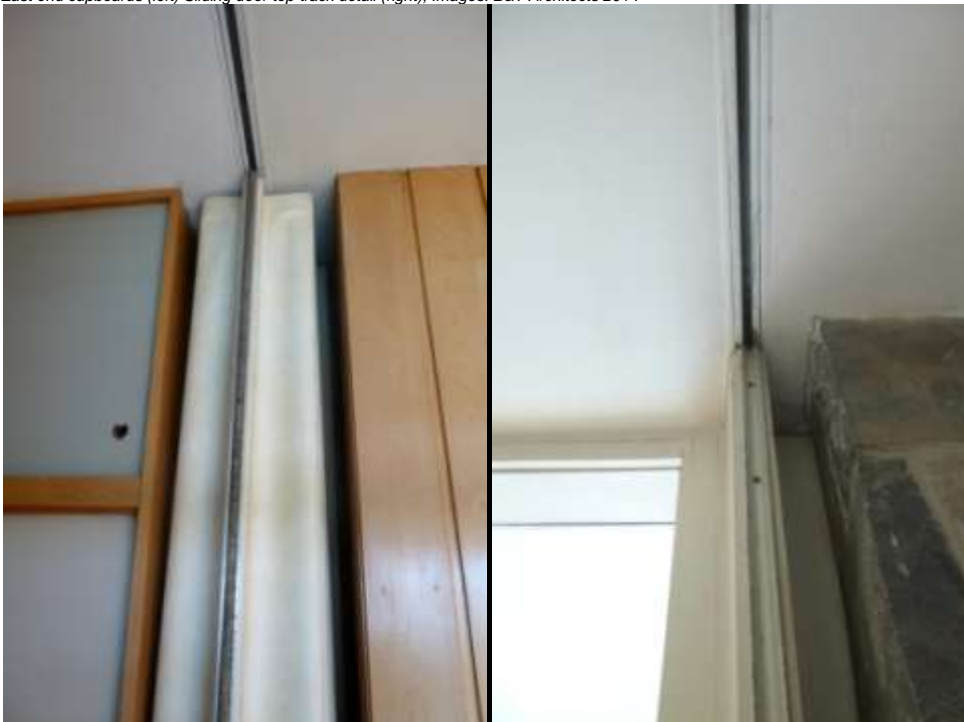
Concertina door open position south wall (left) Sliding door top track detail (right), Images: B&T Architects 2014

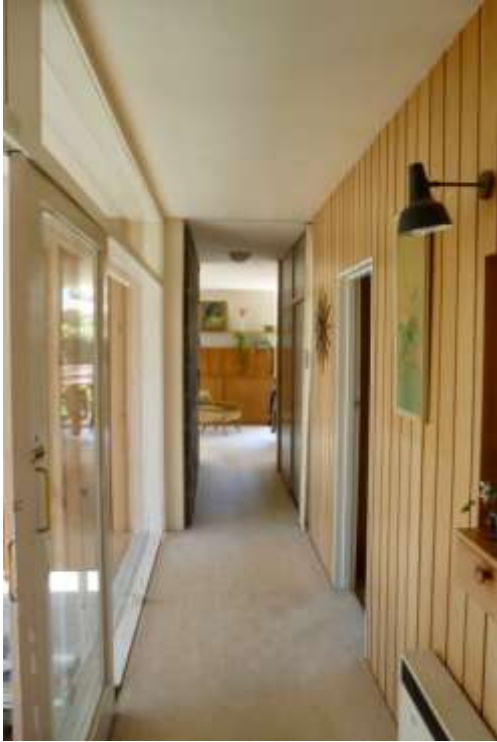
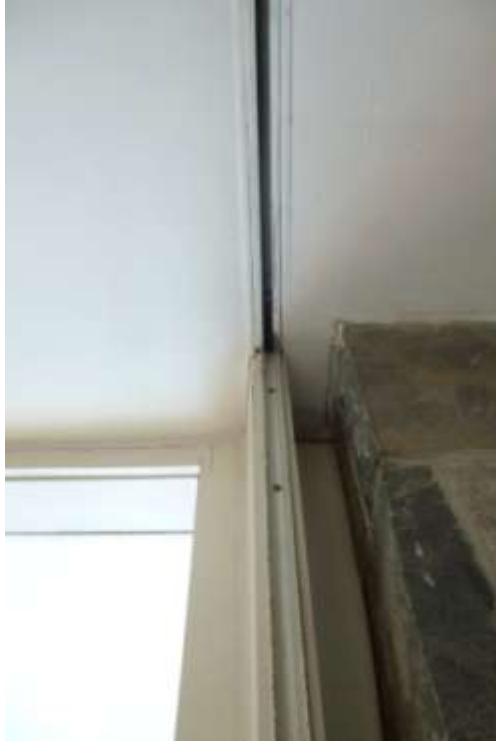
View east down hall from entry (left) Concertina door track + stone wall detail (right) Images: B&T Architects 2014

The stone wall is one of the great elements of the house, its mass anchors the house and provides a counterpoint to the lightness of the exterior. The placement of the wall defines the spaces within the house. The effect of the wall was a key element in the overall house design, as the exterior elevations drawn by Cacala, show the stone wall, an internal element, as if it were an external element. From the hall the stone wall theatrically defines the entry into the living area of the house and directs the view and movement towards the picture window at the southern end of the eastern wall of the house. A concertina vinyl door is fitted in line with the western wall of the living room across the hall at the garden room end of the stone wall. The head track of this unit is concealed within the ceiling. The concertina door remains in place but is not in good condition. On the right hand side of the hall beyond the concertina door, is a floor to ceiling cupboard unit. The lower section of the cupboard, up to door height, has two sliding panelled doors, with a bottom rolling track. The top doors of the cupboard are oil tempered hardboard panels set to slide in grooved timber frames. The area behind the cupboard is the kitchen. This end of the hall is physically within the living area of the house, open to the dining area.

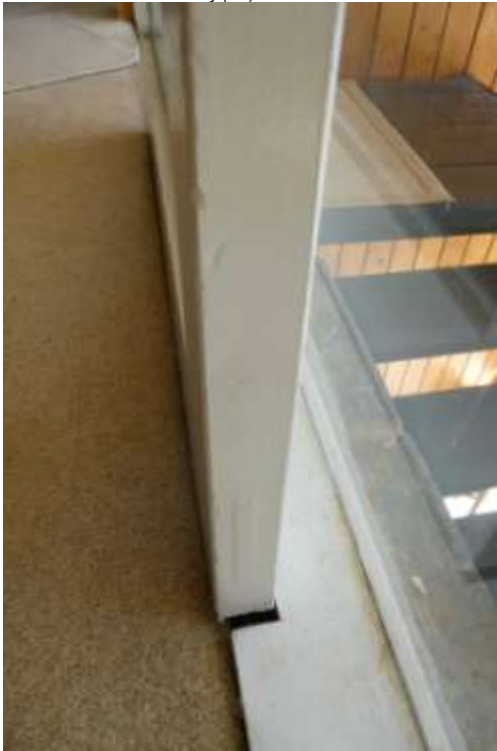
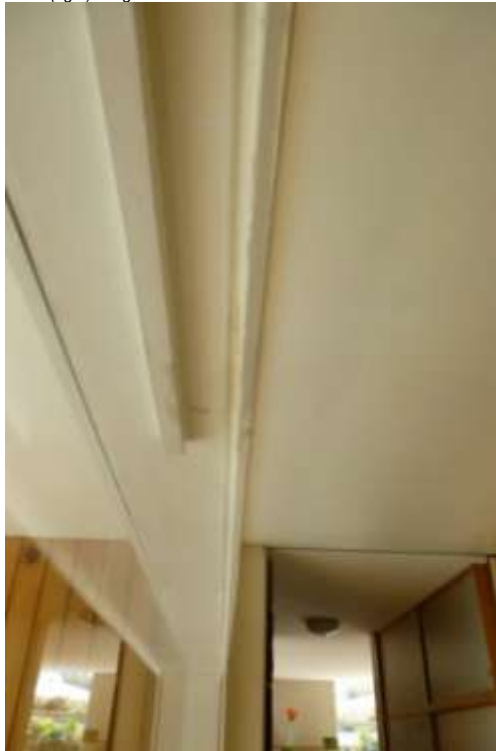
Sliding door bottom track detail (left) Sliding door top track detail (right), Images: B&T Architects 2014

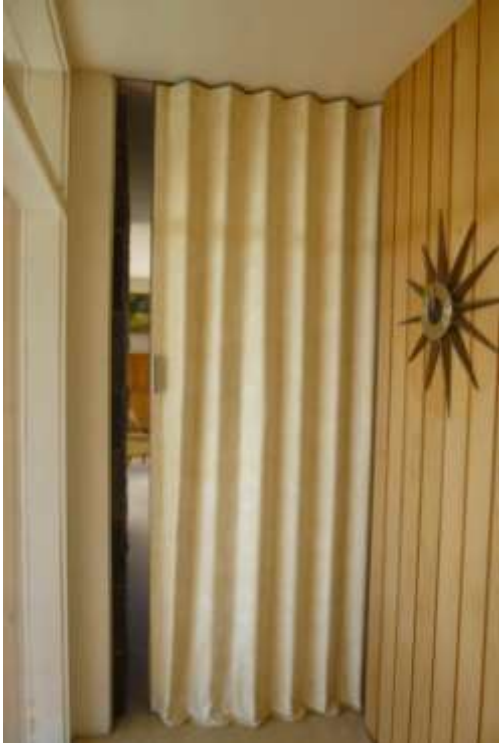
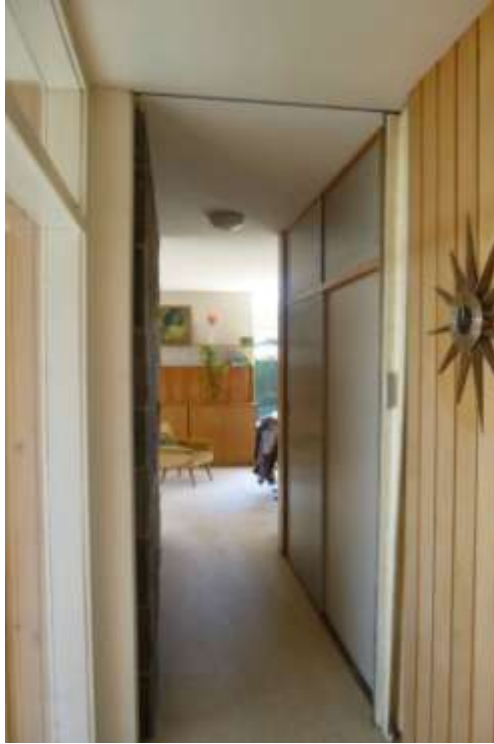
Concertina door closed position (left) Concertina door open position (right), Images: B&T Architects 2014

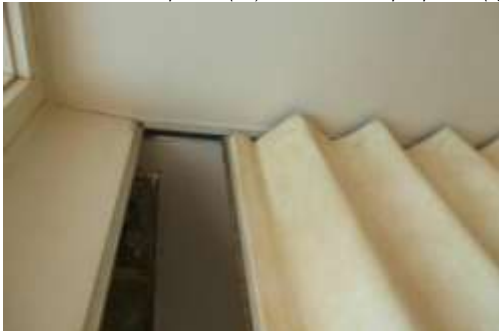
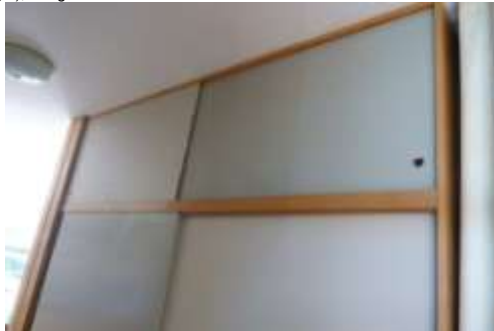
Concertina door track detail (left) Cupboard door detail (right), Images: B&T Architects 2014

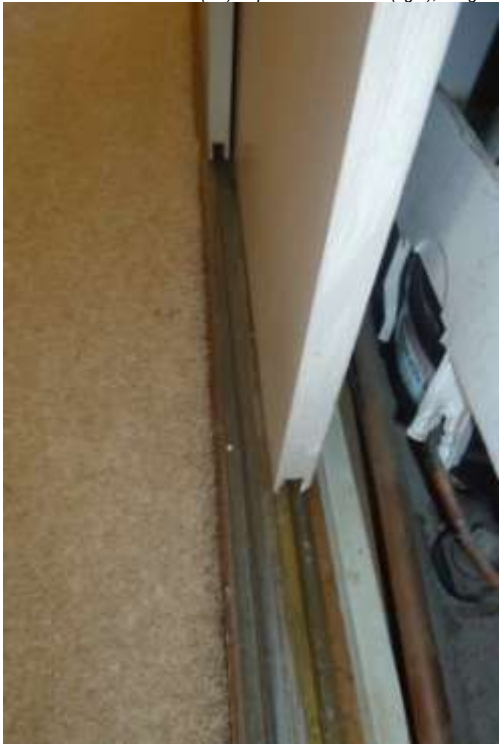
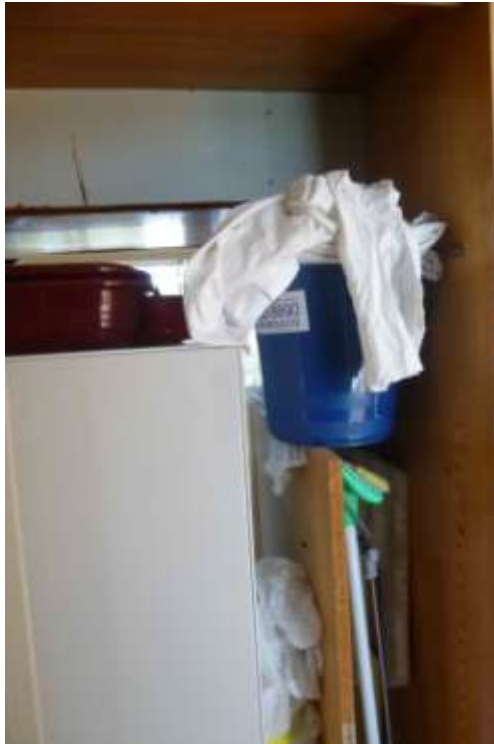
Sliding cupboard door + track (left) Cupboard interior showing fridge recess (right), Images: B&T 2014

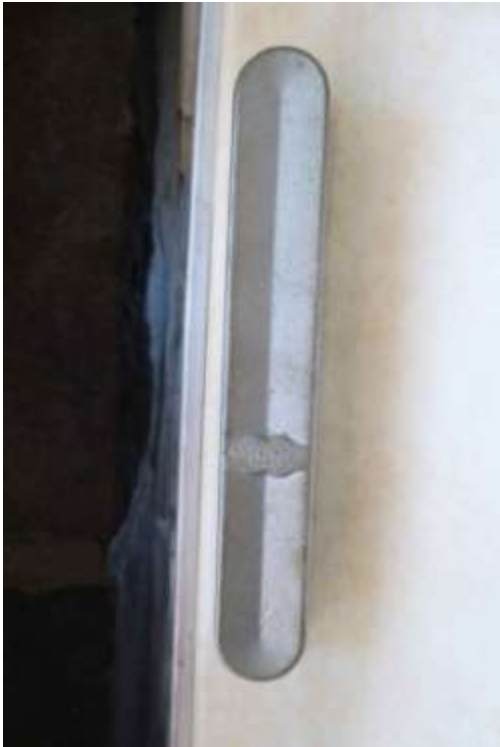
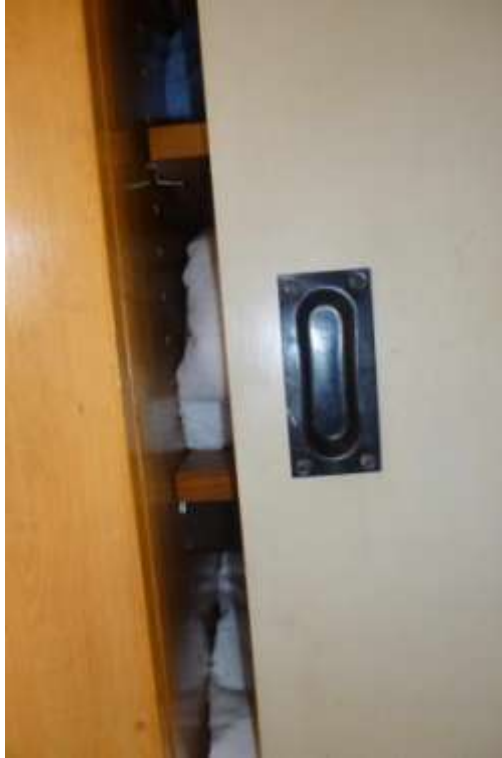
Concertina door handle (left) Recessed cupboard door handle (right), Images: B&T Architects 2014

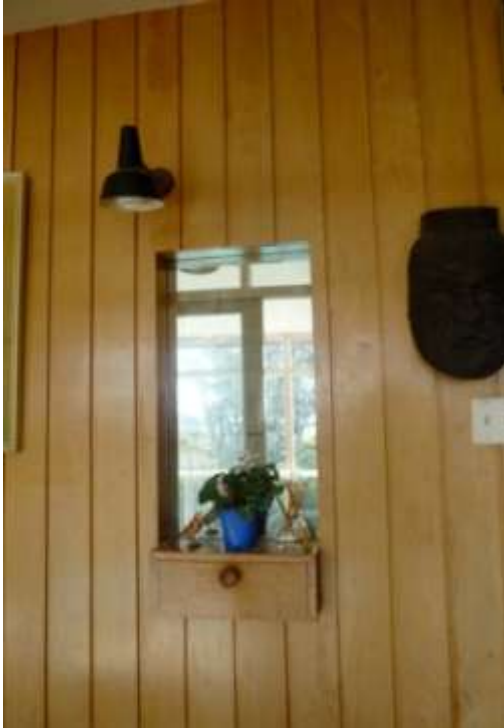
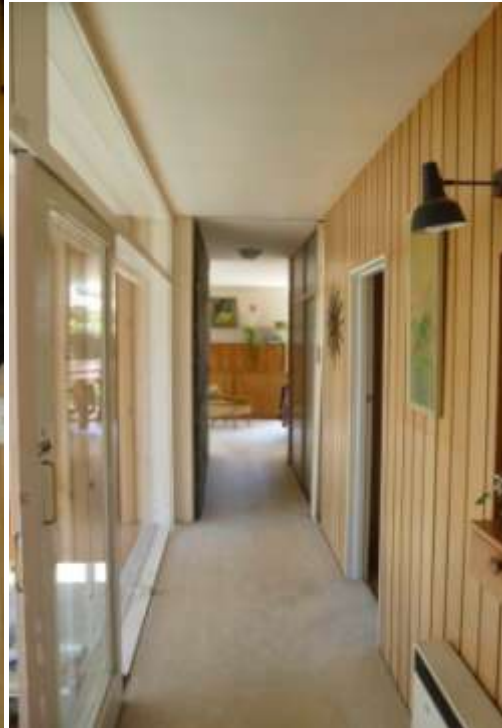
Mirrored telephone recess, lamp above (left) View south down hall from entry (right), Images: B&T Architects 2014

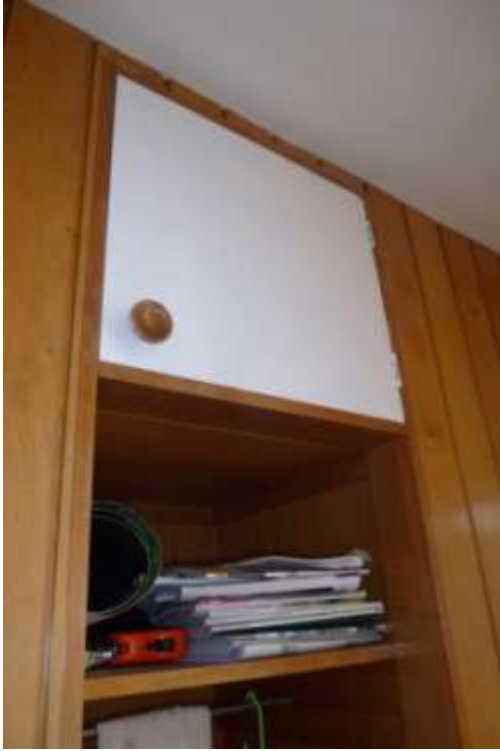
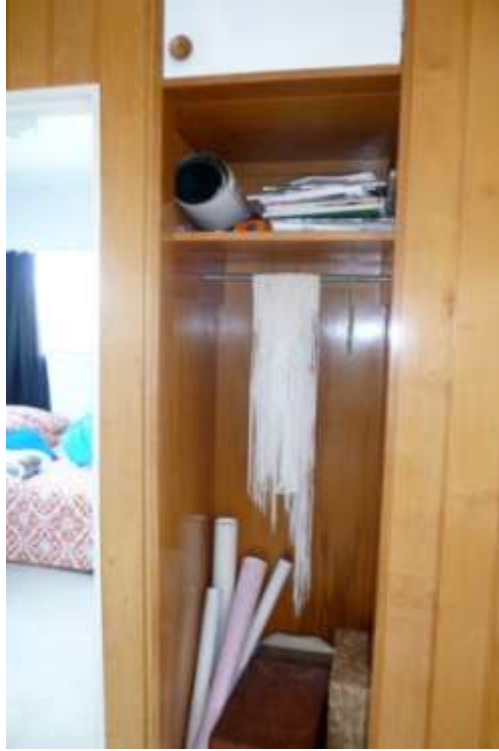
West end coat cupboard door detail (left) West end coat cupboard (right), Images: B&T Architects 2014

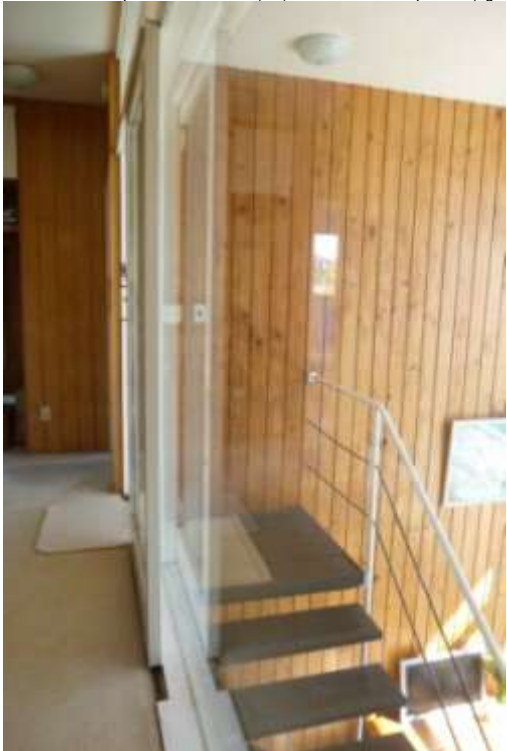
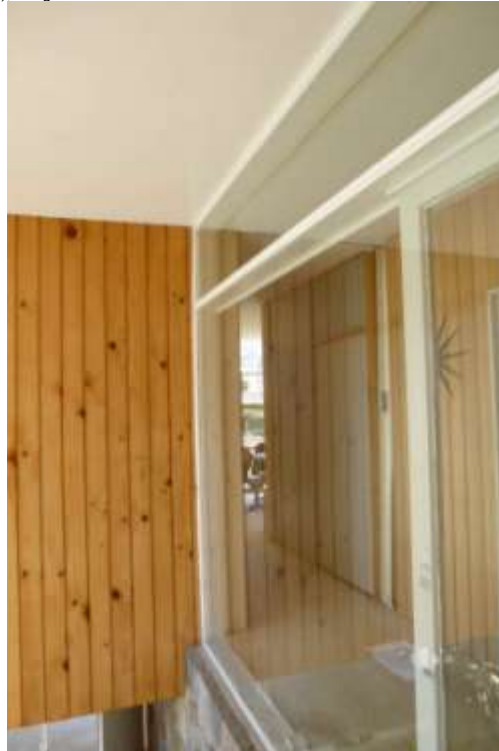
Hall window to garden room + stair (left) View south down hall from stair landing (right), Images: B&T Architects 2014

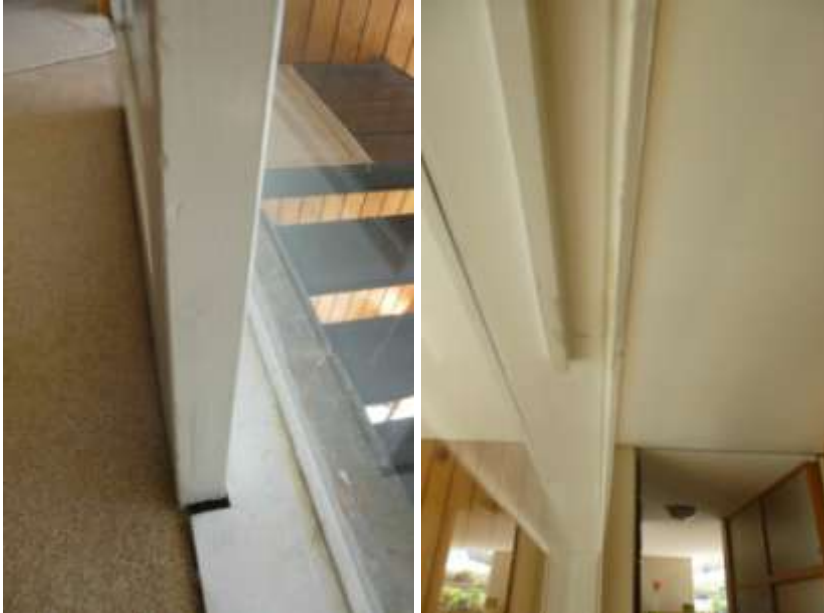
Sliding door open (left) Sliding door guide moulding (right), Images: B&T Architects 2014

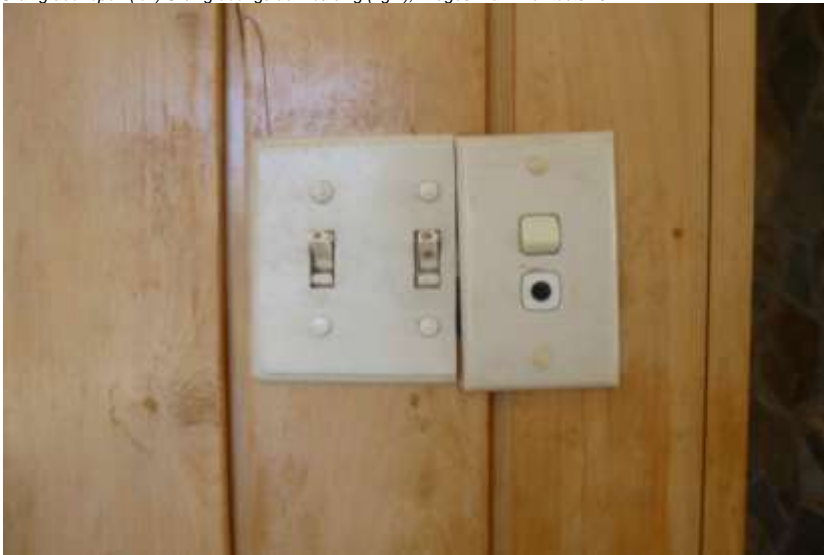
Switches at east end of hall, Images: B&T Architects 2014

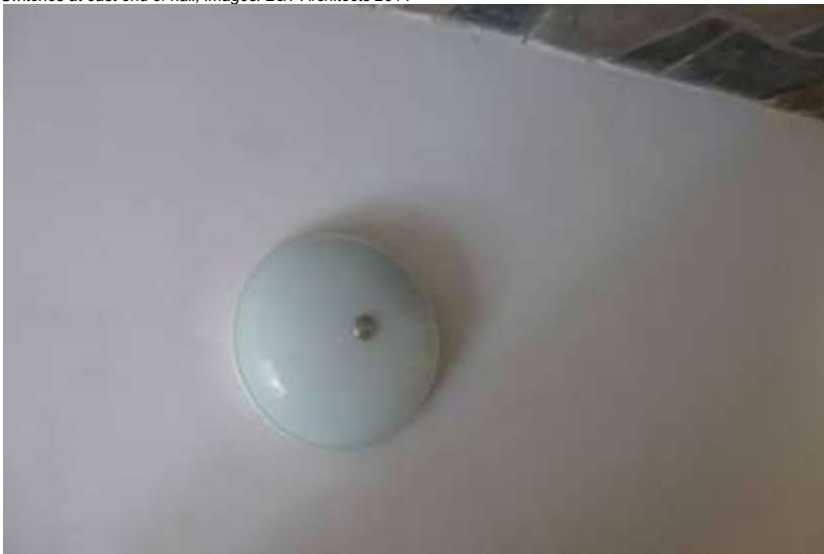
Light fitting fitted by Bob Simpson, east end of hall, Images: B&T Architects 2014

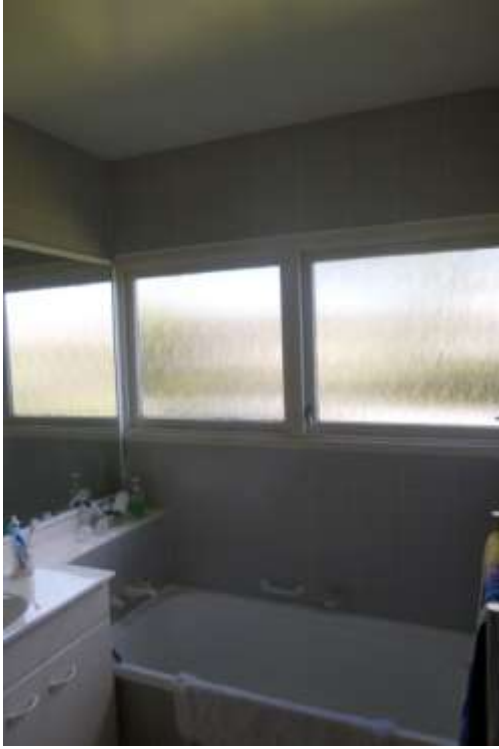
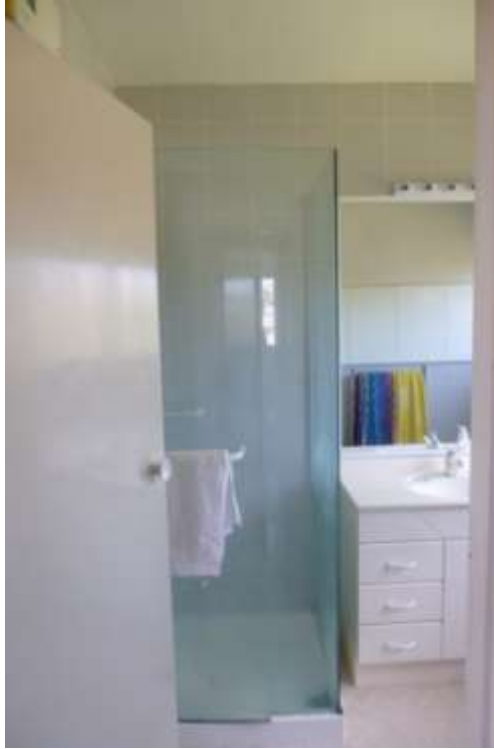
Window, bath + sink vanity (left) View to shower from hall door (right) Images: B&T Architects 2014

The bathroom is beside the kitchen. It is part of the bedroom wing, accessed from the slight return at the west end of the hall. The door to the room is at the north end of the west wall at the corner. It is a simple room with a shower, hand basin and a bath. Most of the fittings fixtures and finishes within the bathroom, are relatively new (the 1958 plans show a different arrangement of the fixtures).

The walls have been tiled, and the openings are finished in mouldings. On the western wall between the window and the door recessed medicine cabinets are built into the wall. Beside the door is a small plinth, the laundry chute, set against the wall. The floor is vinyl.

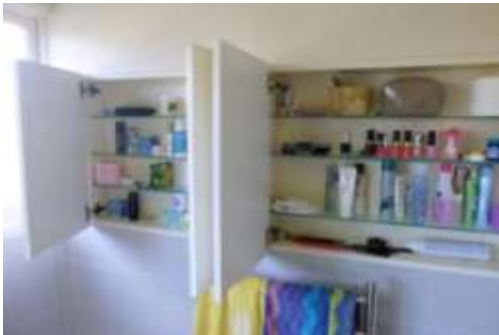
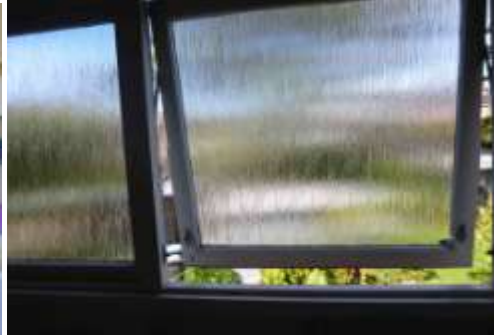
Shaving cabinet (left) Awning window with obscure glass (right) Images: B&T Architects 2014

There is a slot window from wall to wall across the south wall. This is in line horizontally with the window in the kitchen, and continues into the W.C. and the end bedroom. The window has two sashes, an opening awning sash on the right and a fixed sash on the left. It has been glazed in obscure glass. The glass does not appear to be the original.

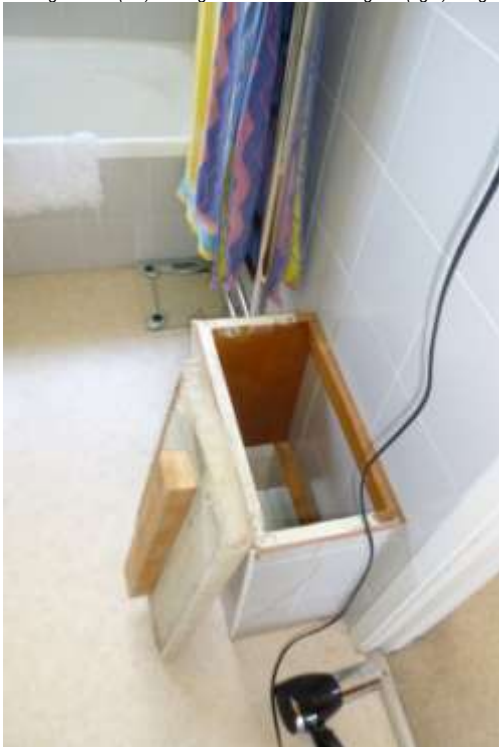
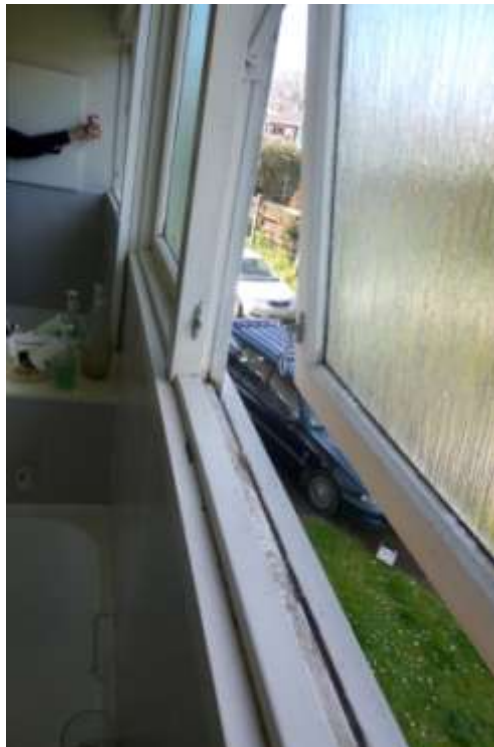
Laundry chute on west wall (left) Awning window open (right) Images: B&T Architects 2014

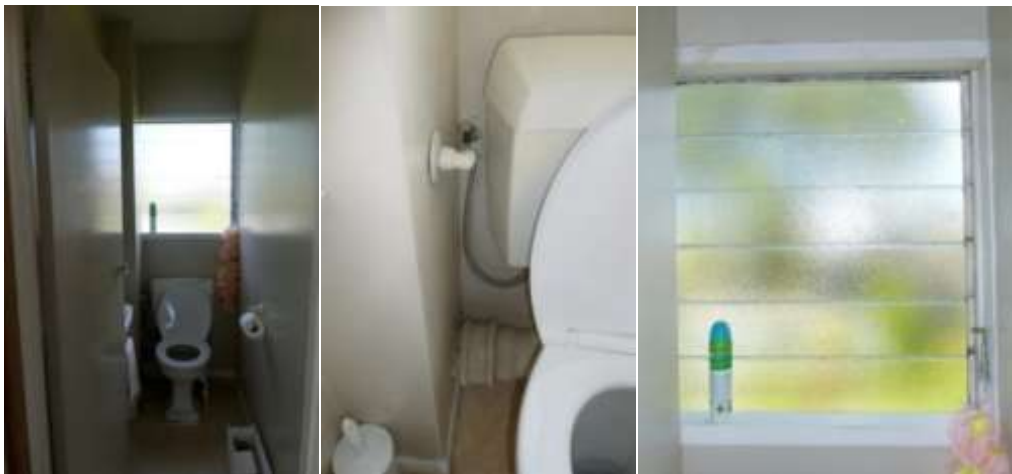
Toilet (left) Toilet connection (centre) Glass louver window (right) Images: B&T Architects 2014

The toilet is directly ahead at the small leg of the 'L' of the hall. It is the width of the hall with a step in the left hand side of the wall beside the toilet. The door is an enamel painted flush panel door, with a turned timber handle. The window, the width of the room, is fully louvered. A narrow hand basin has been fitted to the side wall. The walls and ceiling are finished in enamel paint. The floor is vinyl.

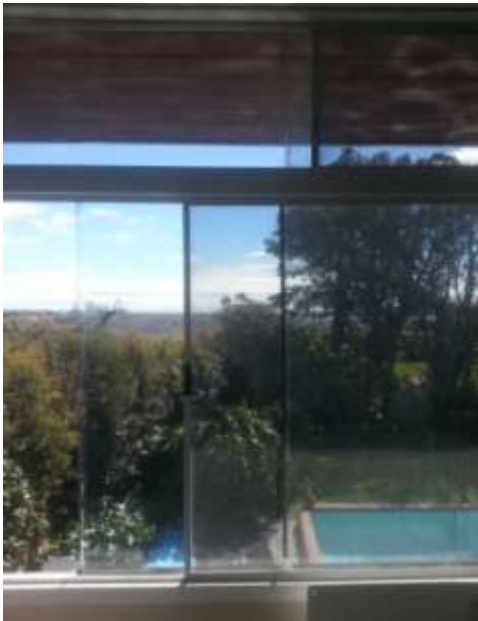
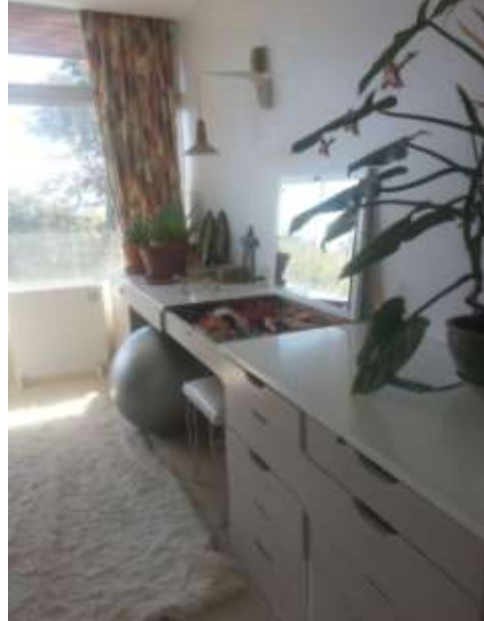
Sliding window joinery unit, north wall (left) Built in dressing table on east wall, open (right) Images: B&T Architects 2014

The main floor of the bedroom steps up from this level. A built in dressing table runs across the east wall of the room from the change in level through to the north wall. At the left hand side this unit has a recess for seating, and the top lifts to become a mirror. A lamp on a rotating wooden bracket is set above the dressing table at the centre of the wall. A low unit is set across the side of the stepped area between the two levels. The west wall at the upper level is lined in vertical t & g timber panelling. There are two fixed metal lamps built into this wall. The lower area is painted plastered surface with a fixed mirror. The north wall joinery unit is divided into four panels, the right hand side lower panel is a frame with two sliding sash-less glass panels. This unit still functions. The ceiling is recessed across this wall to allow for the curtain track.

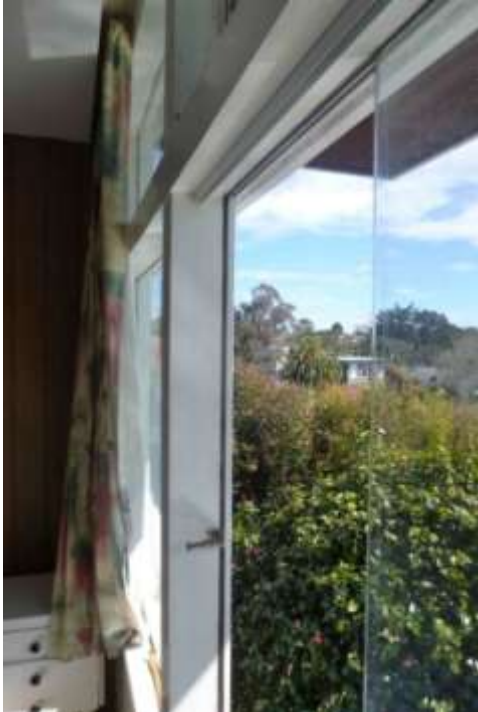
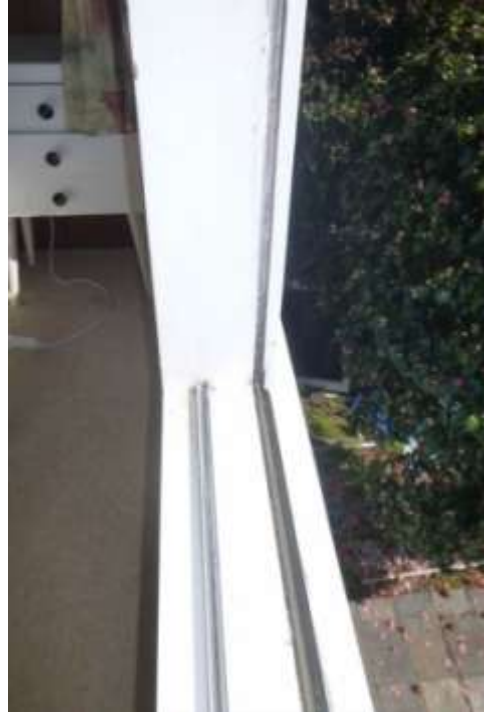
View west across window, north wall (left) Sliding track detail (right) Images: B&T Architects 2014

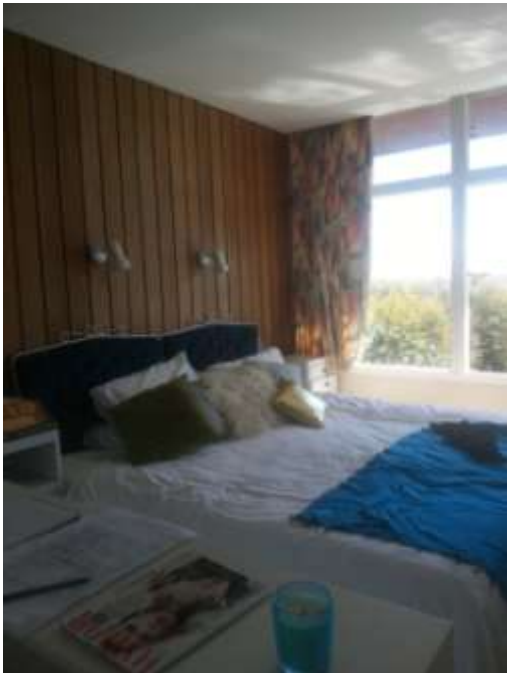
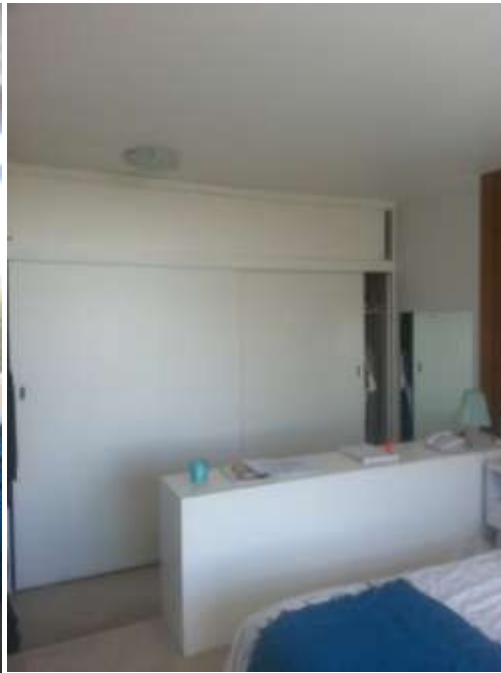
North West corner showing bed and wall paneling (left) south wall showing wardrobe + step (right) Images: B&T 2014

The main bedroom of the house is at the north west corner of the house. The entry is directly off the hall. The room is split level. The first section, level with the main floor of the house runs across the room from the door across the wardrobe space. The entry door is set within a panel of t & g boards. The door is a flush panelled painted door. The door frame is painted white and sits flush with the wall. The wardrobe unit is painted white. It is divided horizontally by a deep lintel. The lower section is the height of the door and the upper section extends up to the ceiling. The wardrobe has two sliding doors at each level. Within the right hand side at the lower level there is a built in drawer unit.

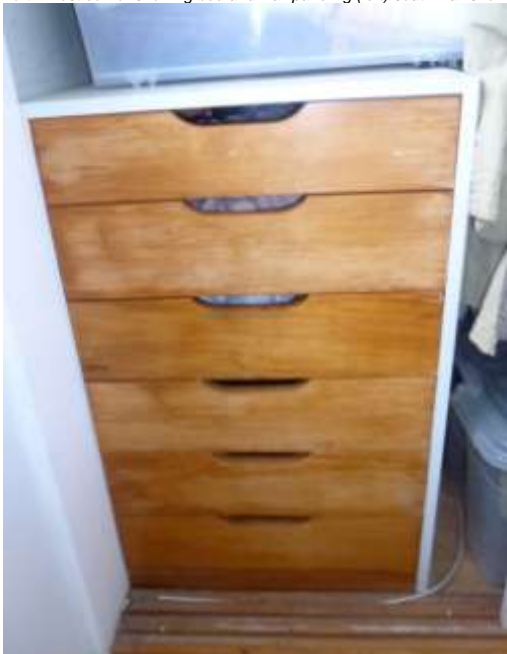
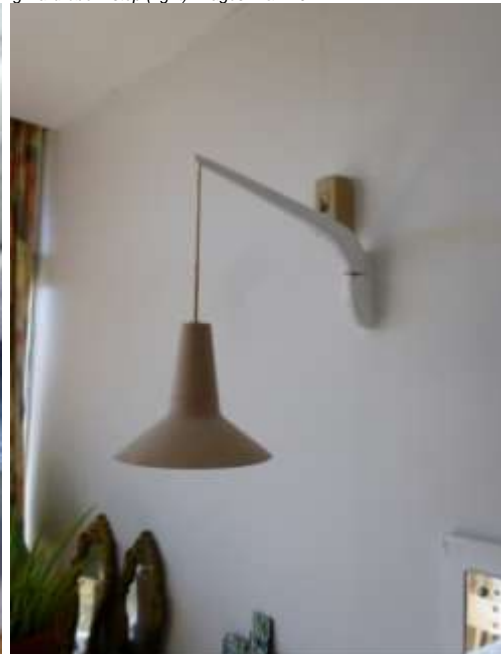
Built in drawer unit in wardrobe (left) Fixed wall light on rotating timber bracket (right) Images: B&T Architects 2014

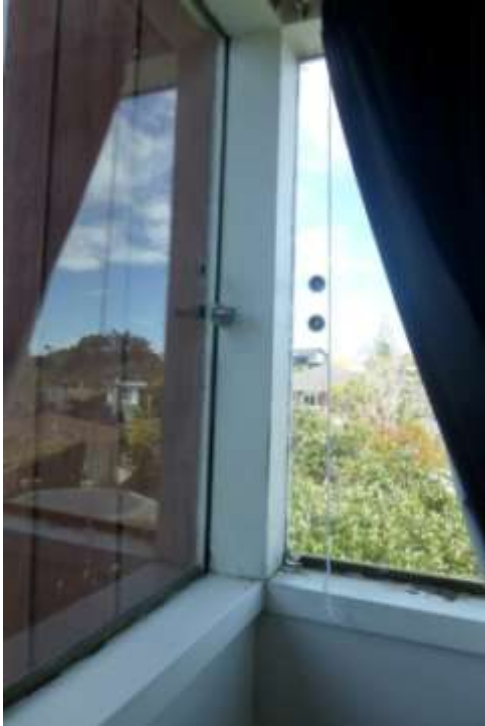
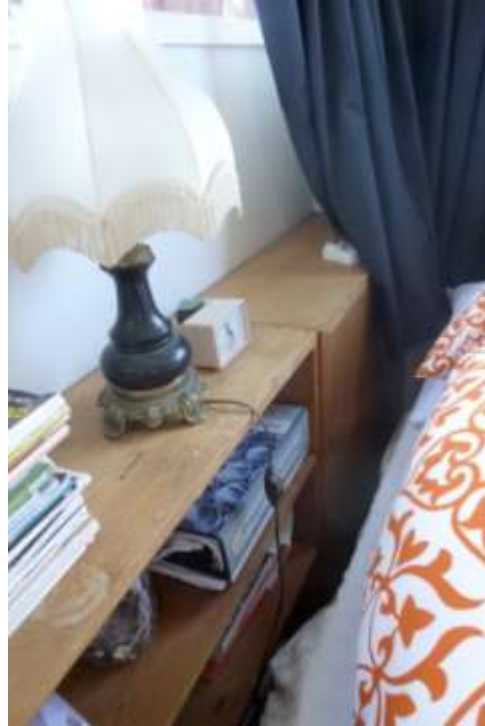
Joinery frames + corner junction (left) Built in cabinetry (right) Images: B&T Architects 2014

A strip window runs across the full width of the south wall and returns across the west wall. This is a slot window that lines with the other windows on the south wall. The window on the south wall is a single frame with two sash-less sliding glass panels. The window on the west wall is the same. Beneath the window along the south wall there is a built in cabinetry unit.

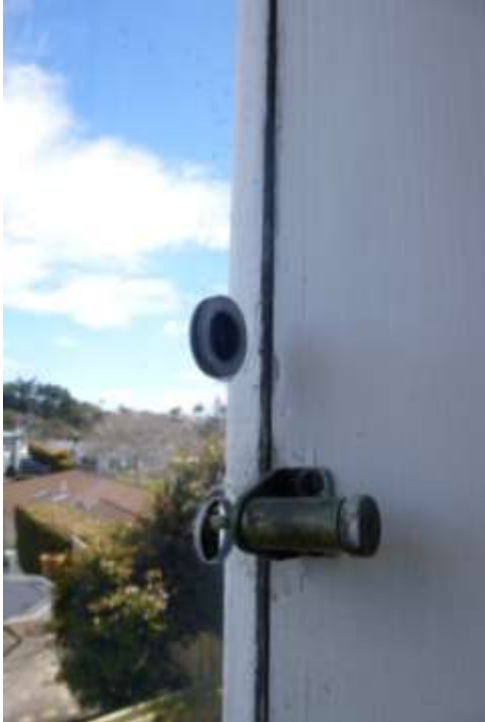
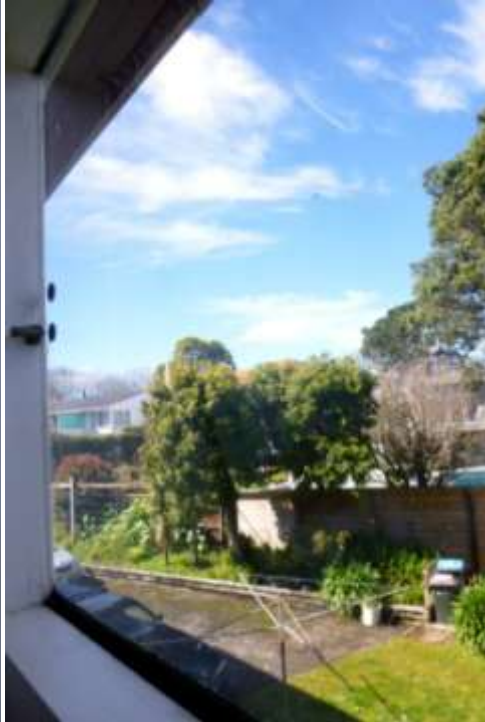
Frameless sliding glass panel hardware detail (left) View east across joinery on south wall (right) Images: B&T 2014

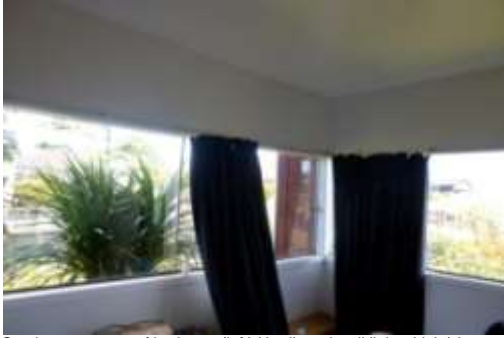
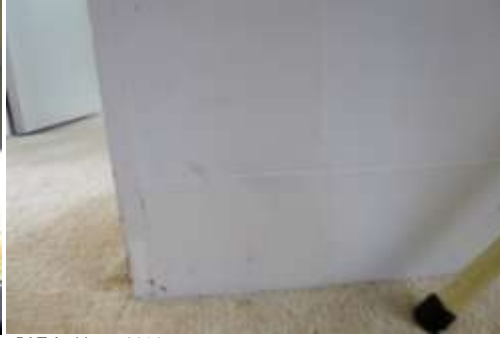
South west corner of bedroom (left) Hardboard wall lining (right) Images: B&T Architects 2014

The east wall, with flush painted entry door to the left, is painted hardboard with the sheet junctions expressed.

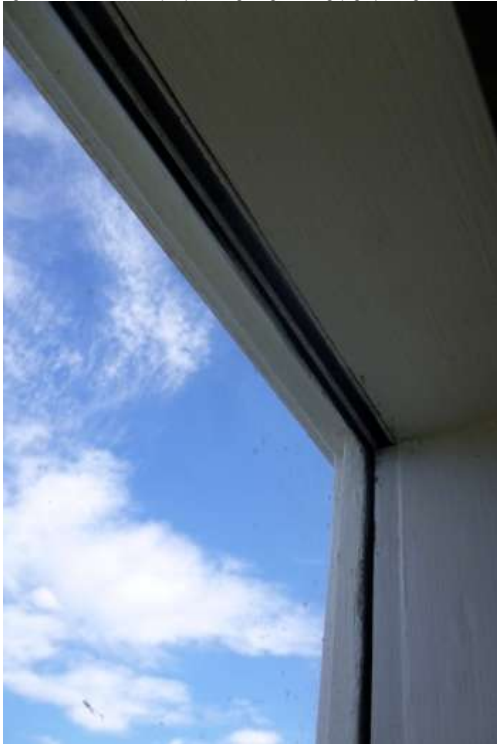
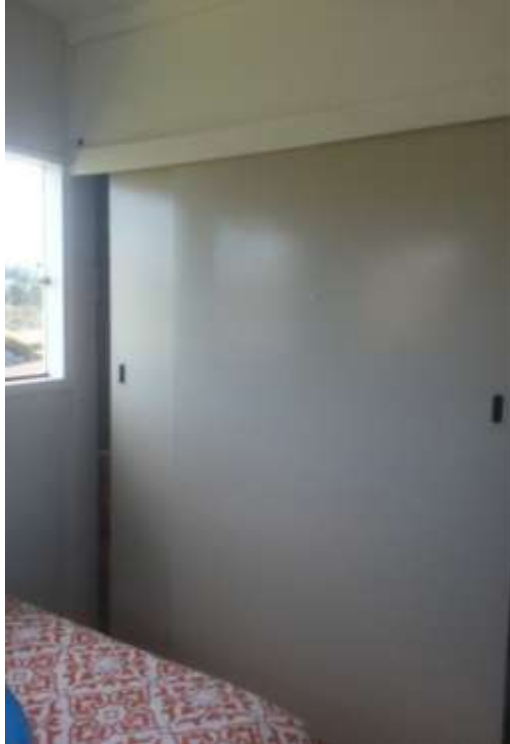
Sliding window track detail (left) Wardrobe on north wall (right) Images: B&T Architects 2014

This is the south west corner bedroom. A wardrobe is fitted across the north end of the room. The top panels of this unit are painted hardboard set to slide in the rebated frame. The bottom doors, painted hollow core doors, are also set to slide in rebates.

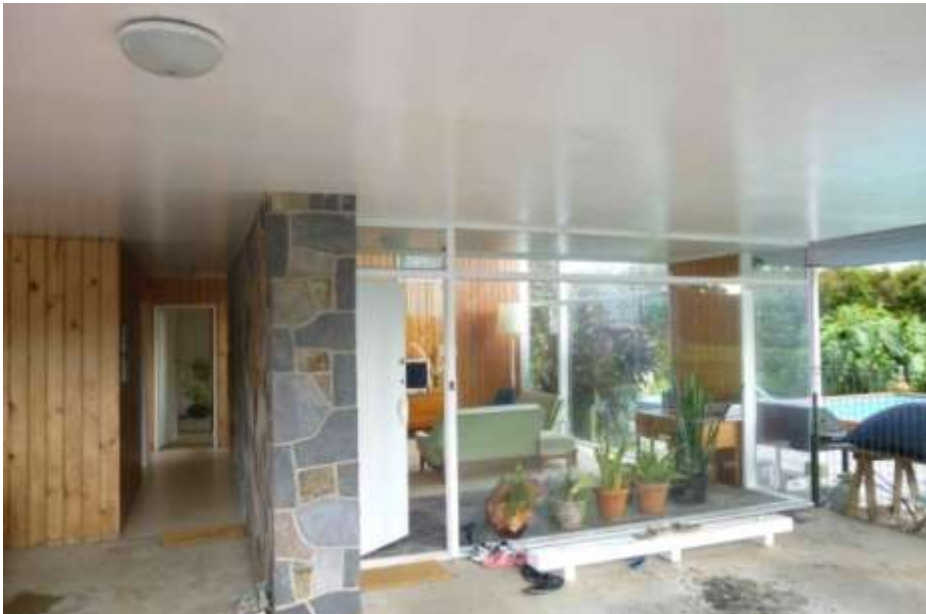
Entry from carport. Image: B&T Architects 2014

The entry to the secondary unit is from the carport down the southern side of the central stone wall. This anteroom is also the entry to the laundry room to the left. The external wall of the laundry is clad in vertical t & g boards. At the end of the stone wall a fixed glazed panel illuminates the space directly outside the door into the unit. This glazed panel is under the stair landing and crisply delineates the end of the wall. The detailing of the panel is intended to create an illusion of openness. The rebated glass disappears into the end wall, the separation exists but is made minimal.
