BLUMENTHAL HOUSE

317 St Heliers Bay Road, Auckland, New Zealand. Built in 1958,
Architect: Vladimir Cacala

CONSERVATION PLAN

Prepared By Burgess + Treep Architects Ltd, Graeme Burgess + Lilli Knight
April 2015

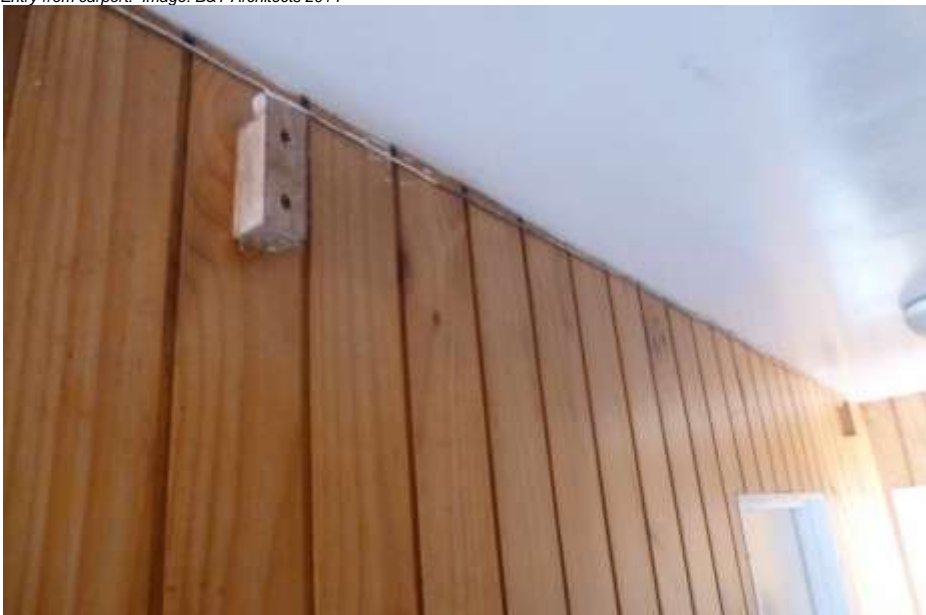
Laundry wall paneling + bracket, Image: B&T Architects 2014

The entry to the secondary unit is from the carport down the southern side of the central stone wall. This anteroom is also the entry to the laundry room to the left. The external wall of the laundry is clad in vertical t & g boards. At the end of the stone wall a fixed glazed panel illuminates the space directly outside the door into the unit. This glazed panel is under the stair landing and crisply delineates the end of the wall. The detailing of the panel is intended to create an illusion of openness. The rebated glass disappears into the end wall, the separation exists but is made minimal.

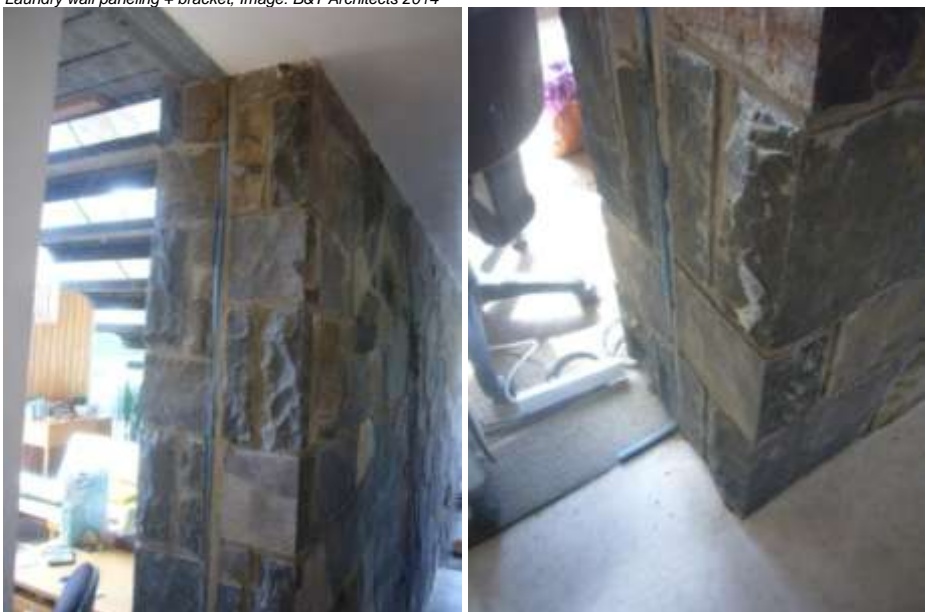
Stone wall + glass partition junction, top (left) Stone wall junction, bottom (right) Image: B&T 2014

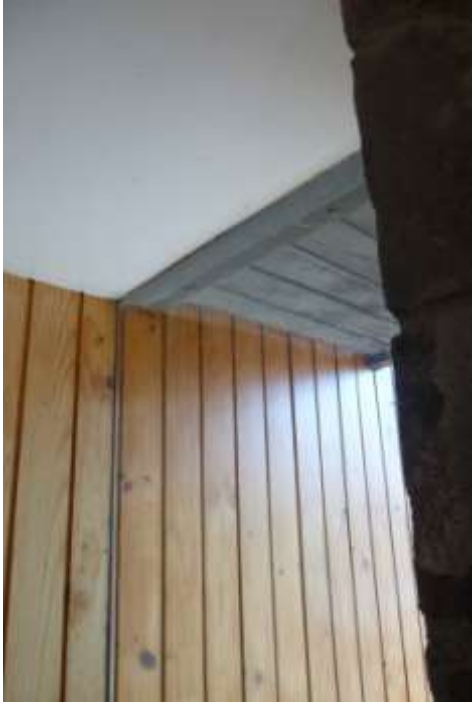
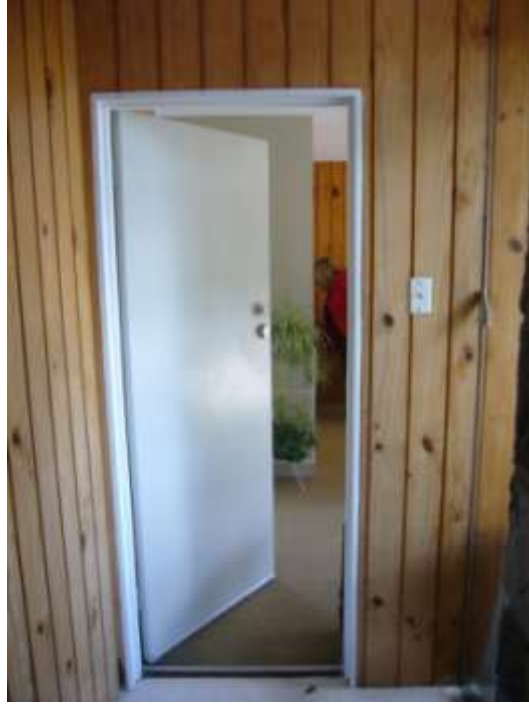
Stone wall, glass partition + wood paneling (left) Entry door to secondary unit (right) Images: B&T 2014

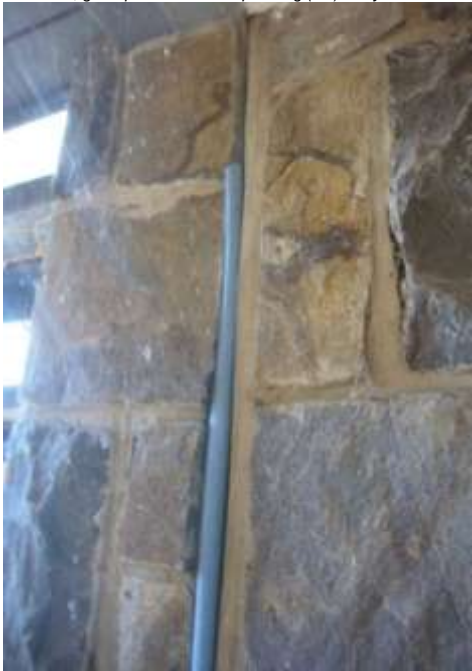
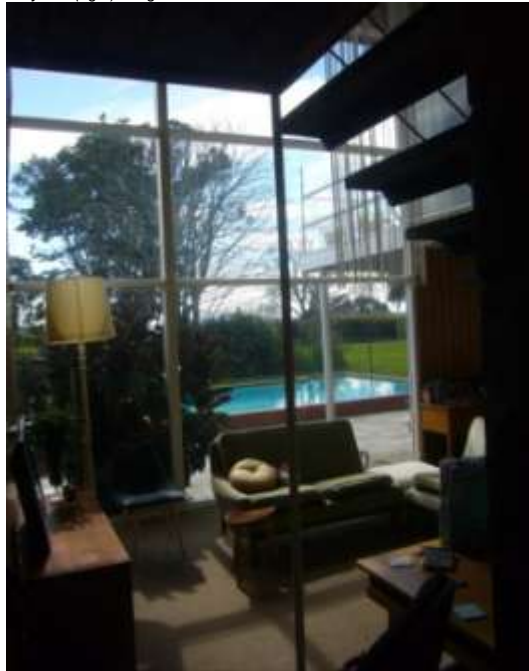
Stone wall, glass partition detail (left) View from lobby to garden room through glass partition (right) Images: B&T 2014

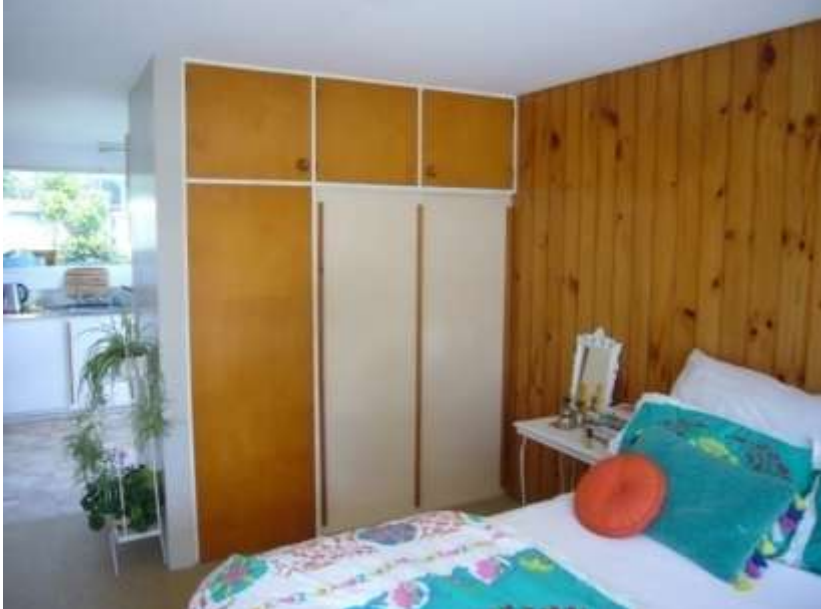
View South to kitchen from bedroom, Image: B&T Architects 2014

To the left of the entry and open to the bedroom is the kitchen space. The panelling by the entry door is returned across the face of the bathroom wall within the kitchen area. The panelling is broken by the flush painted bathroom door. The kitchen bench, a stainless steel bench top on a timber cabinet with three sliding doors, sits against the bathroom wall. At the right hand side of the wall is a free standing stove. Centred between the walls there is a plain batten holder fluorescent light fitting. The kitchen has slot windows across the south wall above the bench area, and back across the west wall. These windows are timber frames with pairs of sash-less sliding glass panels. A high cupboard unit has been fitted across the wall that forms the back of the wardrobe. This unit is set below the ceiling. The cupboard unit is a timber framed with a pair of hardboard sliding doors at the right and a pair of glass sliding panels on the left. The floor in the kitchen area is finished in sheet vinyl.

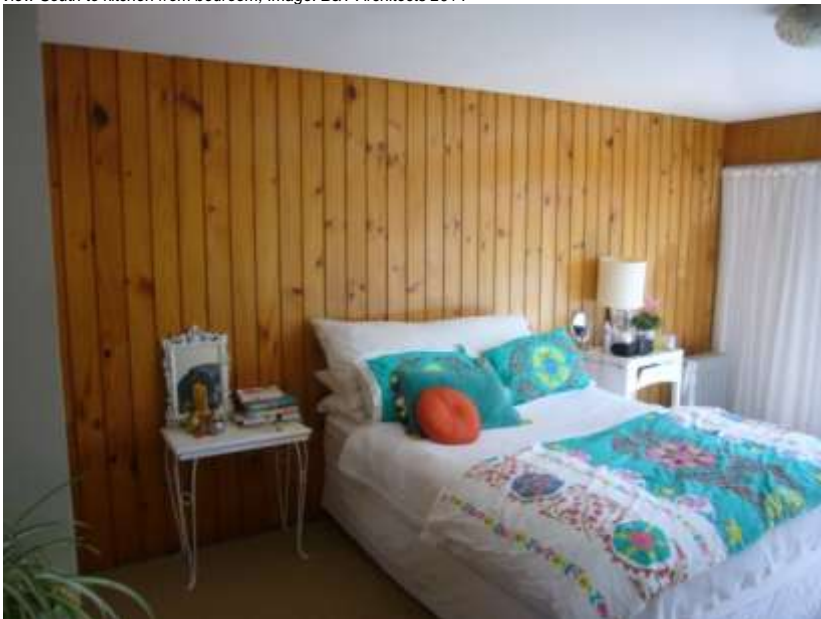
West wall, Image: B&T Architects 2014

The door to the secondary unit from the lobby is a plain flush panel painted door. The door opens directly into the bedroom space of the unit. Ahead is the wing wall that encloses the wardrobe. The west wall of the bedroom area is lined in vertical t & g panelling, the panelling runs into the wardrobe recess. The timber used is a lower grade than the timber used in the panelling of the main house. The wall surface above the joinery on the north wall is also panelled. The joinery is set from wall to wall. The panel to the left was a sliding door. The door is not in place and a plywood panel has been fitted to the opening. To the right the frame has a fixed lower panel, and above a panel with a pair of sash-less sliding glass panels. The eastern wall is finished in painted plaster. The wardrobe unit is divided into three vertical sections, a pair of painted sliding doors to the right with a fixed timber veneer panel to the right. Above are three veneer panelled cupboard doors. At the entry the wall behind the swing of the door is also timber panelled.

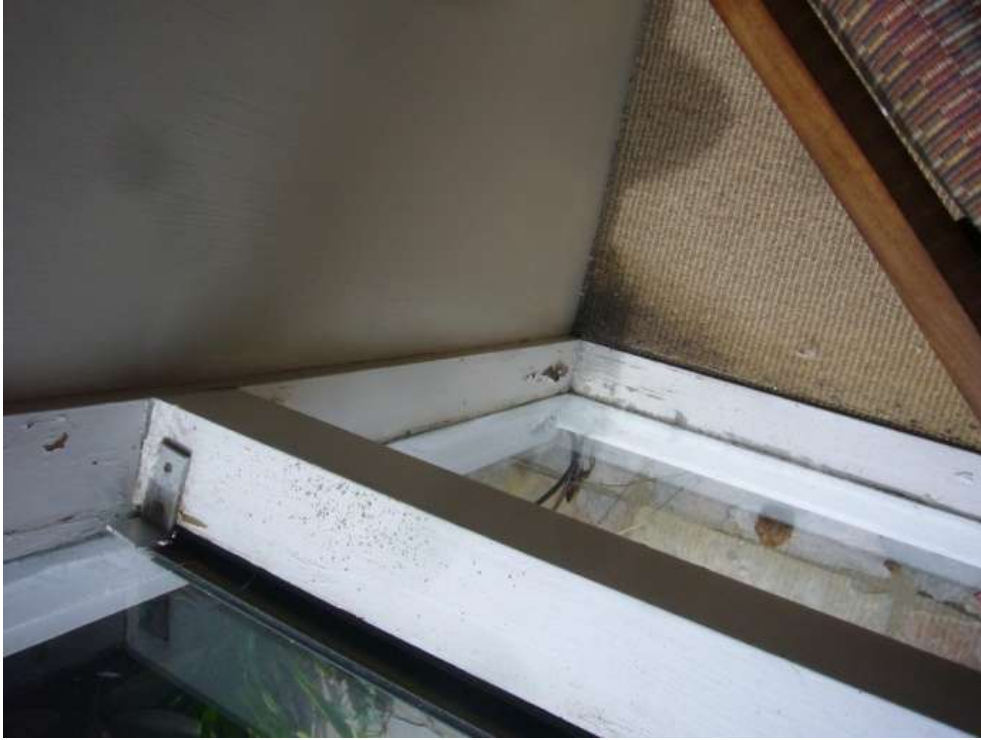
Joinery frame detail on north wall, Image: B&T Architects 2014

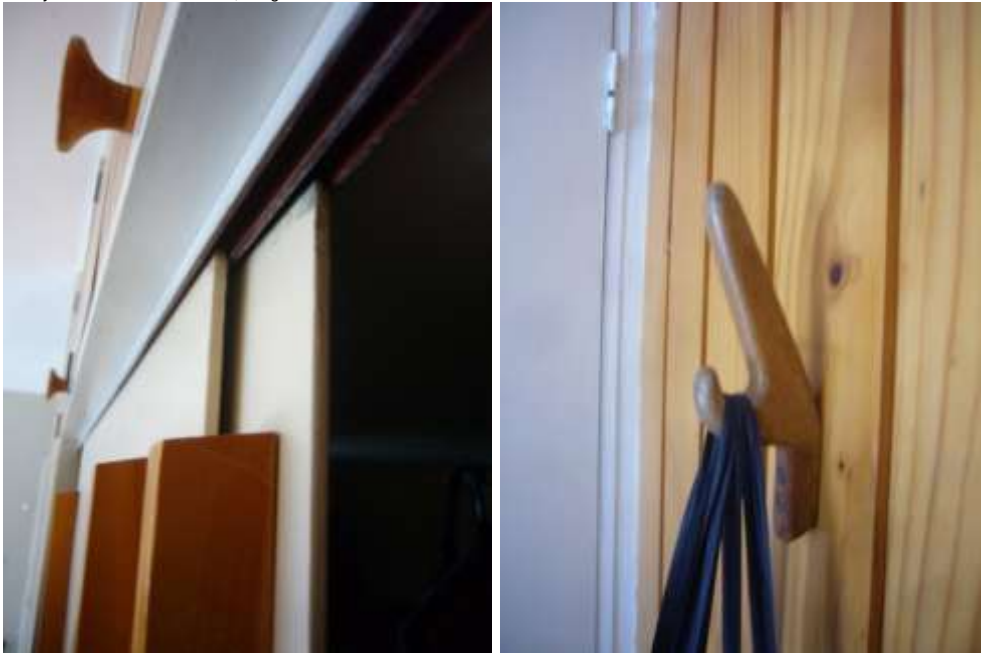
Wardrobe door detail showing turned wooden handles (left) Wooden coat hook (right) Image: B&T Architects 2014

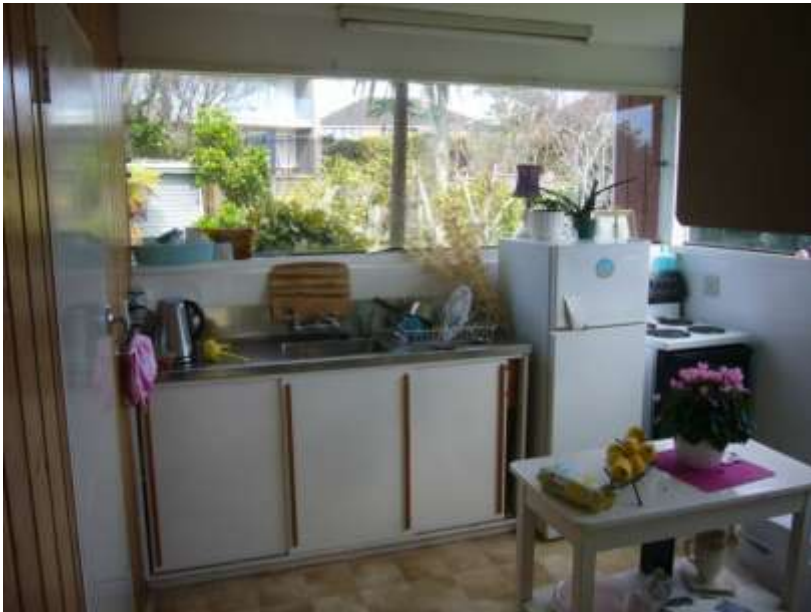
South wall, bench unit + sliding glass window, Image: B&T Architects 2014

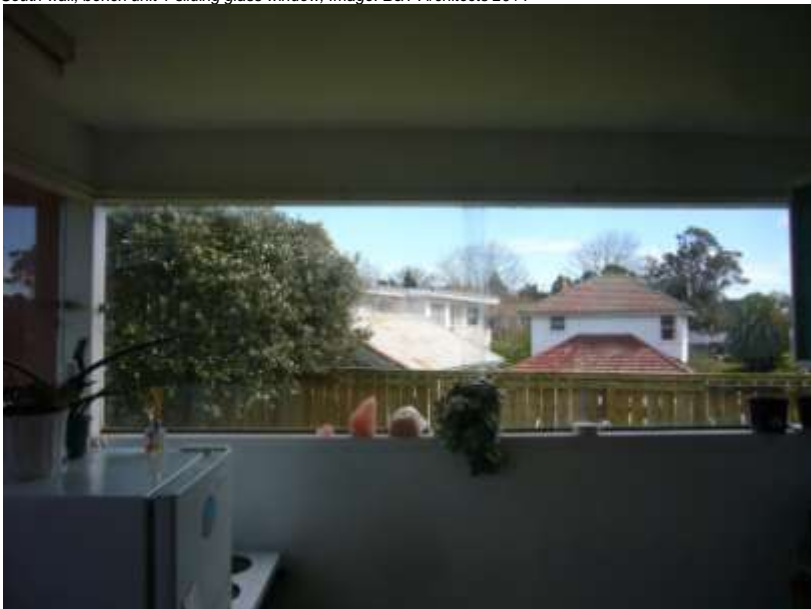
Sliding glass window on west wall, Image: B&T Architects 2014

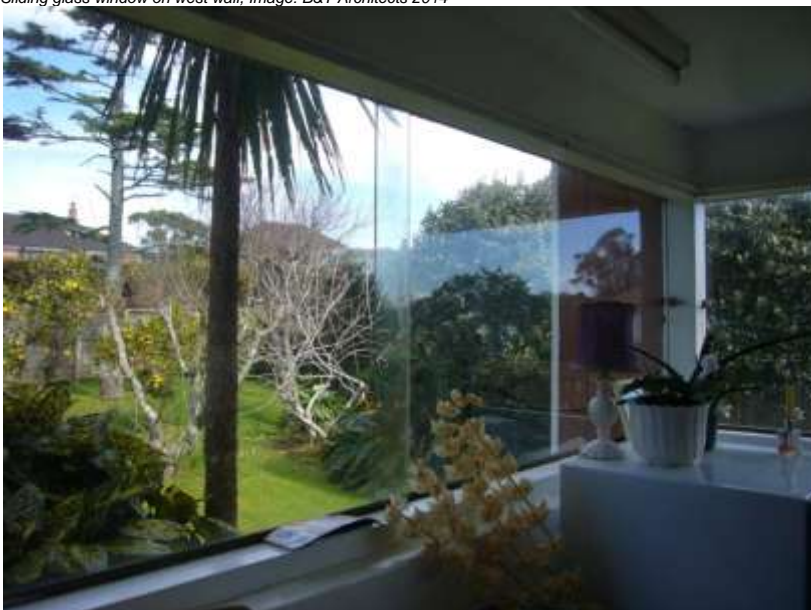
South West corner window, Image: B&T Architects 2014

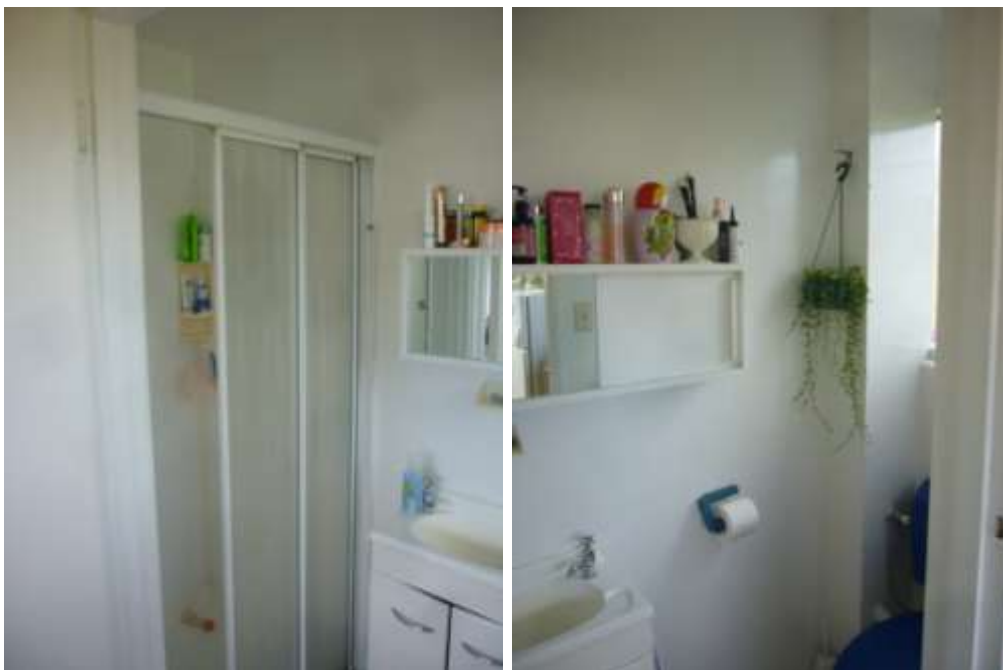
The small bathroom is minimal. It has been refitted. The wall and ceiling surface finishes are all enamel painted. The floor is finished in sheet vinyl. The window of the bathroom is a fully louvered panel and is in line, and continuous with the strip window of the adjoining kitchen and laundry. On the wall above the hand basin there is a surface mounted framed cupboard with sliding panels, similar to the kitchen cabinetry. At the south east corner of the room there is a built in duct finished to match the walls.

Shower + hand basin (left) Toilet + wall mounted cabinet, south end (right) Image: B&T Architects 2014

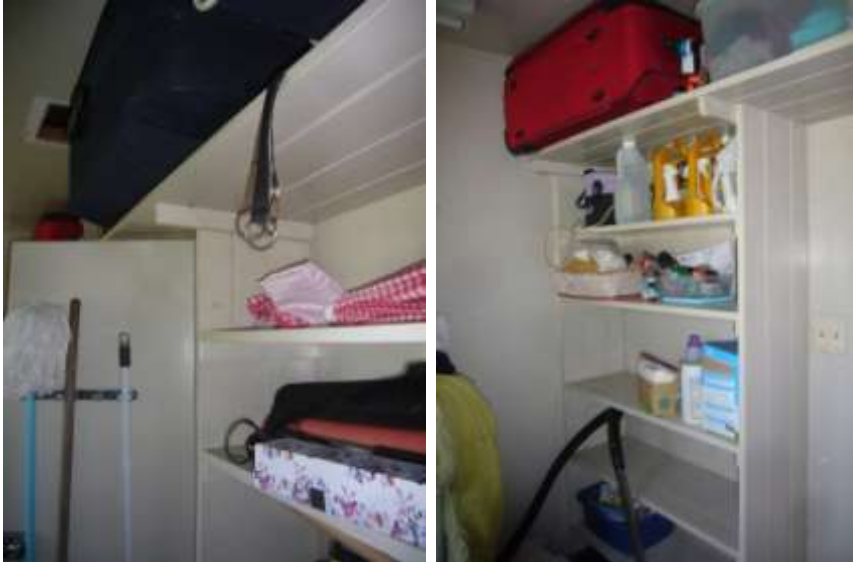
The door to the laundry room is towards the western end of the corridor space. The door is a painted flush panel door in a painted timber frame set flush with the wall cladding. A shelving unit of slatted timber runs across this wall inside the room. The eastern end wall has also been fitted out with a cupboard /storage shelving. Some of this has been removed to make space for a freezer. The hot water cylinder at the south east corner is enclosed by the cupboard unit. At the south west corner is a single stainless steel tub. On the wall to the side of the tub is a surface mounted 'Bakelite' power point on a timber block. A 1970s style switch has been fitted above this.

Shelves across north wall (left) Door + shelves, Image: B&T Architects 2014

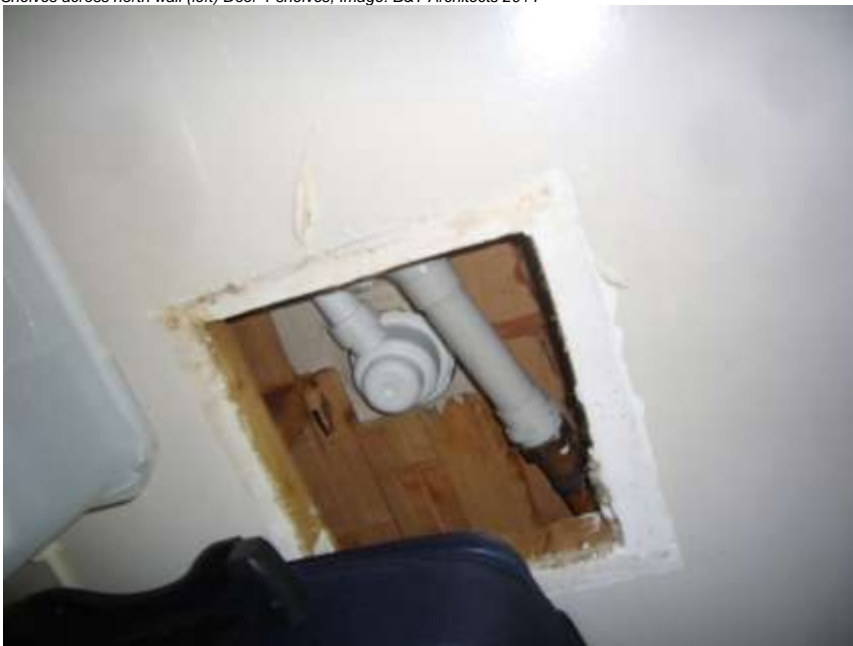
The walls in the laundry are enamel painted. The floor is finished in sheet vinyl. The ceiling is painted fibrous plaster. At the western end of the ceiling is the laundry chute from the bathroom above. The ceiling has been cut out beneath the plumbing of the bathroom above.

Plumbing access in ceiling, Image: B&T Architects 2014

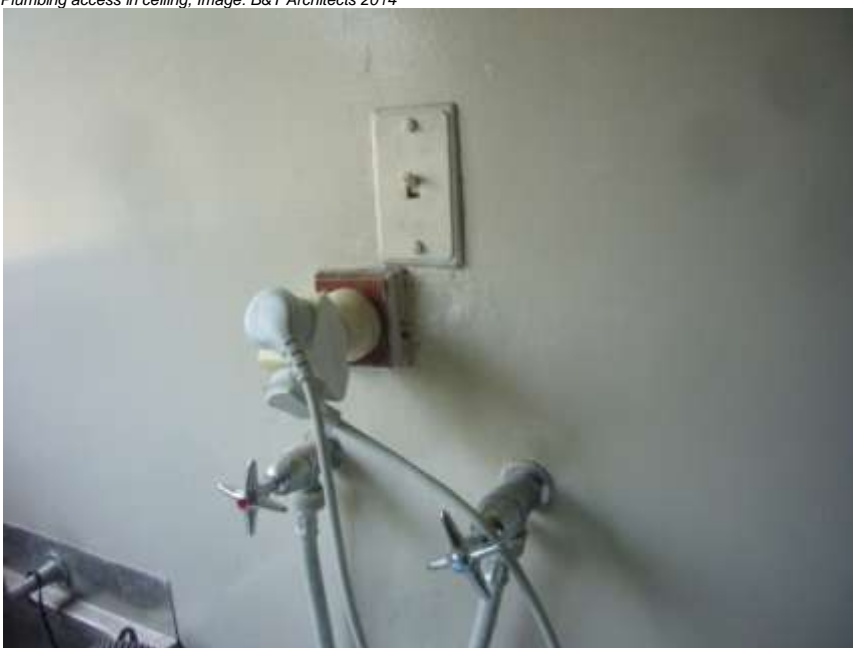
Bakelite power point mounted on wooden block, Image: B&T Architects 2014

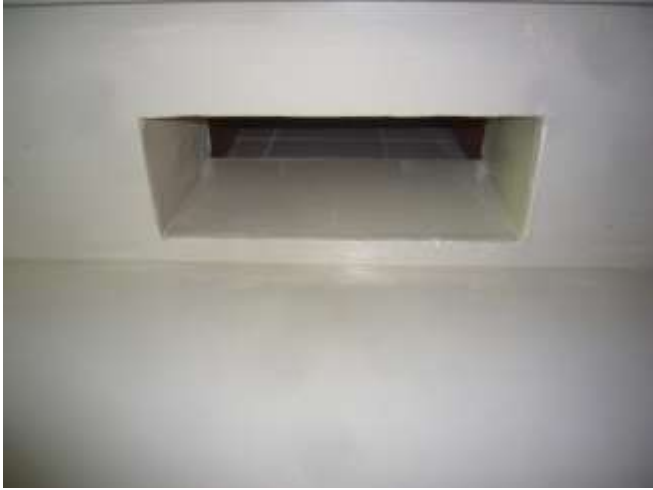
Laundry chute, Image: B&T Architects 2014

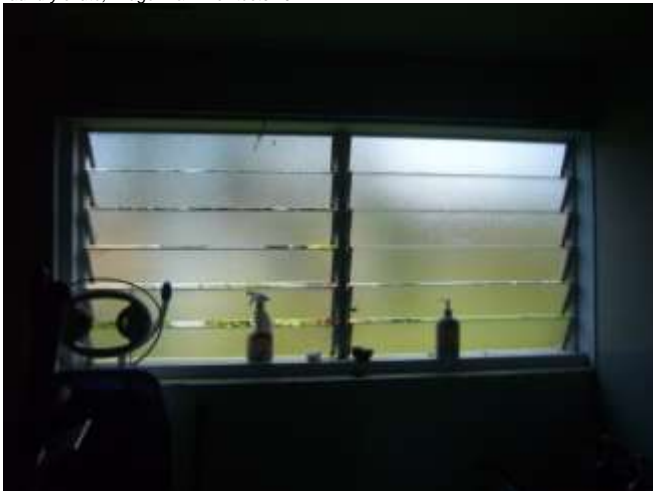
The laundry is lit by a pair of louvered panels set within the horizontal slot window that runs across in line and continuous with the window of the bathroom and kitchen.

Louvered windows along south wall, Image: B&T Architects 2014

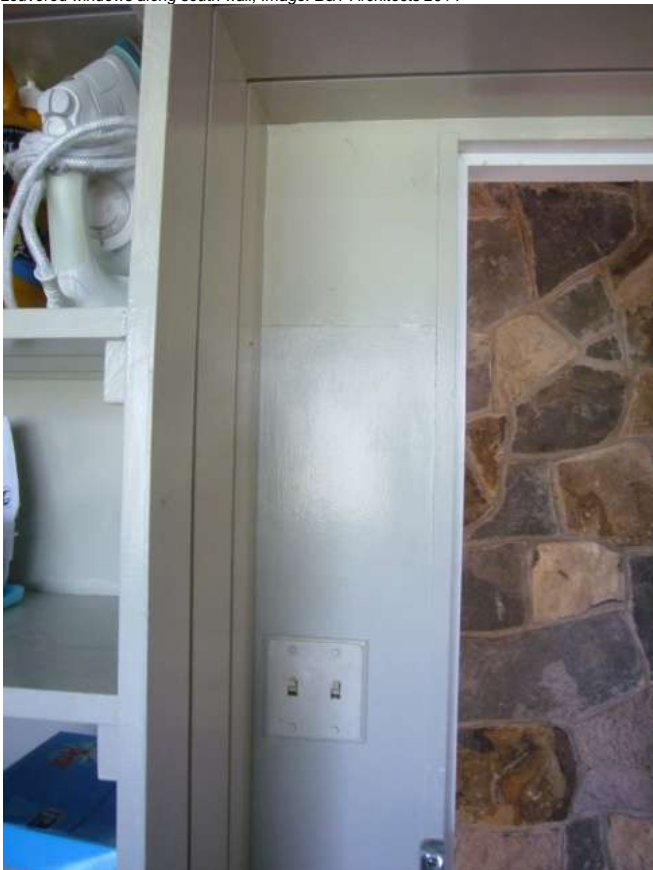
Door + view to stone wall in open lobby, Image: B&T Architects 2014

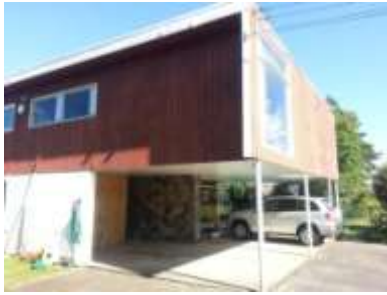
Recessed Carport

<u>ELEMENT</u>	<u>HERITAGE SIGNIFICANCE</u>
T&G board soffit, stained finish (underside of deck terrace)	b
Smooth finish fibrous plaster ceiling	b
Surface mounted light fitting	c
Concrete slab	c
Plastered fibrolite wing wall – south	b
Vertical T&G board wall lining (pine/unpainted)	a
Blue stone central wall	a
Projecting joinery unit to garden room	a
Entry door to house	a
Sculptural wooden pull door handle	a
Slab mounted timber wheel stop	d
Flush mounted switch in stone wall	a
OVERALL	A

CARPORT POSTS: The original posts that support the living room are in good condition. These posts have no visible fixings. The posts fitted to support the exterior corners of the deck are not in good condition. These posts have twisted and the fixing plates are exposed.

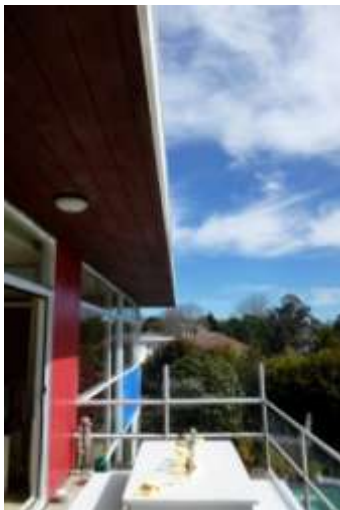
Deck

<u>ELEMENT</u>	<u>HERITAGE SIGNIFICANCE</u>
Asbestos tiled deck surface	b
Pipe rail balustrade (original format)	a
Pipe rail balustrade (additions at east)	int.
Vertical T&G board cladding stained finish (east)	a
Wide facing board	a
Surface mounted light fitting	c
OVERALL	A

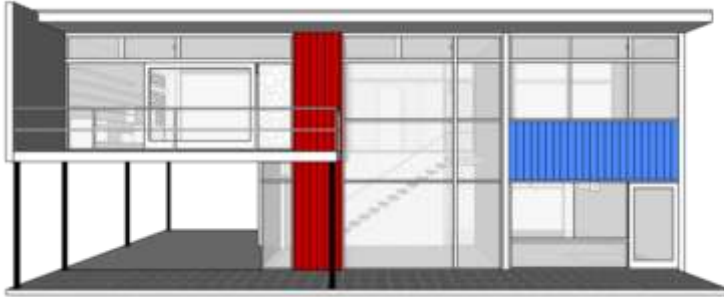
North Elevation

Receded carport /entry area	(see carport)
Deck / terrace	(see deck)
CHS steel columns x 2 (later addition)	c
Fixed glass joinery panels	a
Large sliding doors (lower bedroom & living)	a
Sliding frameless glass units (lower bedroom & living)	a
Projecting roof and side walls	a
OVERALL	A

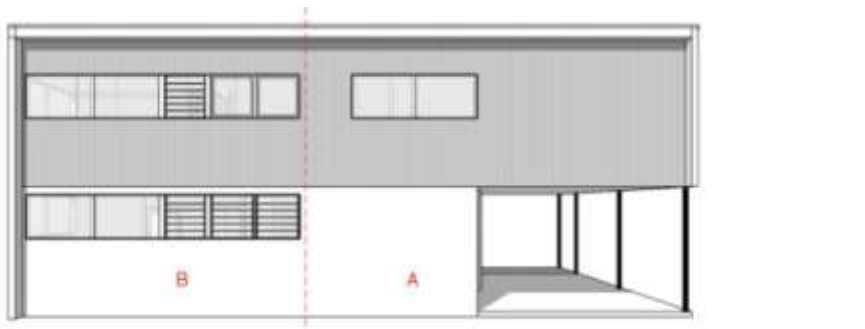
South Elevation

Plaster finish to cladding (lower level)	b
Concrete plinth (lower level)	b
Projecting roof and side walls	a
Decorative hose bracket	d
Sash-less sliding glass windows	a
Louvre windows	c
Double sash awning window (upper bathroom)	d
OVERALL	
Left and section	B
Right hand section	A

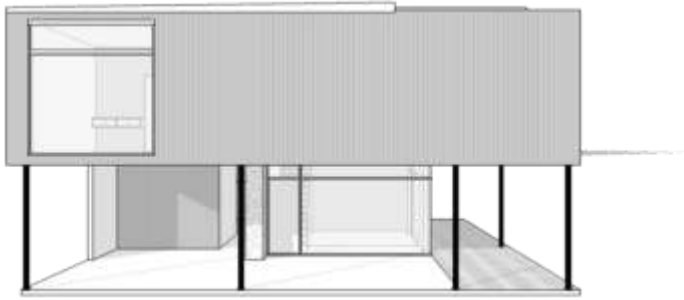
East Elevation

Power connection	c
Weather vane	d
CHS steel columns x 3 (original)	a
CHS steel columns x 1 (later addition?)	c
Divided fixed glazed panel joinery unit (dining room)	a
Receded carport /entry area	(see carport)
OVERALL	A

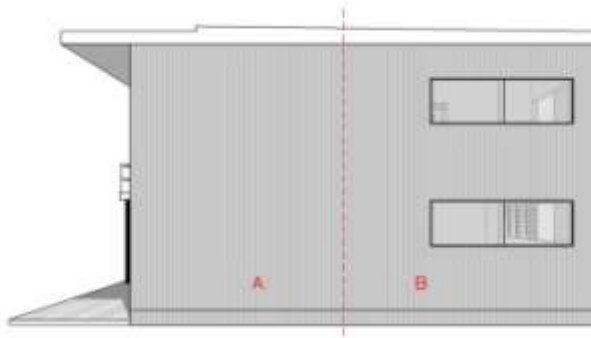
West Elevation

Cantilevered roof edge (northern top corner)	a
Horizontal base board	c
Concrete foundation wall	c
Sash-less sliding glass panel windows	a
OVERALL	
Left hand section	A
Right hand section	B

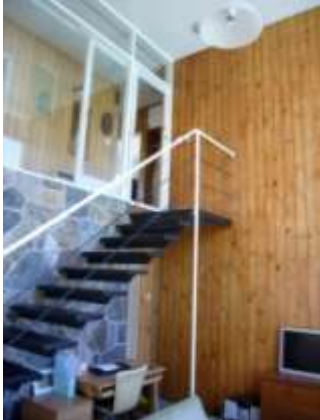
Winter Garden & Stair

Cantilevered stair+ landing	a
Pipe stair hand rail	a
Wire modification to stair hand rail	int.
Remnant of garden irrigation system	b
Double height joinery unit (north)	a
2x horizontal steel rods fixed to joinery frame	a
Vertical T&G board wall lining	a
Projecting corner unit to carport	a
Fixed glazed panel to open lobby	a
Carpet	int.
Blue stone 'crazy' paving (floor)	a
Blue stone central wall	a
OVERALL	A

The stair treads cantilever out from the stone wall on steel 'T' sections. The blocks under the lowest tread indicate slumping. The remaining treads do not appear to be drooping. The steel is rusting. It is recommended to strip back the stair and stair support structure, to carry out repairs if necessary and to apply a suitable metal finishing paint system. The base of the handrail pipe is rusted at slab level. The pipes have been drilled through to fit the two horizontal cables. The fixed glazed panel at the end of the stone wall needs some attention. The seals have failed.
