Corban Estate Winery

426 Great North Road
Henderson

CONSERVATION PLAN
July 2005

BURGESS & TREP ARCHITECTS

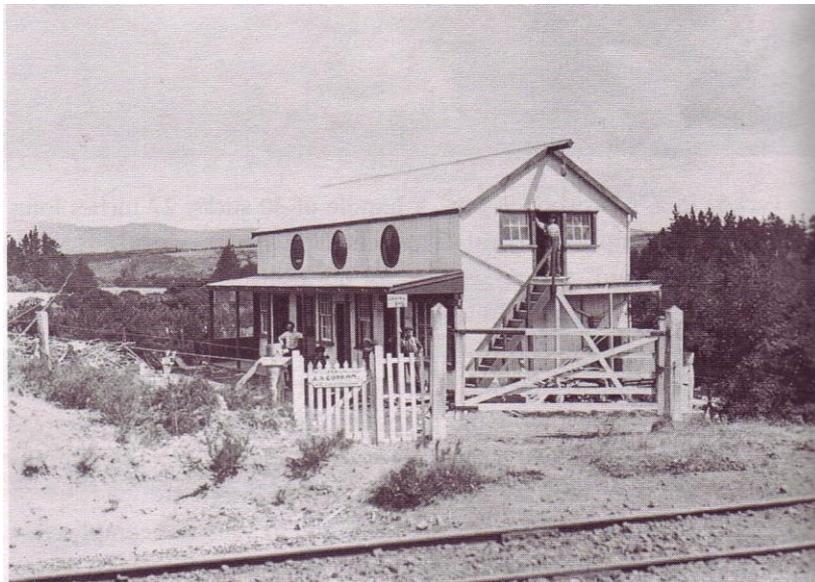
Cellar from the road c.1907 photo Khaleel Corban

The cellar building was commenced in 1903. Building the cellar, the first winery, was a long-term project not fully completed until 1909. The early photographs of the free-standing cellar building show a fresh building, slightly idiosyncratic as a consequence of the unusual windows, very clearly visible to the public eye. The Corbans were very aware of the importance of having a public profile, and the cellar has a considered appearance at this time, reflecting the importance of this building as the place for the sale and manufacture of fine wine. The verandah became Najibie's stall, and she sat here selling vegetables and other produce to locals and passers by.

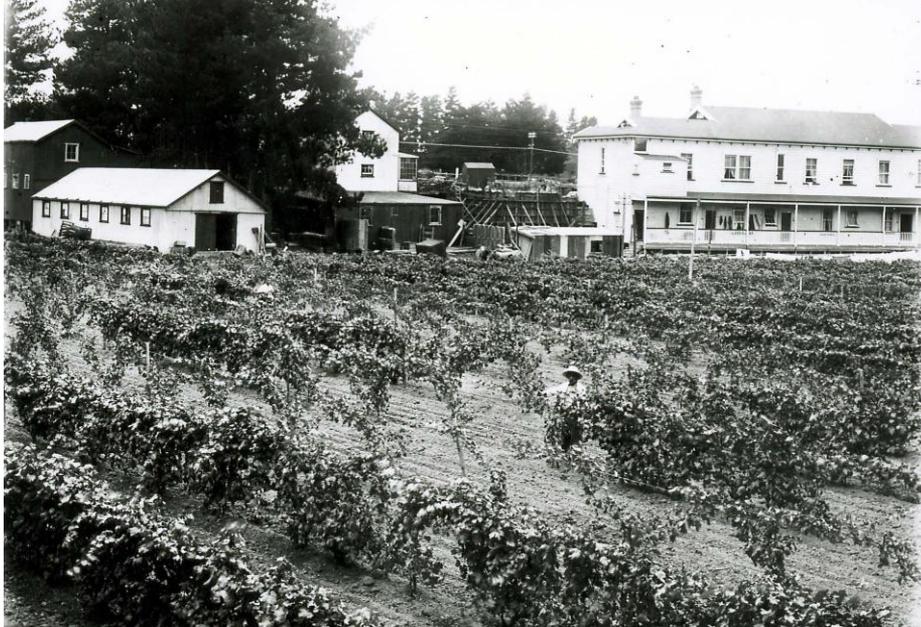
*Photo: Khaleel Corban; rear of the estate c. 1924
the sheds below the retaining wall housed the bore and the generator⁵*

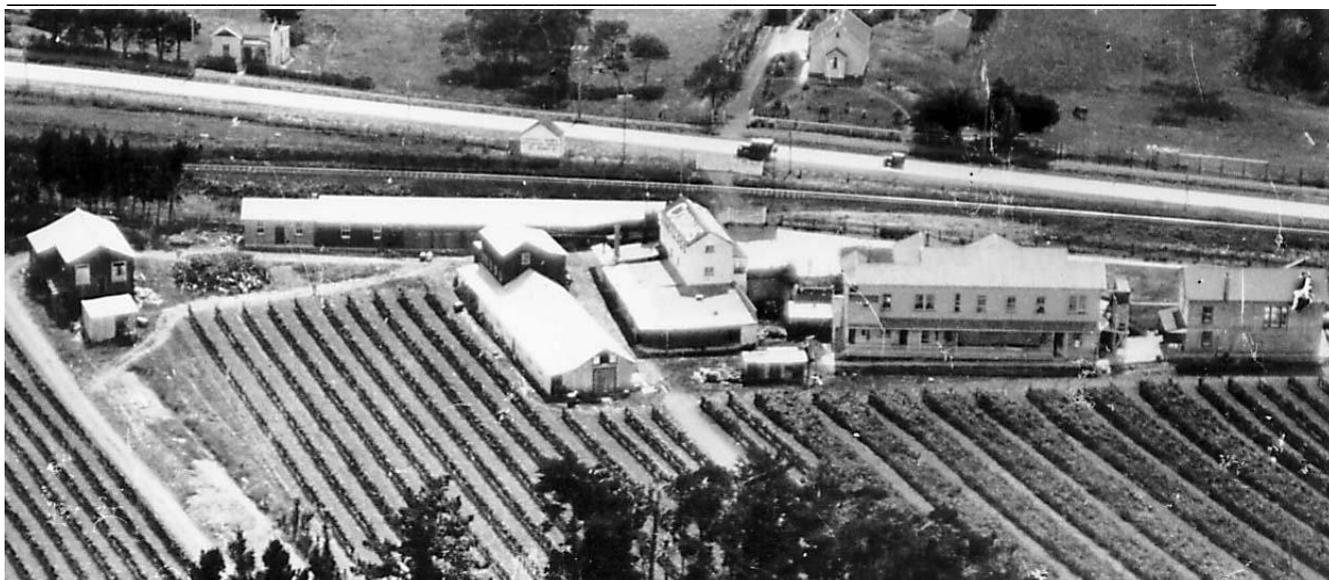
Whites Aviation oblique aerial photo from the south 1935, detail

By 1935 the pine trees were gone, the long shed by the stables had grown a lean-to down its length and down the side of the stable building, and the stable also had an additional lean-to at the upper level on the cellar side. The cellar did not spread a great deal further. In further evidence of the Corbans talent for marketing, the roof of the cellar has been painted with the name Corban in large letters, unmistakable from the air.¹¹

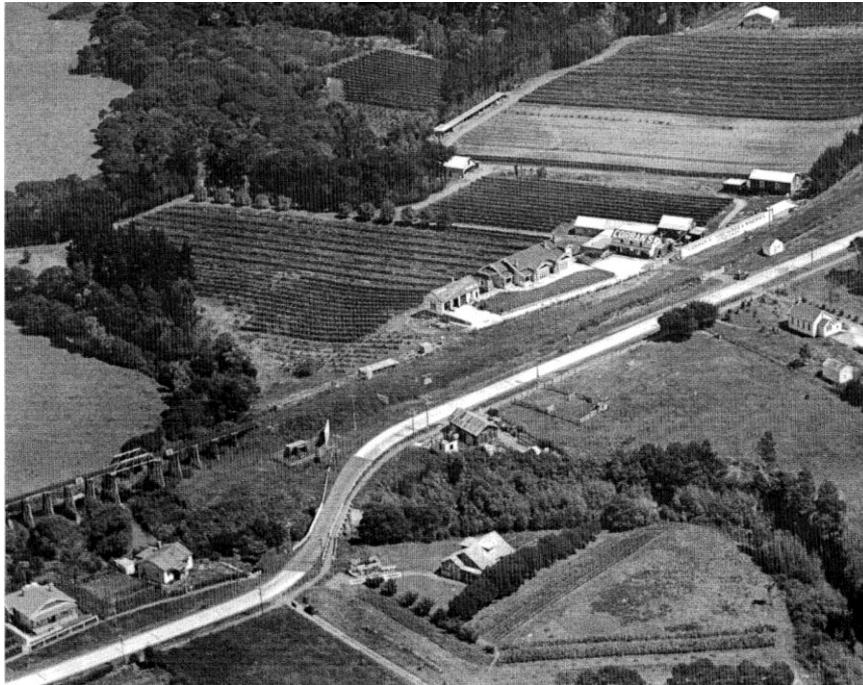
Whites Aviation aerial photo 1935 #55936

An external stairway to the gable end was the only access to the loft space of the building. This was a simple, unbalustraded stair up to the loft, and a gantry beam projected from the ridge above the doorway. On each side of the central doorway were two six light windows set level with the head of the door. A lean-to addition was made to the western side of the cellar after 1935. At that time there appear to have been windows to the loft down the western wall and at the southern gable end a single window to the loft and a single window to the ground floor area of the building. By 1935 the name “Corbans” had been painted in large letters on each side of the roof, a remarkably prescient example of early advertising²². In 1960 the entire northern frontage of the building, from the cellar through to the stables, was reclad in fibrolite sheeting and a concrete block based entry was formed at the eastern end (refer image above). This entry porch opens into the office and meeting area at the end of the cellar and gives access to the studio rooms over the expanded basement level cellar towards the stables.

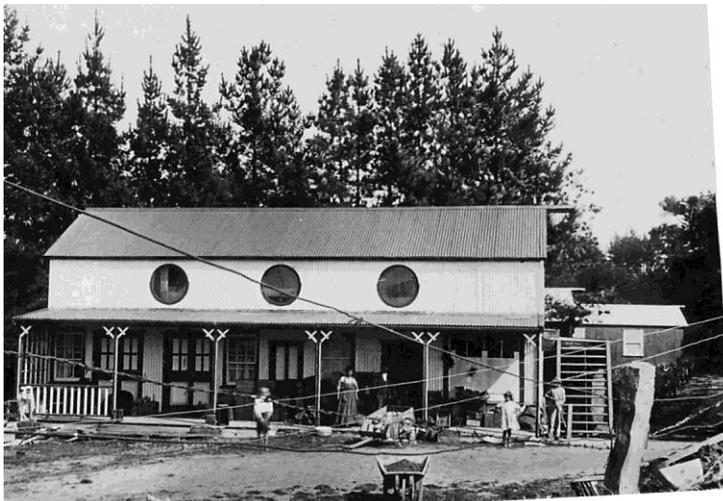
outside the Old Cellar, photo Khaleel Corban, c.1908

The original cellar building is a long gabled structure 5m wide and 14m long. A verandah ran the length of the building down the eastern side and a single external stair at the northern end accessed the loft space, an attic room the length of the building. The entire area beneath the cellar building and the verandah has been excavated to form a basement. The basement, when it was finished, was the cellaring area, the attic room was the first processing room. The grape harvest was carried up to this room in boxes. The ground floor of the building was initially used as a shop for the goods left over from Queen Street, with two bedrooms at the southern end, one a parlour and guest room, the other a bedroom for the older boys. The last room on the ground floor of the building, closest to the railway end of the building, began as a vat room.

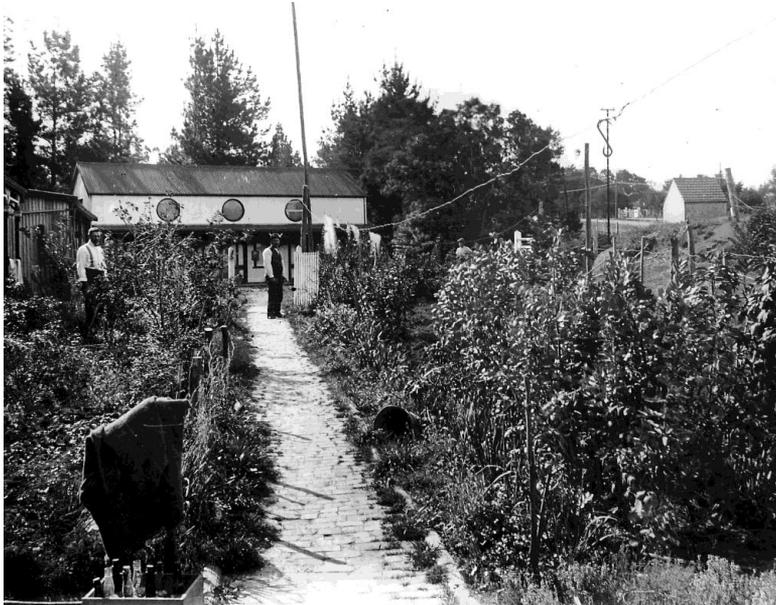
The Old Cellar from the vegetable garden, note the Depot beyond. Photo Khaleel Corban c. 1914

enlivened by three remarkable round windows, on the eastern wall of the loft space, evenly set down its length, by the verandah, and by the quality of the joinery to the verandah elevation. The upper windows, recovered from the fire damaged Auckland Town Hall²¹, do not appear to have lasted long.

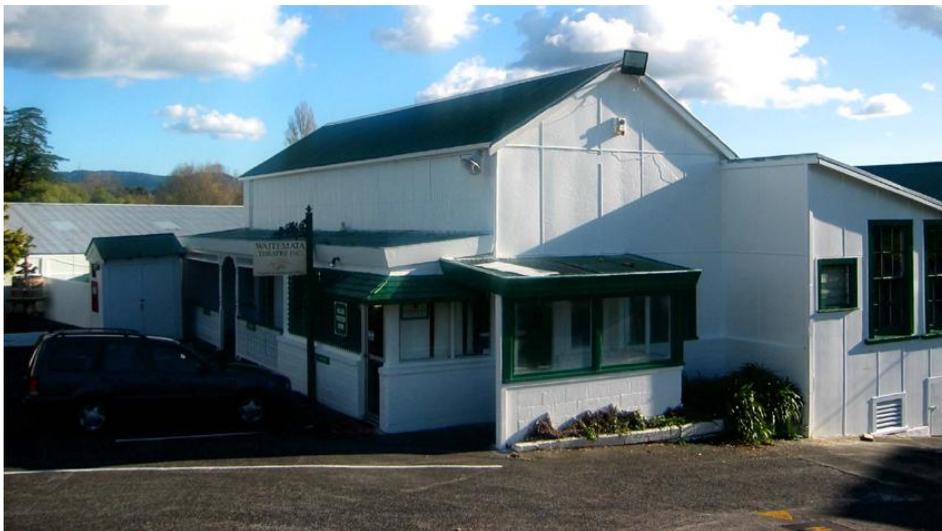
North east corner of Old Cellar 2004, photo Graeme Burgess.

The roof of this structure was, and remains, corrugated iron. The spouting is fixed to a planted fascia. The roof has no eave. The original cladding of the building was vertical corrugated iron. On the northern frontage of the building this was replaced by sheet fibrolite material in the early 1960s. The walls above the verandah and to the west and south are still clad in vertical corrugated iron.

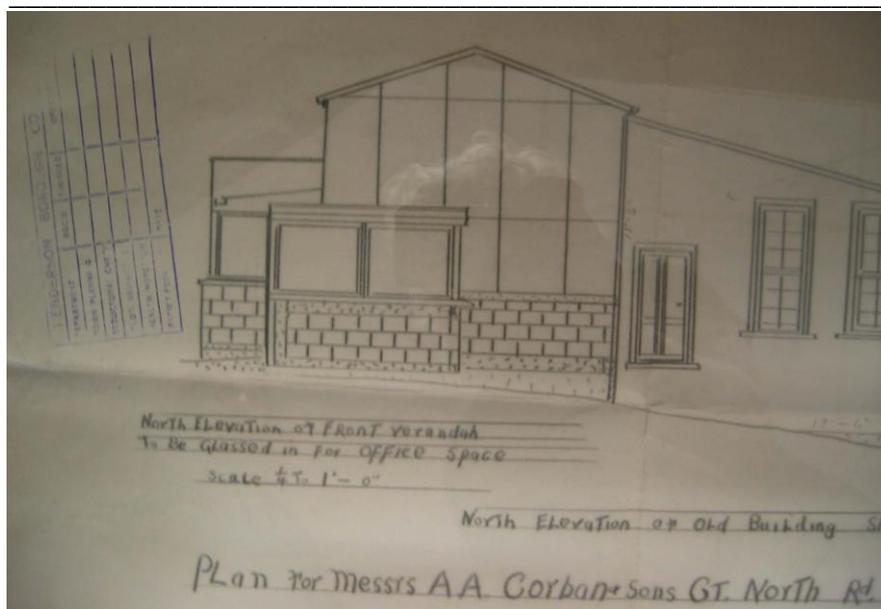
Part elevation, alterations 1960, Waitakere City Property File #10094

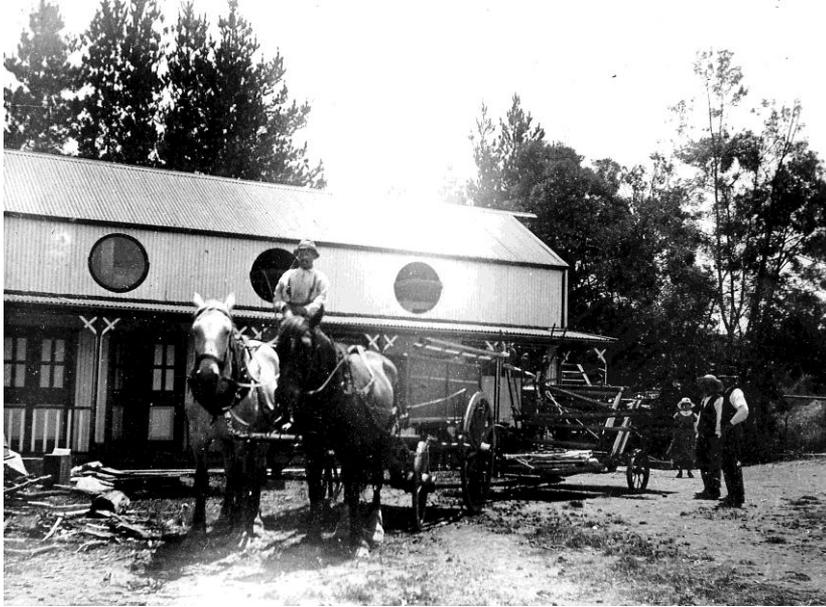
Verandah elevation of the new cellar, photo Khaleel Corban c.1908

The verandah has been filled in at the northern end in the 1960s. The finishes on the verandah are not the original finishes. The early post detail was plain, with simple brackets (refer to Khaleel Corban's photographs, p15, p.16, p. 39 and this page). These have been replaced with fretted brackets. The southern end of the verandah was closed by a glazed panel. The verandah was open when first built (refer photo page 15) and this screen was fitted before the house was built. The first section of the verandah from the southern end was balustraded, as the ground dropped away at this end of the building. A twenty light fixed window had been fitted as a screen at this end of the verandah by c.1908 (refer photo p.39). This area is now clad in corrugated iron. The original doors and windows remain towards the southern end of the verandah. At the north eastern end a new lobby and stairway was formed in 1960 to access the basement as a sales area, as described previously.

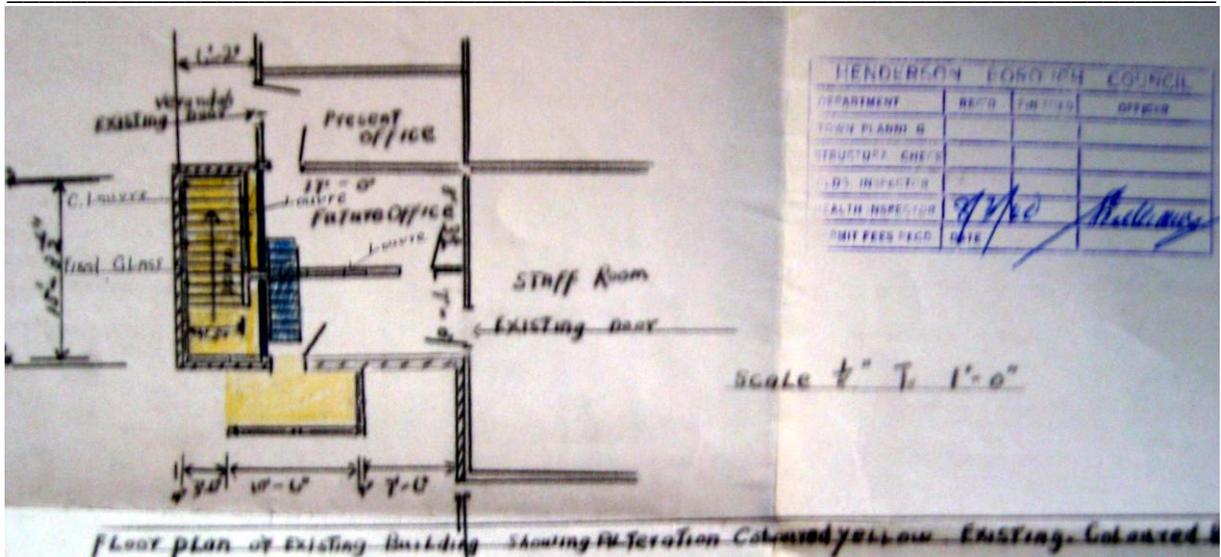
Plan detail, alterations 1960, Waitakere City Property File #10094

All of this has been covered or removed. Dick Scott’s quote implies that there may have been remnants of these finishes in 1977 when he wrote the book. These rooms have since been substantially modified. The northern end of the building was altered in 1960. At this time a new stair was built in the verandah space down to the basement, and a new entry to the office space made of concrete blocks and louvres on the northern face of the building. There is no record of any building consents to modify the interior of the building since that time. It has been relined and new ceiling beams have been installed.

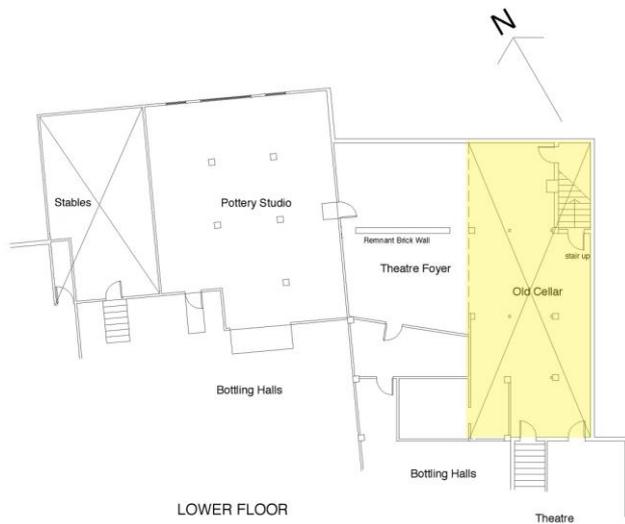
The stair to the basement has elements of glorious kitsch. A band of fake barrel staves lines the wall, at the base of the stair is a wrought iron gateway with more fake barrel elements. The basement was fitted out as the sales area in the 1960s. The barrel staves, wrought iron and plastic grapes remain, in the themed bar/lobby of the theatre. The barrel stave bar has been shifted (Helena). The external wall of the basement is painted concrete. This is the retaining wall beneath the exterior line of the verandah. There are remnant posts, although some posts have been removed and new beams fitted. There is a small section of brick wall, possibly from the original boiler room as this is outside the line of the cellar. The floor throughout this area falls in different directions. There are odd changes of level, ramps and generally a sense of this area having evolved rather than being planned. The floor, once earth, is now concreted.

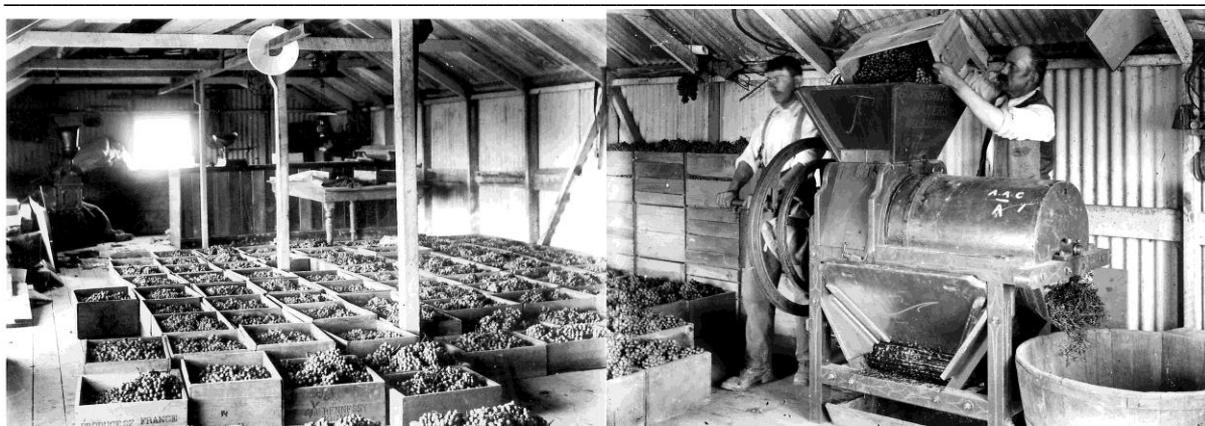
Old Cellar, Loft. Wadier working the crusher, A.A. feeding grapes, photo Khaleel Corban c.1910

There is a fine pair of photographs by Khaleel of the upper room, the attic space, with A.A. and Wadier working the crusher. The space is filled with boxes of grapes and flooded with light from the eastern windows. This room was the first step in processing. All the openings, apart from the window in the southern gable end have now been removed. The space remains as it was left by the Corban family. There are no linings. The roof and walls are exposed framing with the underside of the corrugated iron roofing and cladding also exposed. The floor of strip timber flooring is very fragile. Some boards have turned to dust. There are some boxes of packaging from the 1950s (and perhaps earlier) still in this space. This room can now only be accessed by a ceiling hatch in the end room of the ground floor. There are a number of electrical cables and some orange plastic conduiting.

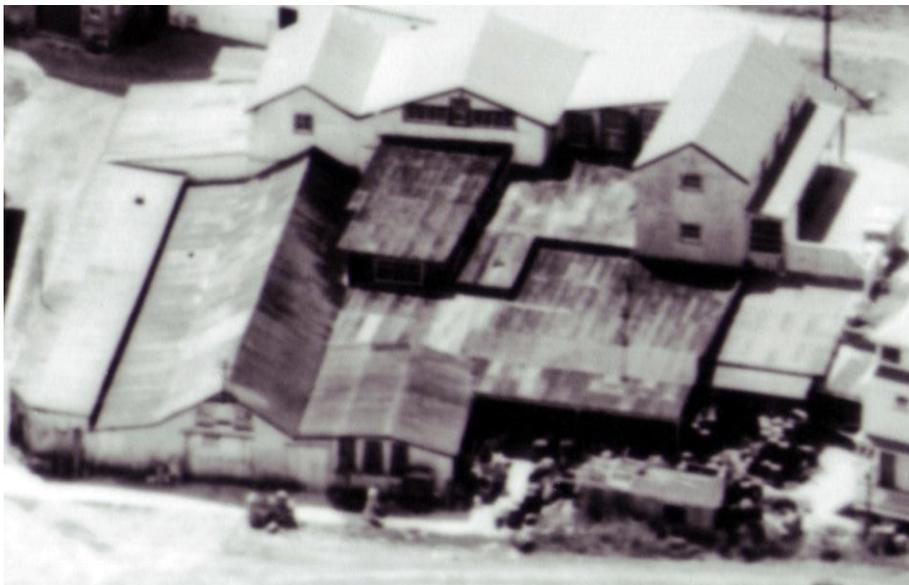
Detail, Whites Aviation photo #34781, 1954

The sequence of gables and lean-tos connecting the Cellar to the Stables was constructed at some time between 1935 and 1948²³. This area was used as the boxing rooms and the staff lunchroom²⁴. These additions are in line with the face of the stables, and finish at the side of the Cellar in a projecting lean-to. The lean-to flows seamlessly into a wide gable which is contiguous with the gable of the stables. The connecting buildings are relatively narrow, with the main gable projecting out beyond the lean-to. These sections of the building are finished to match; corrugated iron roofs, plain planted fascia boards (i.e. no eaves), vertical corrugated iron cladding to the southern side, fibrolite sheet cladding to the northern side, timber joinery. At the internal corner between the boxing rooms and the cafeteria the corrugated cladding is run for a short distance along the wall of the cafeteria. The downpipe on this internal corner has been covered by the cladding.

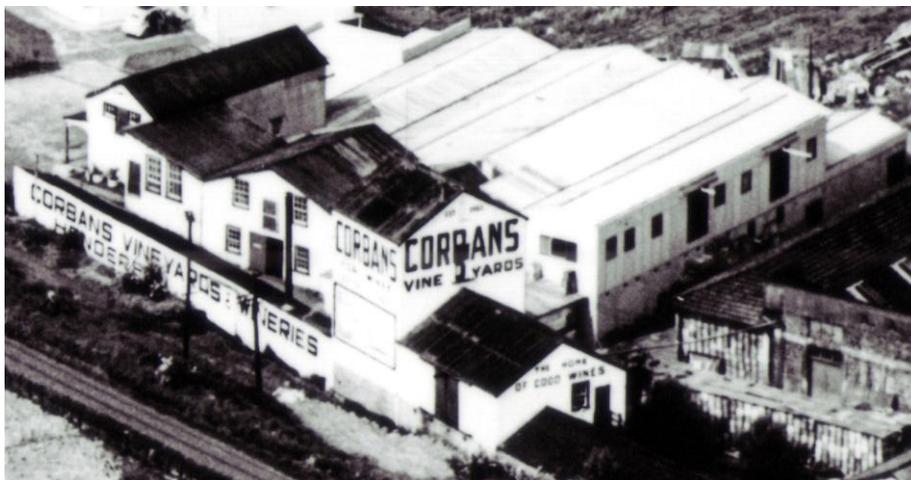
Detail, Whites Aviation photo #51430, 1959

The next section of the building, the wide gable end, has two double hung windows formally placed each side of a tongued and grooved panelled door at the upper level. There are three openings below. Only the right hand opening is in line with the openings above. The windows have been blocked. On the southern side of the wide gable are three symmetrically placed windows. The central window is a double hung window. Either side are long horizontal twelve light fixed windows. The early photographs, and the plans submitted in 1960 show different joinery. At that time there was a large pair of tongued and grooved doors. Each side of these doors is a double-hung window.

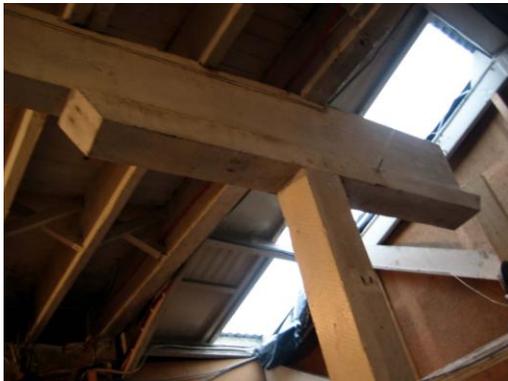
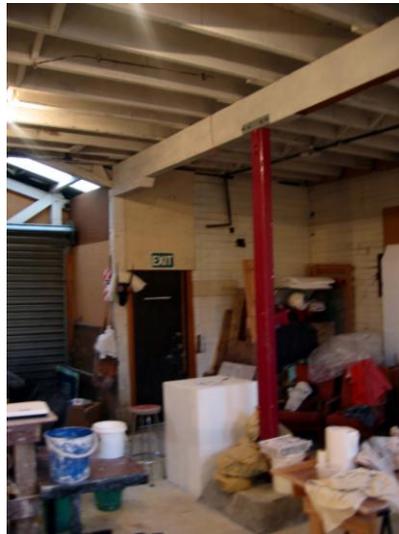
The area below the Boxing Room is currently a pottery studio. It is larger in plan than the room above and steps out along the southern wall. The ceiling of this room is exposed framing, with lines of herring bone strutting between the joists. The joists are supported on deep timber beams on large square timber posts, set on raised concrete plinths, with a spreader block beneath the beams. At the southern end of the room the structure of the gabled truss is exposed. Clear plastic roofing has been fixed over this area bringing natural light into the room.

*Looking across the Pottery studio
Post/beam intersection in the Pottery studio,
clear roofing beyond, both photos Graeme Burgess 2004*

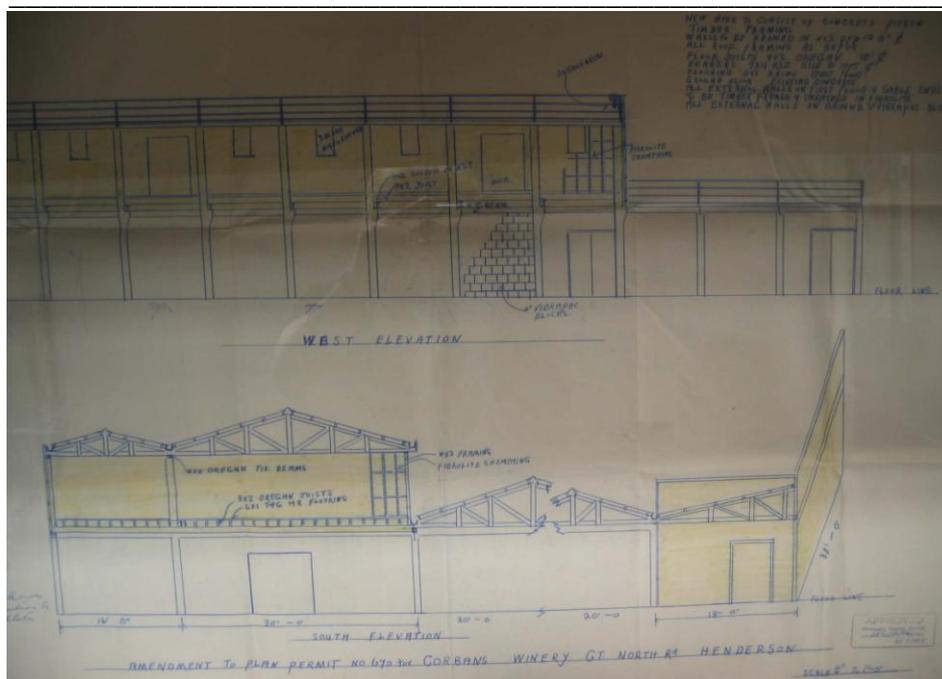
Bottling Plant –elevations, permit drawings 1957, Waitakere City property file # 10094

The lower area of the old cellar buildings, outside the footprint of the Old Cellar, the Stables and the connecting building, was rebuilt in 1959, as the Bottling Plant. On the western side a second level was added. This was used as a labelling and dispatch and later became the staff cafeteria (at this time a free standing staff cafeteria was built at the back of the building behind the house- this was demolished in the 1970s). This room is now used as a performance studio.

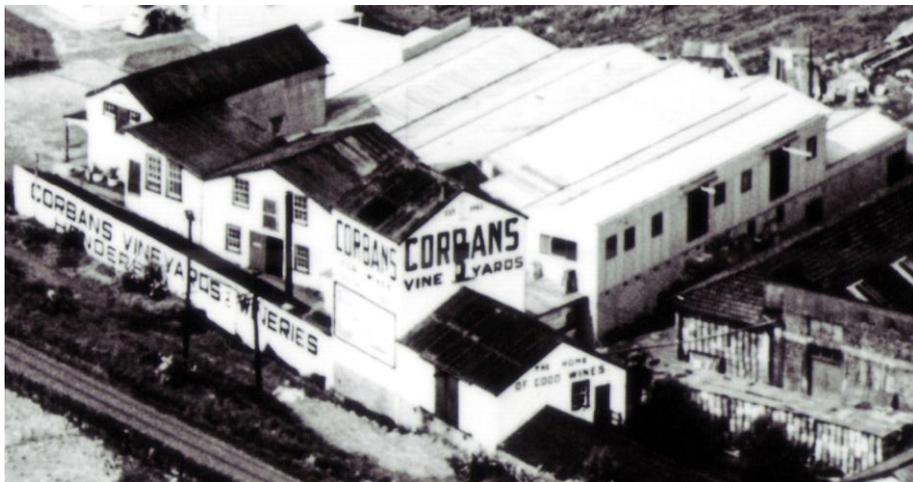
Detail, Whites Aviation photo #51430, 1959

The Whites Aviation photograph #34781 taken in 1954 clearly shows the conglomeration of sheds which had grown in this area before that time. The Waitakere City Council property file #10094 contains a number of permit applications relating to this work and further additions and alterations made to this section of the building. The elevations of the 1959 proposal, drawn by an amateur, look remarkably similar to the set-out of the 1941 cellar buildings. The new area is divided into four gabled bays running north-south, two wide central bays and two narrower side bays.

Before work was completed a half gable was added at the south eastern corner, and a second storey of two gables was added above the two western bays down two thirds of the length of the building. These engulf the form of the stables. In 1963 the southern end of the building was extended in a style to match across its full width. The lower sections of this area of the building are in concrete blockwork, the upper floor and gable ends are clad in sheet fibrolite. There are two sets of external sliding, vertically tongued and grooved doors at the upper level on the western side of the building and six louvred windows. At the lower level there are three doorways, one below the southern end of the double storey section, one into the area added in 1963 and a third between these. There are two windows into the lower area below the double storey section of the building.

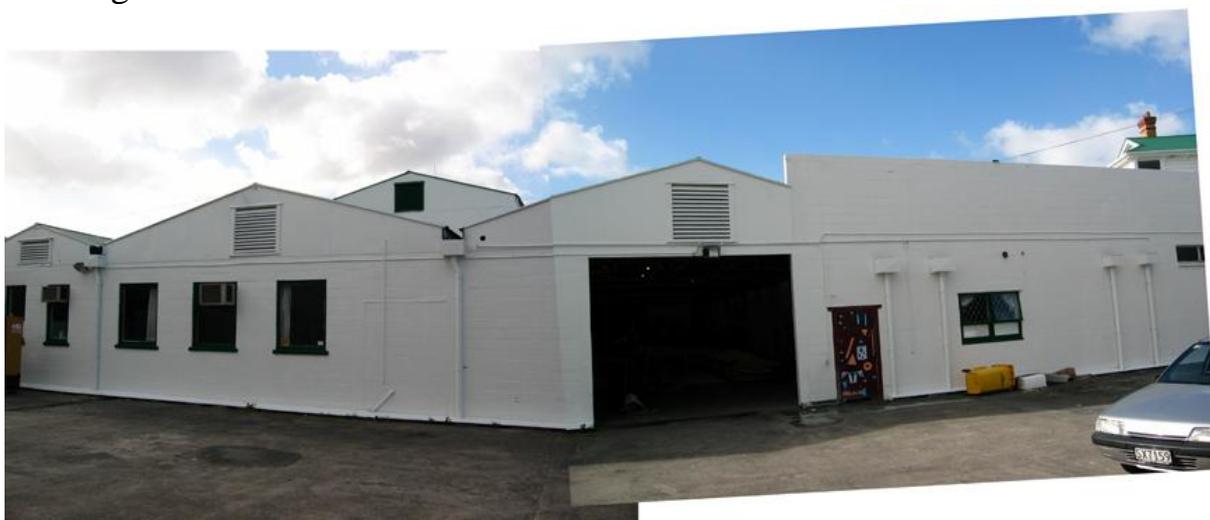
Southern Elevation Bottling Halls. Photo Graeme Burgess 2004

The southern elevation of the new area of the old cellars is a clumsy combination of parapets and gables. The right hand section of the building is an up-turned lean-to, this and part of the next gable have been enclosed by a

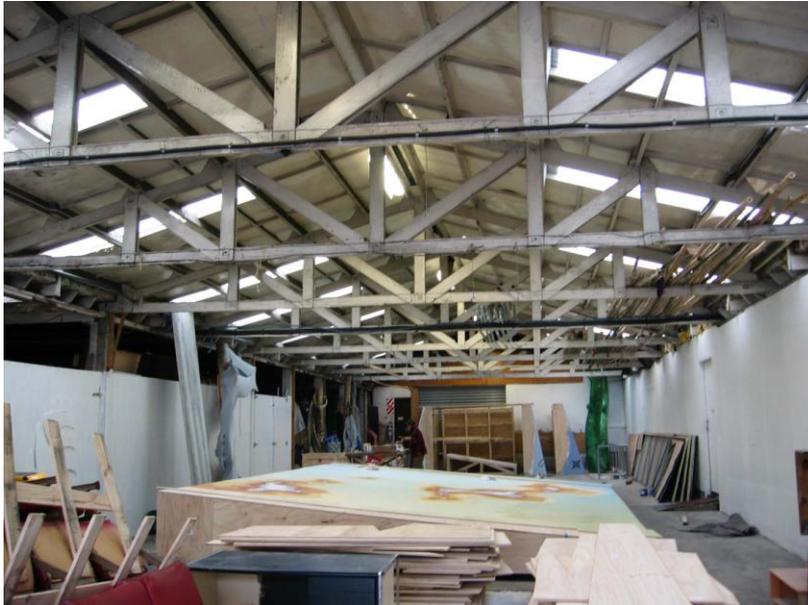
Interior of the Bottling Plant, photo Graeme Burgess 2004

The interior of the Bottling Plant hall is very plain. The roof trusses, made of boards, are all exposed, except in the gable end beyond the cafeteria, where the

roof structure has been lined with painted hardboard. The fibrolite internal gutters are also exposed. The ceilings and walls are mainly lined with painted hardboard. In the area beneath the cafeteria the floor structure above, and the steel beam structure supporting the floor, is exposed. The supporting posts in this area are reinforced concrete. The wall of the stables facing into this area is vertical corrugated iron. The walls between the toilet area and the main area are exposed concrete blockwork, as is the external wall down the western side of the building.

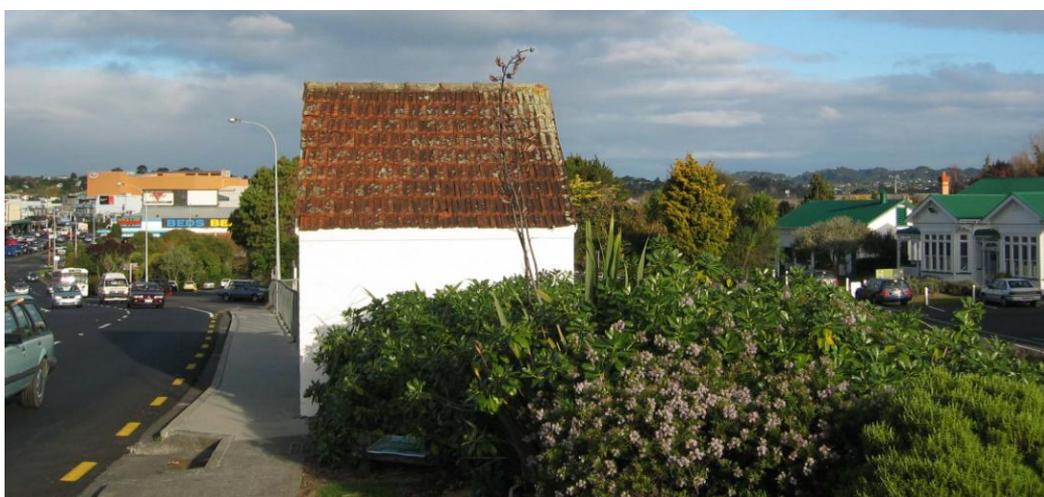
Western side of Depot, photo Graeme Burgess 2004

The depot is a single room, a simple gable structure with brick walls and a concrete tiled roof. In keeping with the form of the original winery building,

this building has no eaves. It also has no spouting. A fascia board is planted to the brick face at the eaves. At the gable end a scribed board closes the edge of the tiles. This has a batten fixed to it to give a detail line. Four gaps have been formed in the brickwork of the gable ends as ventilation. There are two openings in the gable facing the street. The other elevations of the building are of plain bonded brickwork. The two openings are a doorway to the left, and a window to the right. These openings are eccentrically placed in the wall. The head of each opening is slightly arched. The window head is a single course below the head of the door and the doorway is a course below the intersection of the barge with the outside wall. The door is a rectangular vertically panelled tongued and grooved door, the head of the door frame is radiused to the arch of the opening. The window is a plain timber window, also with a radiused frame. The window is square, and is the width of the door. There is a metal rod grill over the window.

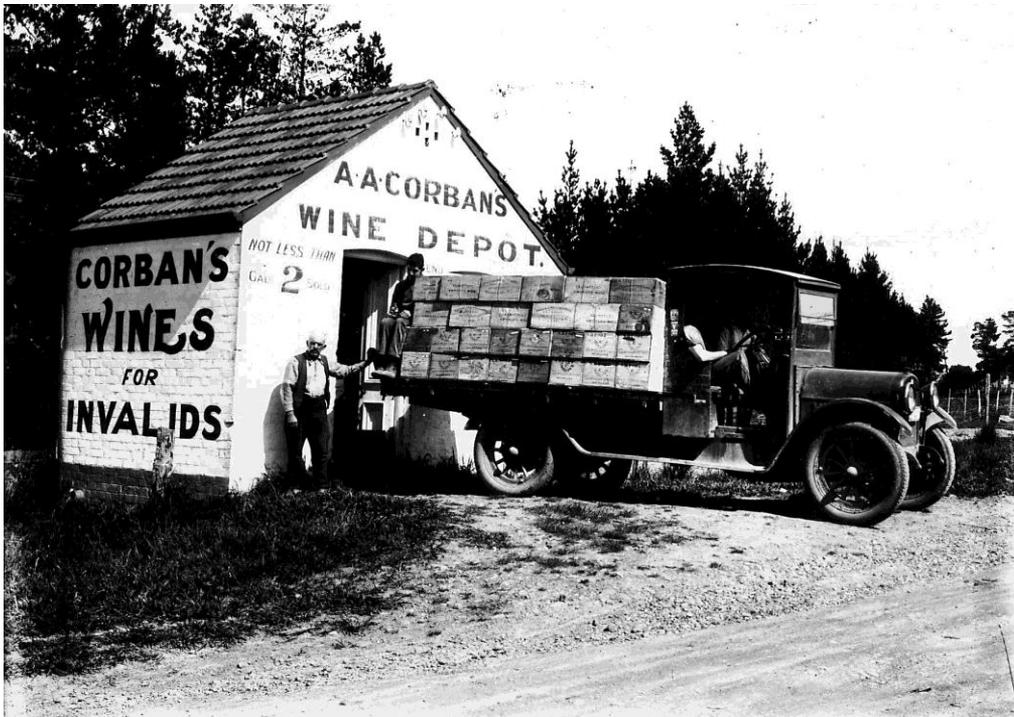
Depot c.1914, photo Khaleel Corban

During the few years it was in use the exterior of the building was a billboard. The wall facing Henderson carried the motto; “CORBAN’S WINES FOR INVALIDS”, the end gable the title “A.A. CORBANS WINE DEPOT”, and to the left “NOT LESS THAN GAL 2 SOLD”. The message on the right hand side is obscured by a truck in the family photograph “Depot”.

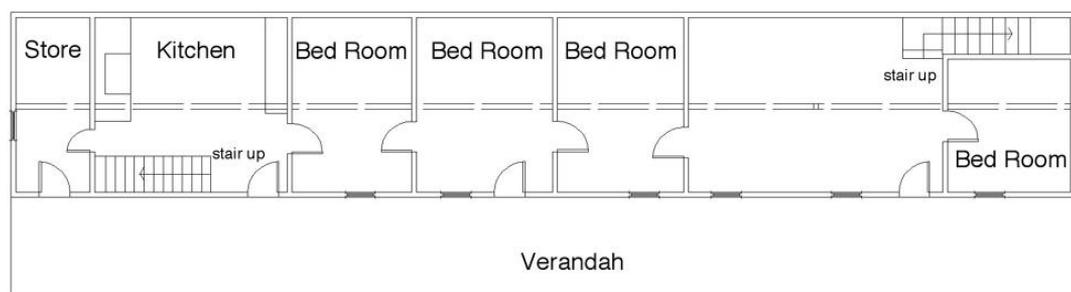
BASEMENT LEVEL

Plan derived from as existing plan 1979 permit. Burgess & Treep 2005

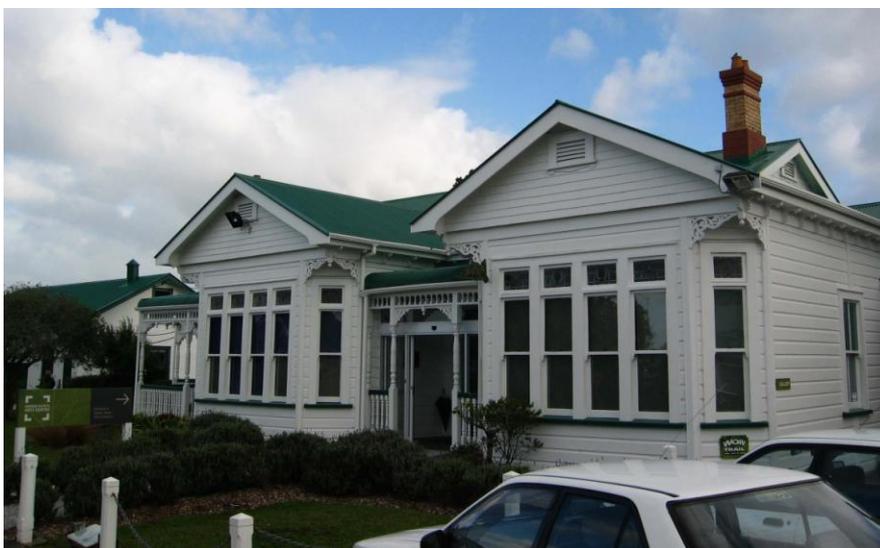
Entry between the gables, photo Graeme Burgess 2004

The house has a long formal frontage facing Great North Road across the yard and the railway. The building is on two levels. The primary form of the house is a long stepped gable parallel to the street frontage, this ends in a tiny projecting gable at the western end, and steps into a narrower gable at the eastern end. The ridge of the diminutive gable at the western end of the building is carried across the face of the main gable and the roof ends at the south west corner in a hip. Two broad gables project out to the street. These are finished as matching bays. Between these gables is the formal entry. In line to the left are two verandah porches, and to the right a verandah porch set back and enclosed to the west by the central projecting gable described above.

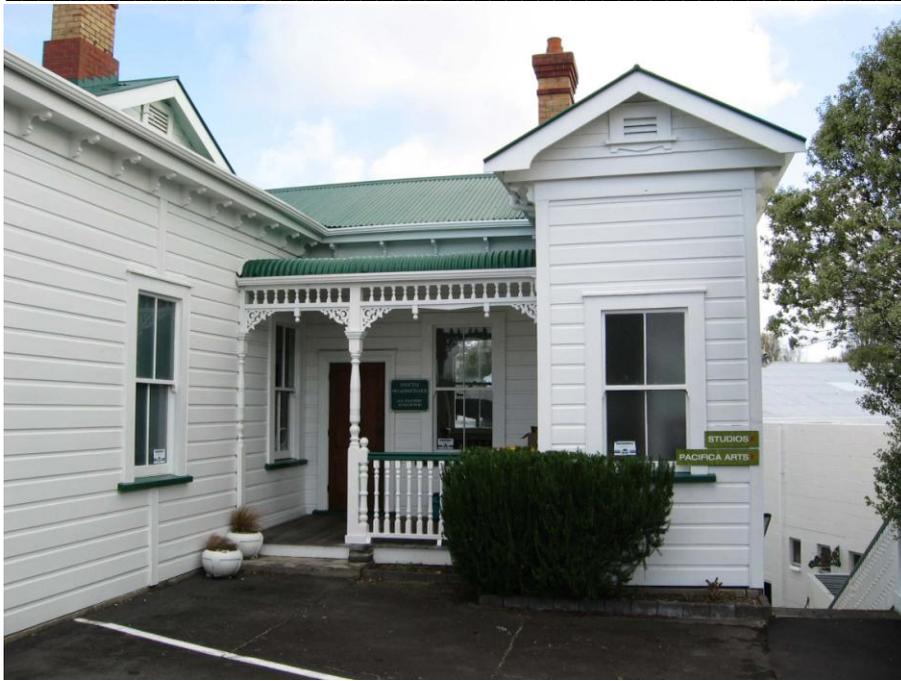
Kitchen verandah, and George Ataya's gabled bedroom photo Graeme Burgess 2004

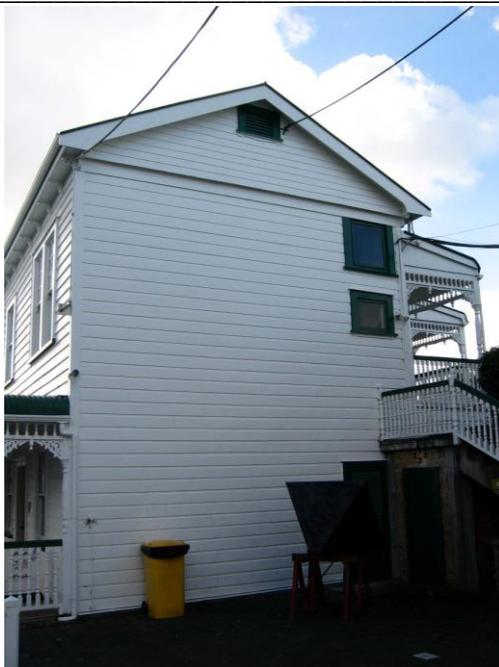
*Eastern end, note the square windows to the toilet and hall,
photo Graeme Burgess 2004*

At the eastern end of the house the building finishes in a gable. There is a bull nosed verandah to the right at the upper level, and two square fixed windows one above the other at the right hand side of the gable end. There is an external stair down from the verandah area. The brick base of the stair platform was a toilet. This is now empty. At the lower level there is a vertical tongued and grooved doorway into the maintenance walkway behind the basement rooms. The verandah finishes at the corner. The existing verandah is wider than the original and more elaborately detailed. This was rebuilt during the Rothmans period.

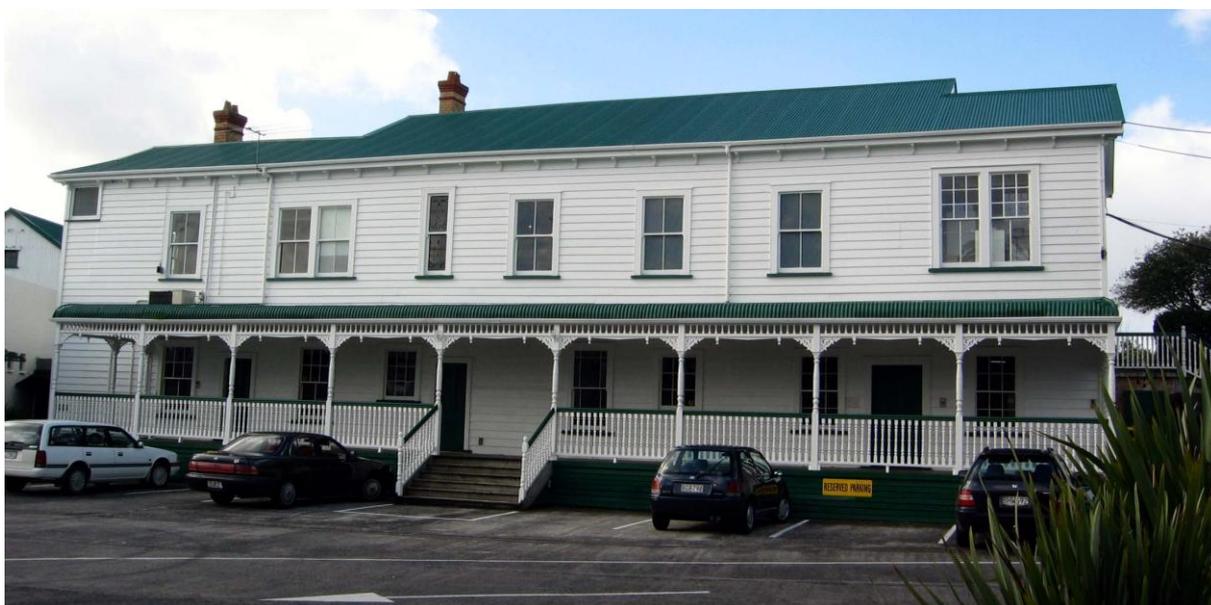
Rear of the Homestead, photo Graeme Burgess 2004

The rear of the house, facing out over the former vineyard, is two storied and plain by comparison with the street frontage. A verandah runs almost the full length of the building at the lower level. The verandah and the verandah deck have been rebuilt. These elements were originally narrower, and the deck did

not project beyond the outside line of the verandah. The verandah originally did run the length of the building. The pantry room overhung the verandah at the western end. The high square fixed window at the top right corner was above this room. The doorway from the verandah at this end of the building has also been removed. All the windows at the upper level on this side, with the exception of the high square window at the left, are double hung. At the lower level there are three panelled doors, one with three sunk panels across, the other with two (originally there was a fourth door at the western end), five double hung windows, and two horizontally pivoting windows.

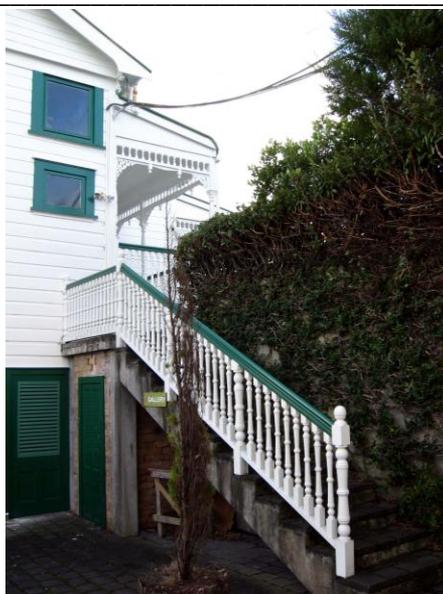
*North east corner, concrete stair, with toilet room below landing. Note access door to sub-floor
photo Graeme Burgess 2004*

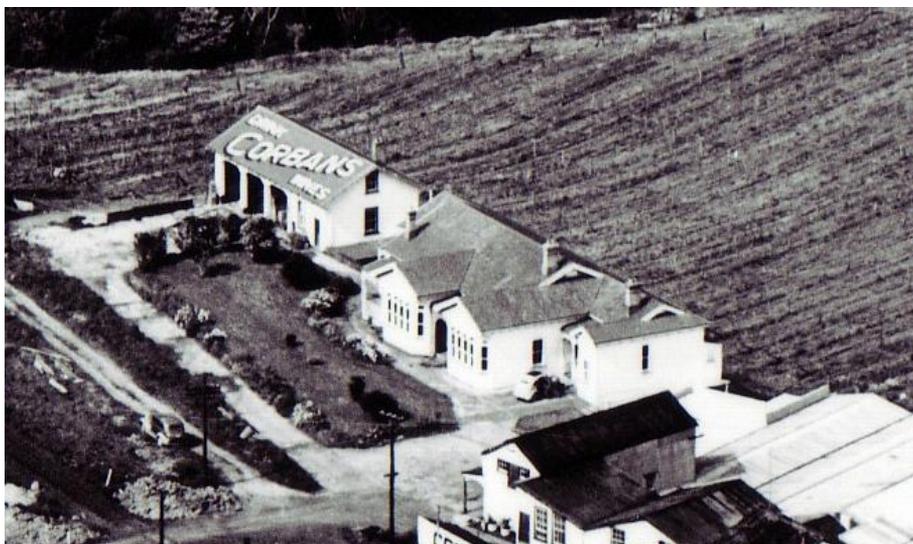
Detail, Whites Aviation photo #51430, 1959

The main entry now has matching timberwork, with an aluminium door screen behind. Until 1979 the archway to the entry porch was brickwork. According to Dick Scott, Assid Corban wanted to build the house in brick with arched entryways as a reference to Lebanon.³¹ The cost of building in brick was prohibitive, and a single archway across the most significant opening was the remnant of this ambition. This was a carefully considered decision. Even the selection of the bricks, sourced in Palmerston North at a time when brick making was a prime industry in West Auckland. The brick arch fitted to the edge of the bull-nose.

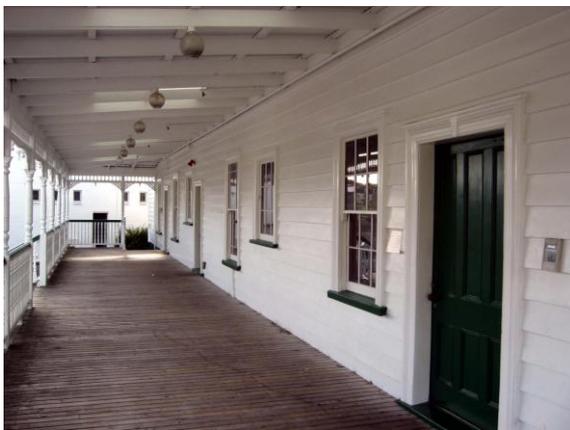
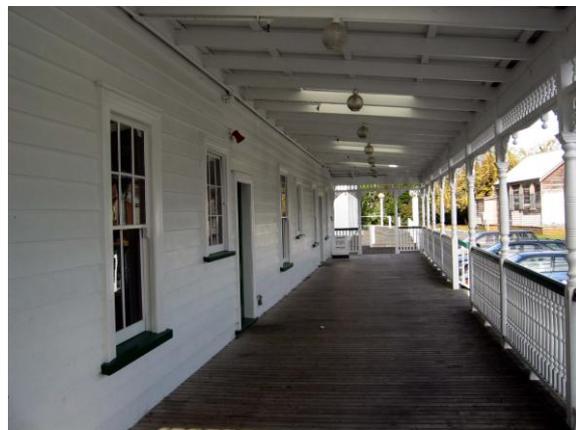
*Looking along lower verandah to the west,
Photos Graeme Burgess 2004*

Looking along lower verandah to the east

The joinery at the lower level is more idiosyncratic. The predominant windows are still double hung. With the exception of the doorway at the Western end which has been removed. From the western end the joinery across the verandah is; doorway (removed), double hung window with six light upper sash and bottom sash with a single vertical glazing bar, panelled timber door, a second window matching the first, a nine light horizontally pivoting window, a second panelled timber door, a large double hung window two vertical glazing bars to each sash set just in from the side rail each side, with a matching horizontal rail at the bottom and head, a second nine light pivoting window, a double hung window with each sash in six lights, a three panel door, a second double hung window with each sash in six lights.

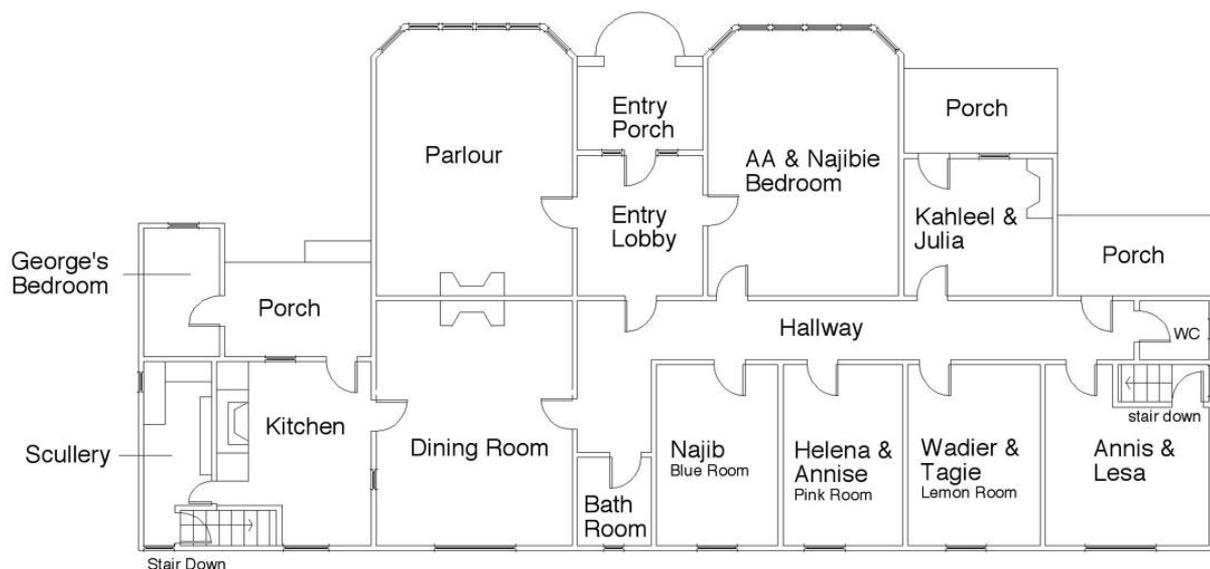
GROUND FLOOR

Plan derived from as existing plan 1979 permit. Burgess & Treep 2005

The house is planned around an “T” shaped hallway. The short leg of the “T” to the north is the entry lobby between the two large projecting bays. This connects to the central hallway of the house running to the east. The two main rooms of the house, the parlour and A.A. & Najibie’s bedroom are the broad bays each side of the wide entry hall, all the other bedrooms were off the central hallway. The short leg of the “T” to the south continued to become the bathroom. The area behind the main bedroom was the dining area. The doorway to this area was beside the bathroom. The rooms at the western end of the building were the kitchen and scullery. Recessed back on the eastern side of the parents’ bedroom is the study. This room was the second cottage. The house is

a farmhouse. There are secondary entryways, each with a covered verandah porch, into the kitchen area at the western end, and, at the eastern end into the study, and directly into the hallway. The room built beside the verandah at the north western corner of the house was a bedroom for George Ataya. There were stairways down to the lower rooms at each end of the house, one from the scullery, another in the last bedroom. At the end of the hallway was a toilet. The two windows in the end of the hall suggest that the hall ceiling was open over this room. There is now a bulkhead over this section of the hall and within the bulkhead are traces of the original finishes, a dappled cream wall paper with a deco pattern frieze, and varnished panel batted timber ceiling with a coved varnished cornice.

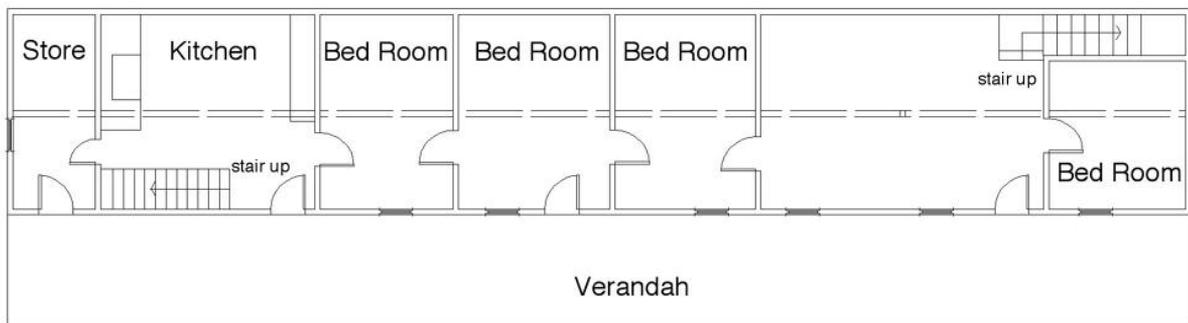
BASEMENT LEVEL

Plan derived from as existing plan 1979 permit. Burgess & Treep 2005

The rooms below were in line, connected by doors through on the inside with no hall, and by a verandah along the outside. The ceilings throughout this area are varnished board and batten, running the length of the building. The original walls are horizontal tongued and grooved also varnished, with a dowel to the ceiling and corner intersections. Architraves are plain bevelled boards. The timber floors are covered. The internal doors are four panel timber doors, in the villa style. There is a timber beam running the length of the building supported on posts with spreaders at each wall, and at the centre span of the open rooms. The post is expressed in the cross walls. The original coal range is still in place. This is set within a white tiled recess. A plain board mantle has been fitted over the arched opening. The mantle is supported by bandsawn brackets on each side. To the right of the range is a slim cupboard in two sections. The cupboard is made of vertical tongued and grooved boards. The doorway to the left of the range, and the gib board wall to the stair, are new. Original doors have been reused in the doorway and the door to the storage area under the stair.
