Corban Estate Winery

426 Great North Road
Henderson

CONSERVATION PLAN
July 2005

BURGESS & TREP ARCHITECTS

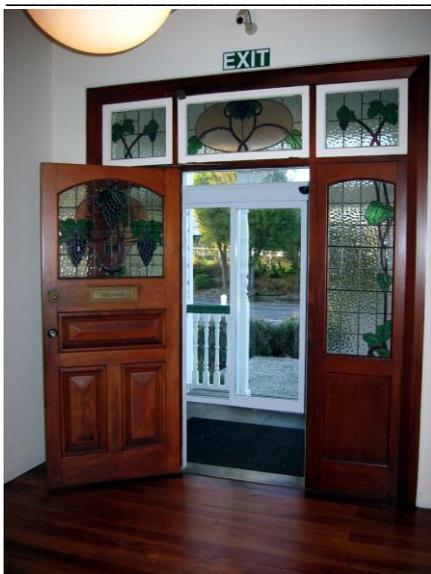
Front door, photo Graeme Burgess 2004

The main entrance to the house, as stated above, was between the two large bays. The remnant brick archway was at the outer edge of the verandah, and the ceiling of the verandah space is lined with tongued and grooved match lining. The doorway set back within the verandah space is a complex panelled unit, a central doorway with two wide fixed panels each side and fanlights above. The door has an arched, stained glass top panel, a broad lock rail with a brass letter slot, a horizontal sunk panel over two vertical sunk panels. These panels are diamond faceted with bolection mouldings around. The side panels have taller, arched stained glass panels, with a flat sunk panel below. The three fanlights over are also finished in stained glass. The stained glass is in a grape pattern. This joinery unit is finished as natural timber. The doors to the parlour and main bedroom and to the hall are elaborate panelled doors. The upper section is

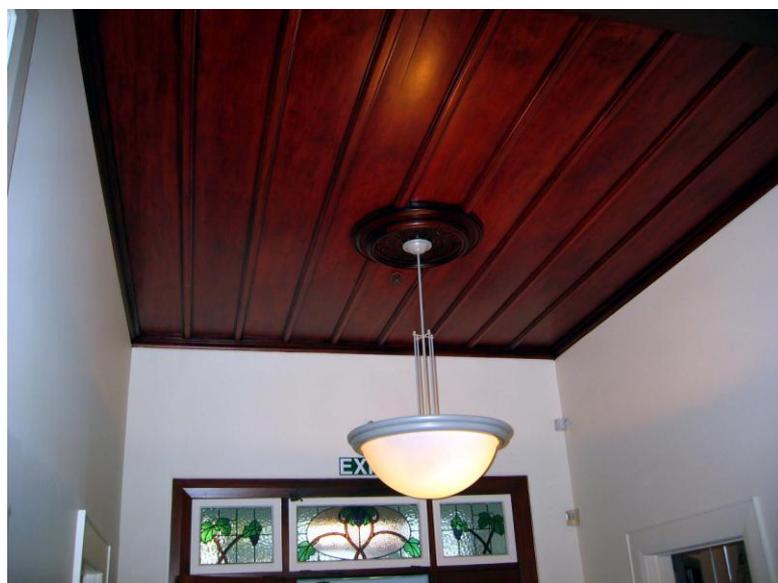
Entry lobby ceiling, photo Graeme Burgess 2004

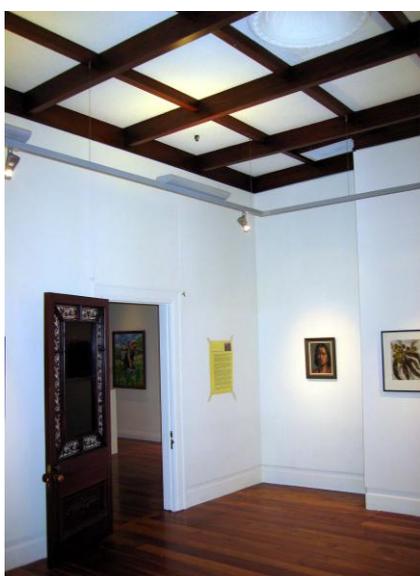
Parlour ceiling, photo Graeme Burgess 2004

The two bay rooms are similarly finished. The ceiling in the western bay is in bungalow style, a coffered ceiling of plasterboard sheeting between dark stained

beams with a central domed plaster ceiling rose. Ceiling vent panels have been integrated into the composition at the window frontage. These are new. The ceiling in the eastern bay is a board and batten ceiling with a fretted ceiling rose. The fanlights above the double hung windows in both bays are finished in stained glass. The stained glass is composed as a classical pattern across all the windows in each room, a swag with a drop at each end. The grape motif is incorporated into the composition but is not dominant. The fireplace in the parlour room has been enclosed.

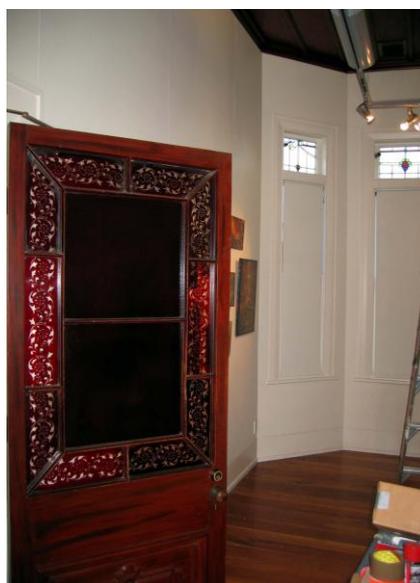
Etched glass door, bedroom bay, photo Graeme Burgess 2004

glazed, two horizontally divided burgundy panels with a radially divided border of etched red glass in a grape leaf pattern around it. There is a single sunk timber panel beneath this with a planted pattern of timber mouldings. The architraves to the original openings here, and throughout the upper floor, are single-bevelled wide boards. This area and the hallway had a timber dado before 1979. This was removed and new linings fixed. The wall between the entry lobby and hallway was also removed at this time and the etched glass door relocated in the hallway. The ceilings in the lobby and hall are natural finished board and batten, with elaborate fretted ceiling roses. The floors here and throughout the house are strip timber tongued and grooved flooring.

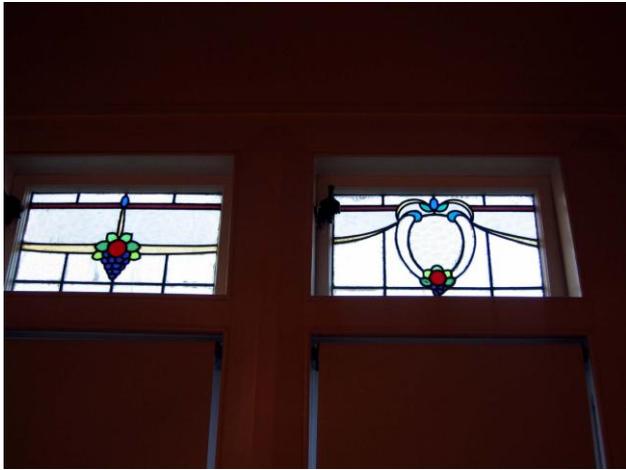
Stained glass fanlights, bay rooms, photo Graeme Burgess 2004

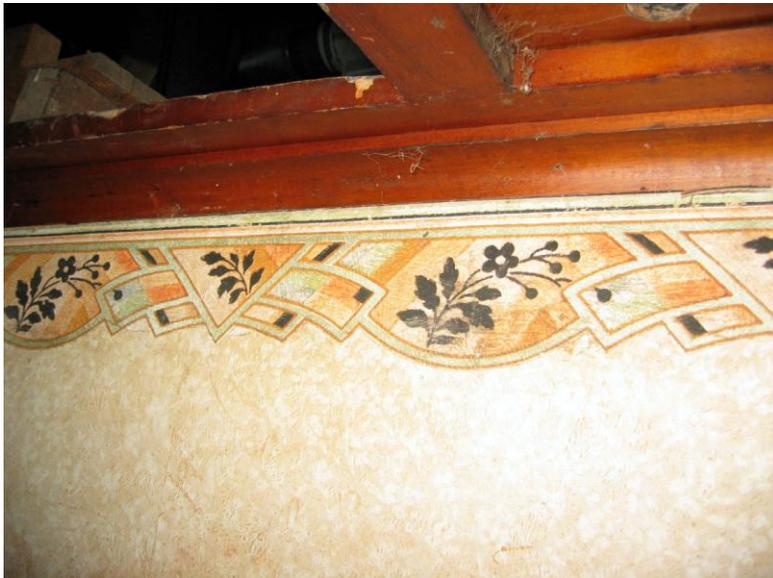
*Remnant of wallpaper and ceiling mouldings, eastern end of hallway,
photo Graeme Burgess 2004*

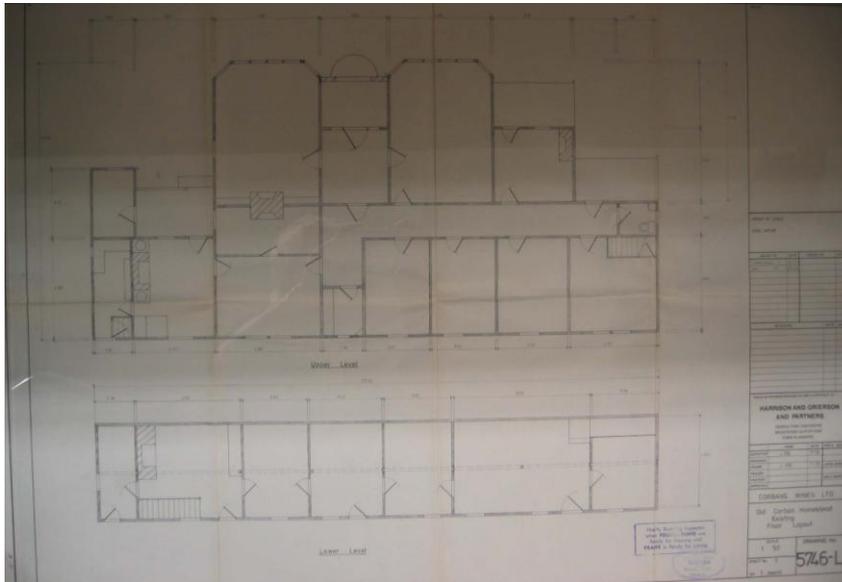
Plan , as existing, 1979 permit application, Waitakere City Council property file #10095

In the 1979 changes, documented by Harrison & Grierson & Partners, Consulting Engineers, the brick archway at the entry was removed. The internal stair at the eastern end of the building was removed and a women's toilet built in its place. The entry lobby was opened into the hallway to form a reception area. The bathroom was opened into the dining room to form a general office area. The stair from the scullery is shown in the plans as boarded over at the upper level and left in place below. The "Existing Plan" shows that the stair was enclosed within the kitchen area, and clearly show the original run of the stair, now reversed. By this time the scullery area has been converted into a kitchen

The “Existing plan” also shows a wall across the dining room. This wall, not part of the original plan of the house, was to be removed as part of these works. It remained in place, as it is clearly shown on the “Existing Plan” drawing done in 2001. The pattern of the ceilings, showing the outline of the original spaces, was retained. The “Existing Plan” also shows a door, almost at the corner of the hall, into the main bedroom, removed in the “Proposed Plan”. The location of this door was confirmed by Helena. A hatch for the reception was cut into the entryway wall of this room. The small gabled room, George Ataya’s bedroom, was fitted out as a men’s lavatory. The permit drawings from 1979 also show a semi-circular area outside the main entry on the “Existing Plan”, which is removed on the “Proposed Plan”. The specification for the work at this time also describe the removal of the original dado panels in the entry lobby and hallway. A new retaining wall of reinforced concrete blockwork was built across the face of the excavated bank behind the back wall of the basement area. At this time a full sprinkler system was also installed. According to the permit documents no changes were made at this time to the lower floor area.

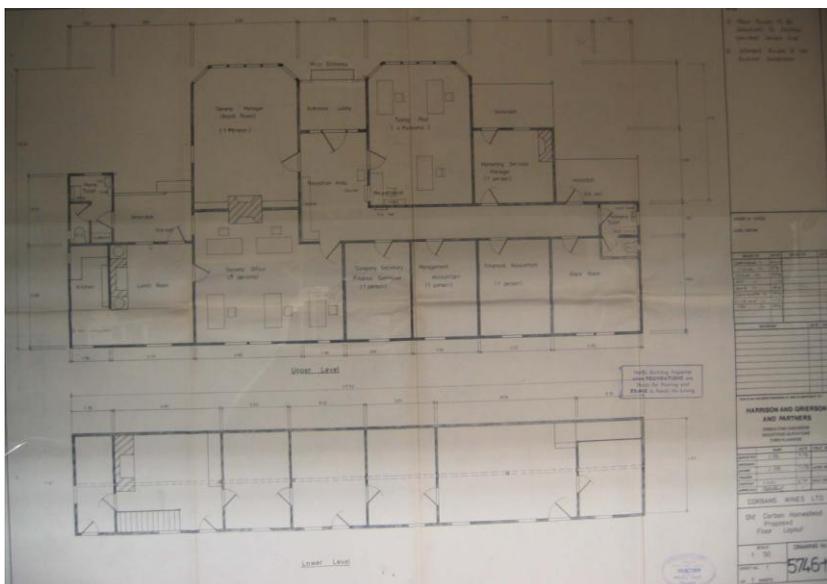
Plan , proposed, 1979 permit application, Waitakere City Council property file #10095

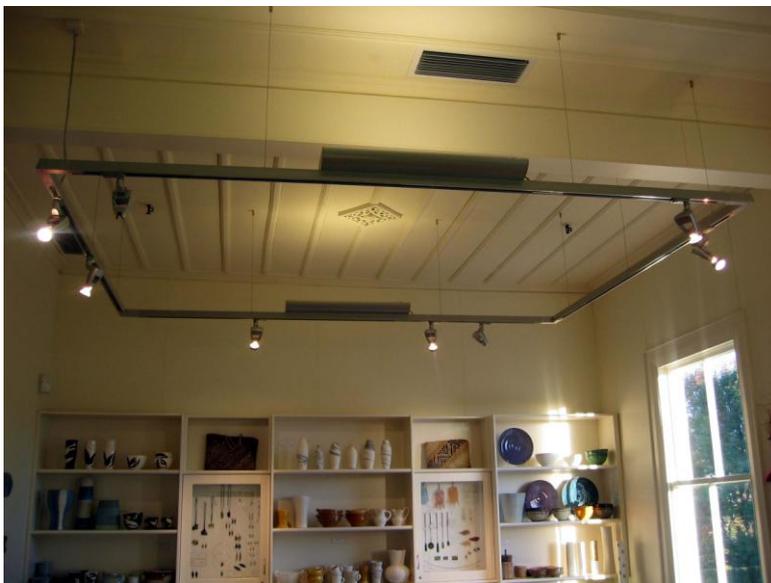
Ceiling in the reception area, previously a bathroom, photo Graeme Burgess 2004

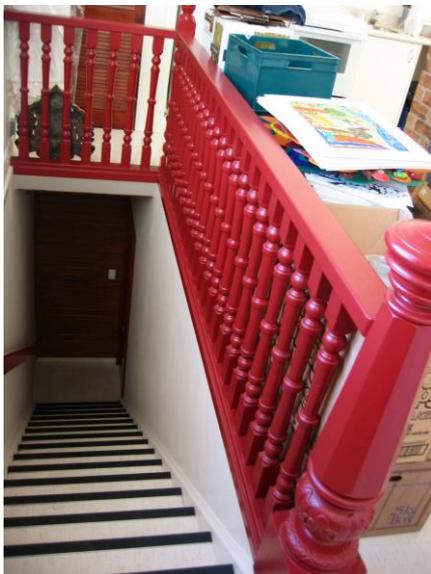
*Stair down from kitchen, this has been reversed
photo Graeme Burgess 2004*

In 2001 plans for further alterations were prepared by Graham Keys Architects. The intention of these alterations was to create an office and exhibition spaces for the Corban Estate Arts Centre. The existing plans show the western stair below reversed, but otherwise the lower floor is unchanged from 1979. Change has, however, occurred. The doorway into the store room has been removed, and the wall between the next two rooms. The notes on these drawings show that the stair had been reversed by this time and a “new” open balustrade fitted. Two large aluminium joinery units were fitted as part of these works, one at the

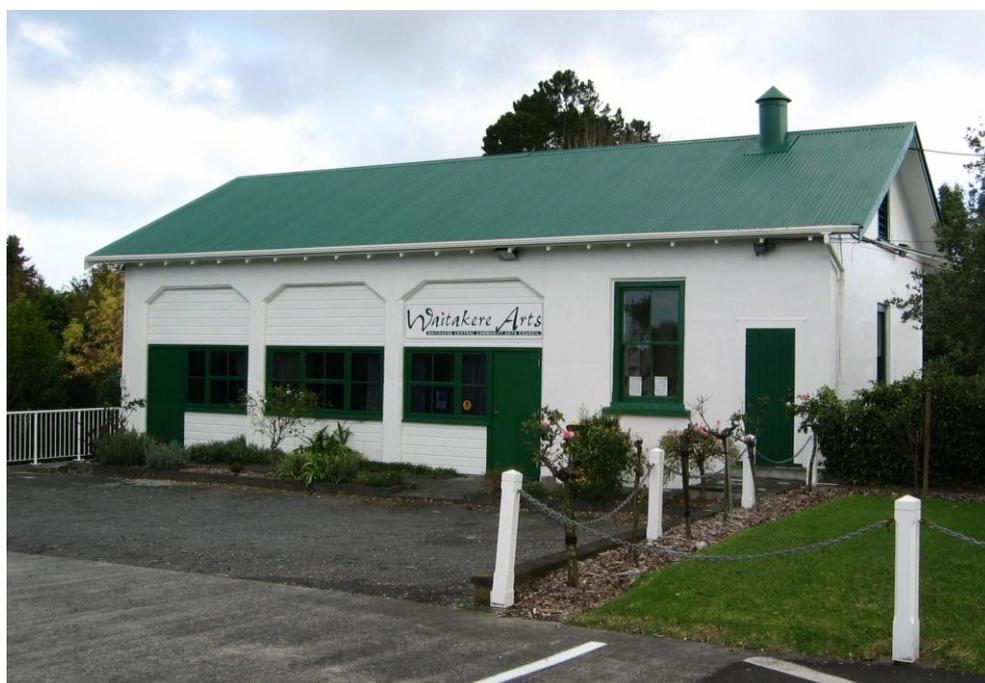
North elevation of garage, photo Graeme Burgess 2004

On the northern face of the building were three parking bays at the eastern end and a doorway and window to the office at the end of the building facing the house.

The garage was built after the house was completed in 1924. In the manner of the other buildings on the property, this building is also set at the edge of the natural bank. As a consequence the building is double storied at the western end. The rooms beneath the building were the laundry and the dairy room, and are now a toilet and a studio. In form the building is a plain gabled rectangle. The primary elevation of the building faces the road. The gable runs parallel to the road. Although this building is the contemporary of the house, and is sited beside it, the garage does not follow the style of the house. This building is closer to the bungalow style. The building was built of off-form concrete. The north, east, and west sides of the building are plastered, and the south has been left as it came out of its boxing. This gives the exterior of this face of the building a rough texture, very apparent as the backdrop in the photograph of Assid and Najibie sitting against the back of the building. By the mid 1990s this building was covered in creeping fig. The roof is corrugated iron and the rafters are expressed at the eaves. The barge ends are narrow, cantilevered out with a broad soffit.

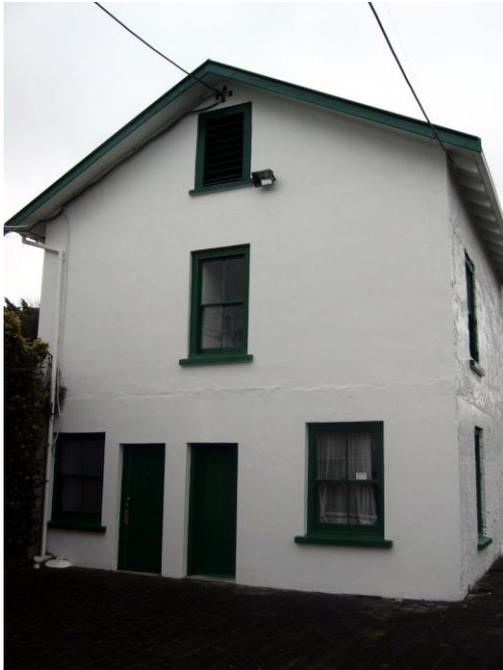
West elevation, photo Graeme Burgess 2004

At the western gable end of the building there is a timber louvred vent panel at the peak of the gable. Beneath this is a single double hung window at the upper level. The 1935 aerial photograph shows a verandah right across the western face of the building at the lower level. This has been removed. At the lower level there is, from the left hand side; a double hung window, a panelled timber door, a second panelled timber door, a double hung window.

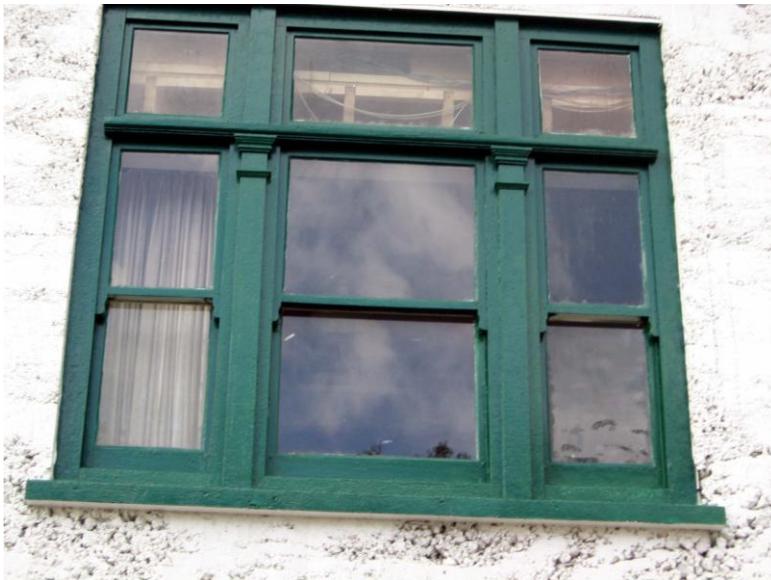
Tripart window, south wall, note texture of concrete, photo Graeme Burgess 2004

The rear frontage of the building, the south elevation, has three openings, two double hung windows one above the other, but slightly out of line, at each level at the western end, each sash with a single vertical glazing bar, and a tripartite window centred on the garage space. This window is composed of three vertical elements, two narrow double hung windows each side of a large double hung window, with a line of matching width fanlights above. The facing boards

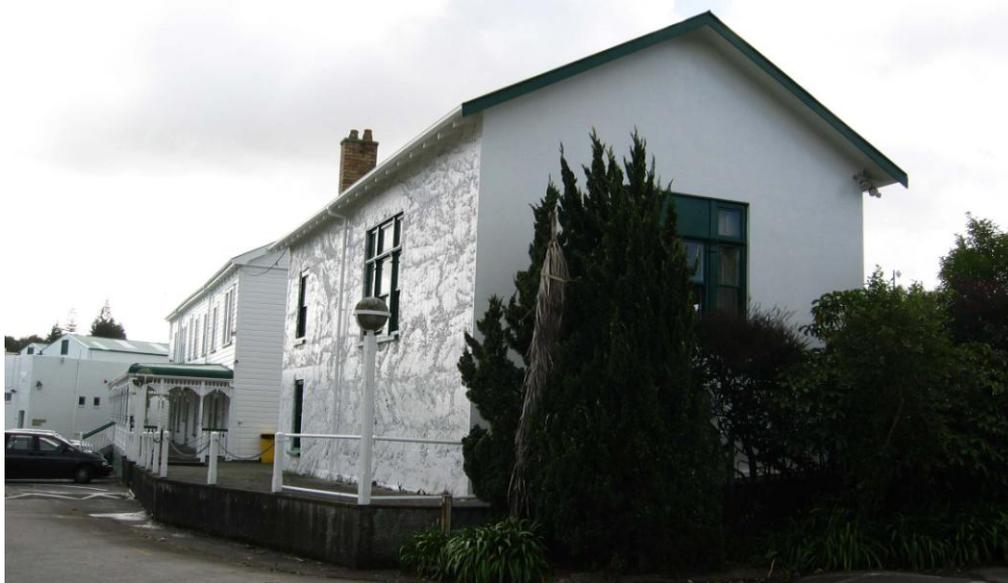
Eastern end view showing relationship of Garage to Homestead, photo Graeme Burgess 2004

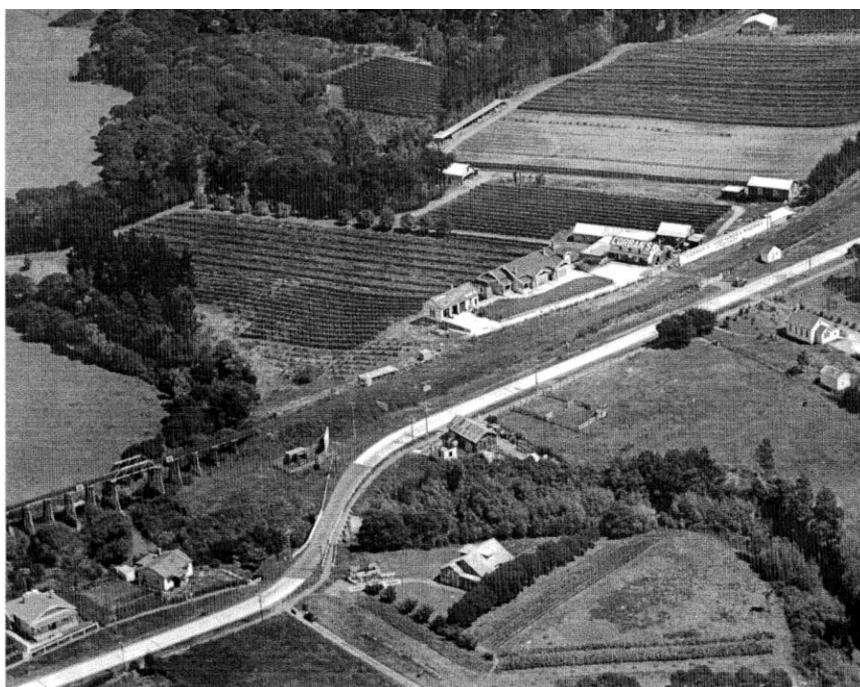
*Whites Aviation aerial oblique photo 1935 #55936.
Distillery building long and low against the railway boundary*

The distillery buildings define the railway edge of the site. This is a long sequence of buildings, of similar width, built against the railway embankment since 1925 (they are not shown on Corban Corban's thesis diagram of 1925, reproduced on p183 of "A Stake in the Country"). These buildings were built for a variety of functions and are called the distillery because this was the most dramatic use. The first building was a single storey brick gable built as barrel storage against the railway boundary. Comparing the oblique aerial photographs of 1935 & 1960 it appears that this building is the base of the still tower. A long lean-to shed, which may have predated the brick building, was built to the east of this along the boundary. Other sheds were added over time at each end to house boilers and eventually a transformer facility for the property (western end).

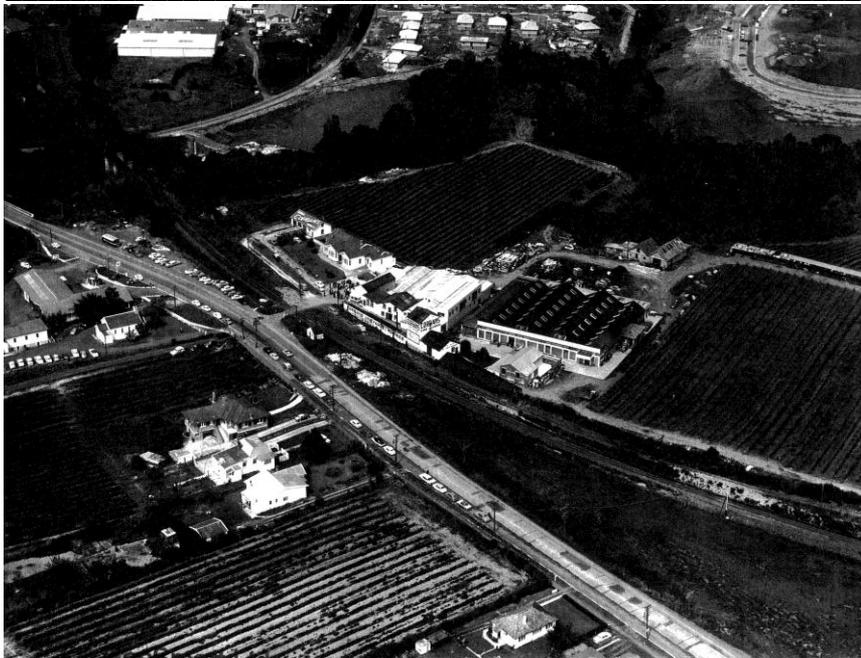
Whites Aviation aerial oblique photo 1960 #52767

Note the long low lean-to towards the house beyond the still tower

In 1960 a long wall with the sign “CORBANS VINEYARD & WINERY HENDERSON” ran from the side of the tower to the entranceway, and behind this was a lean-to, with the flue of the boiler in the section closest to the still tower. These are the buildings which occupy the site in 1935, with the same sign, and a small brick building on the site of the still tower. Whites Aviation #52767, 1960, #52770, 1935. This lean-to structure has gone.

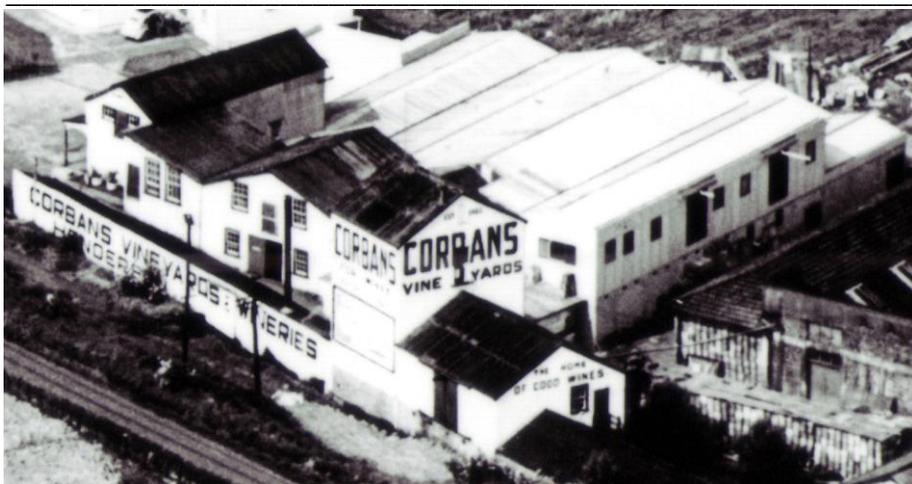
Detail, Whites Aviation photo #51430, 1959

Distillery buildings in the foreground with the Old Cellar and Bottling Plant behind. The Gables Building is to the right.

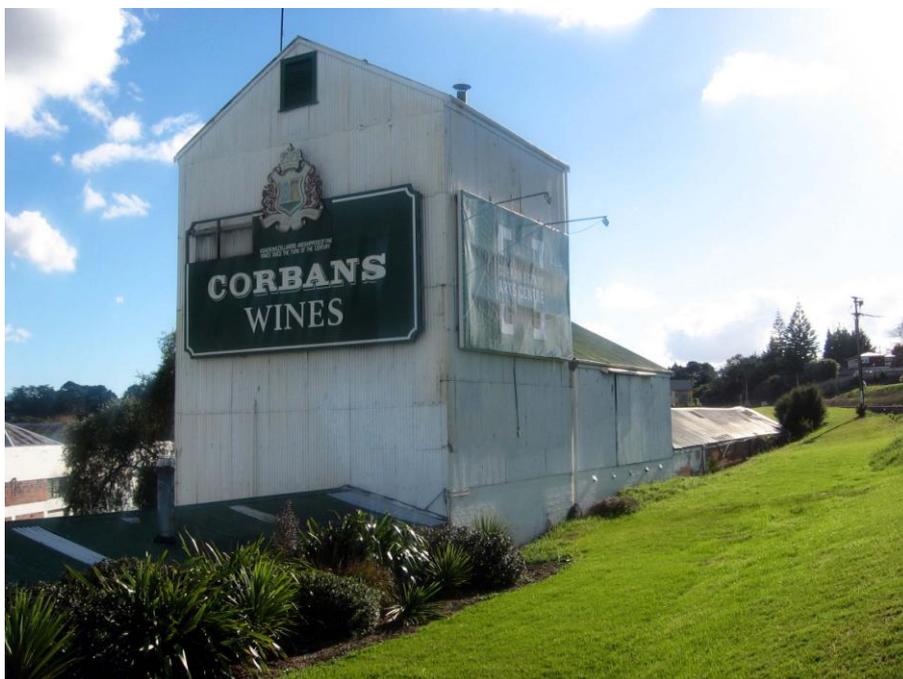
Eastern face of Distillery tower and view along railway embankment, photo Graeme Burgess 2004

pitched gable, and the section of wall above retaining height, concealed from view by a shrubbery. The boiler house abuts the distilling tower. This tower sits on a white painted brick base. The wall is clad in vertical corrugated iron which is wrapped around the corners and lapped down over the brickwork. In 1960 the top of this wall was painted with the sign; “CORBANS FOR WINE”, and beneath this was a framed billboard. In keeping with the Corbans tradition of saying it large and loud, the billboard over the face of the cladding remains, in a slightly higher position. It is lit by two cantilevered billboard signs. The bottom of the billboard is level with the fascia of the adjoining storeroom (in 1960 the middle of the billboard was level with this fascia). The wall ends in a planted fascia and spouting. There is no downpipe. The eastern wall of the still tower is gabled and matches the finishes previously described. The barge is planted to the face of the cladding with the roof finishing in a barge roll flashing over it. There is a fixed four light window at the peak of the gable and a billboard fitted to the face of the wall. The western gable end has a fixed vent timber louvre panel at the gable, and a double hung window centred above the ridge of the storage room. The finishes are consistent with those facing east. The 1960s aerial photographs do not appear to show the top louvre. This wall also carried large signage at that time; “CORBANS VINE YARDS”.

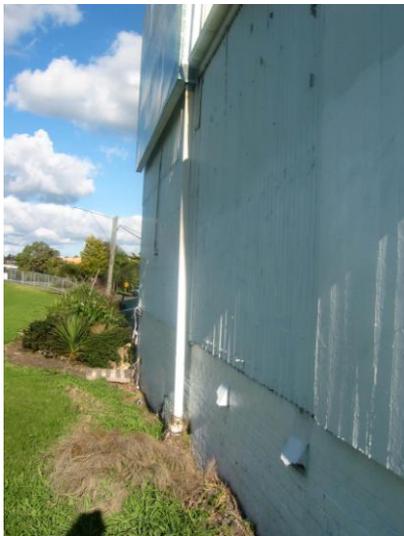
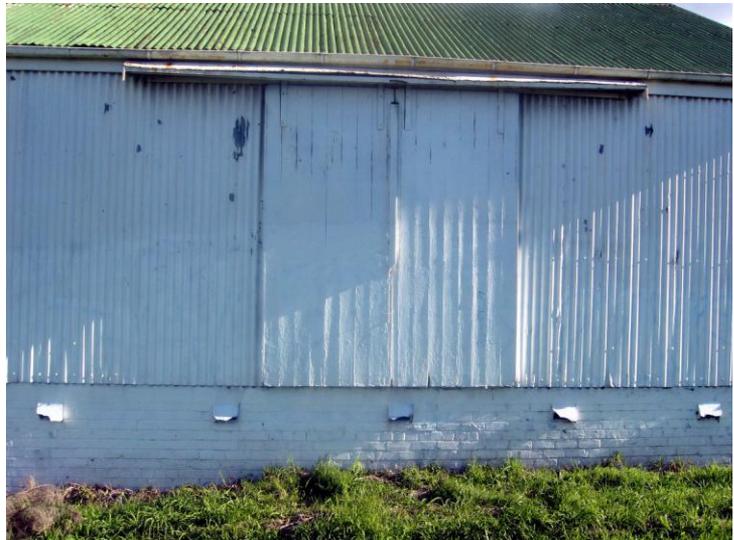
Left, base of still tower and Exhibition Storeroom looking east. Right, sliding doors to Exhibition Storeroom, photos Graeme Burgess 2004

The base of the “Exhibition Storeroom” is white painted brickwork continuous with the base of the still tower. In this section of the base five metal vent hoods have been fitted to the upper section of the wall. The exterior wall of the storage room is clad in corrugated iron continuous with the cladding of the still tower. At the centre of the wall is a pair of top-hung, industrial sliding doors. These are constructed of heavy vertical tongued and grooved. (The door was painted a dark colour in the 1960s.) The pelmet over the top track is fixed to the fascia. The fascia, as with the still tower, is planted on the cladding at the top of

the wall. There is a rainwater head and downpipe at the left hand side. These are new. The gable end of this section of the building, facing west, also carried signage. The roof edge detail of this gable matches the detail of the tower above. The vertical corrugated iron cladding wraps around this face of the building. There are two openings on the right hand side; a doorway where the storeroom projects out beyond the line of the western section of the building, and to the side of this a double hung window. The door is vertical tongued and grooved, the top sash of the window is divided into six lights and the facings are planted to the surface of the cladding.

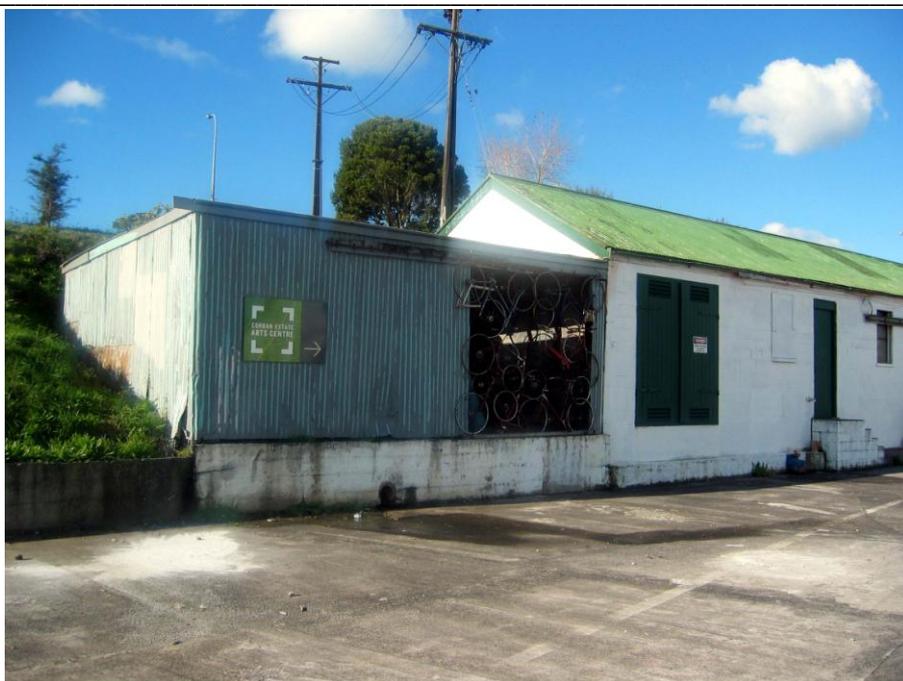
Western end of distillery buildings from the estate, photo Graeme Burgess 2004

At the western end of the complex is a lean-to falling to the railway. The base of this is concrete blockwork, with vertical corrugated iron cladding. There is no fascia or spouting. The western elevation is equally raw. The cladding is run down to the ground and the fascia barely finished. The ground at this end of the building is a bank falling to a four-course concrete block retaining wall. This end room returns along the southern frontage in a poured concrete base set above the height of the retaining wall. The room is half open. The left hand side is clad in corrugated iron, the section to the right was once enclosed by an industrial sliding door. This has now been replaced by a sculpture of bicycle parts.

At the end of the splayed concrete block gable section of the building on the southern side are a pair of large vertical tongued and grooved doors to the transformer room. There are timber louvres in the base and head of each door. The remaining openings in this section of wall are an adhoc collection. A window opening nearest to the transformer doors has been blocked, next to this is a tongued and grooved door at the top of a low set of concrete block steps (which run from right to left). A top hung industrial sliding door, also tongued and grooved, has been installed at the end of the concrete block section of the building. The head track of this door has been fitted across the face of a fixed window. There are concrete steps up to this large door running from right to left. The spouting remaining in this area is quarter round galvanised iron. It is rather dishevelled. The spouting is fixed on a directly planted fascia. There are some surface mounted cables beneath the fascia.

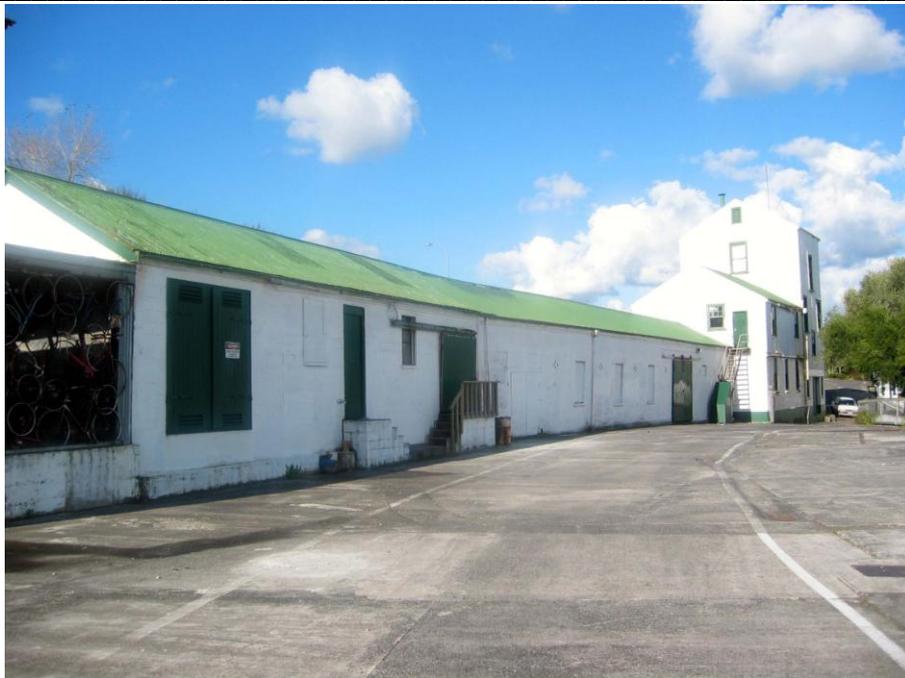
View along the southern sweep of the distillery buildings towards the tower, photo Graeme Burgess 2004

The next section of the building, up to the side of the “Exhibition Storeroom”, is brickwork, with a large infill section of poured concrete at the intersection with the concrete block section of the building. There are five vents formed in the brickwork by spaced bricks. This section of the wall is bulging. The window openings in this section of the building have been boarded over. There are three evenly spaced window openings, a pair of timber industrial sliding doors and a small opening level with the head of the other openings to the right hand side of the doors. The sliding doors are hybrid. The left hand door is a vertical wide board door and has a small panel cut out at the bottom left hand corner, the right hand door is older, with narrow boards, and an exposed frame. This section of the building finishes against the return of the “Exhibition Storeroom” space. A galvanised steel open tread stair runs up to the storeroom level across the face of the building. This has been enclosed for security at the base. Beneath the stair is a blocked wide opening. The timber lintel over this doorway is set into the brickwork, and is rotten.

The base of the “Exhibition Showroom” steps out about a metre from the face of the adjoining building. The exterior walls are white painted brickwork. The base is plastered, there is a concrete lintel across the top of the wall. There are three evenly spaced double hung windows in this wall. Each sash is divided by a vertical glazing bar. The cill of the windows in the lower room of this area are level with the centre of the windows at the base of the still. At the top of the brickwork are four metal vent hoods. Above this is a horizontal water pipe and a cable. The exterior of the storage space above is clad in vertical galvanised iron, lapped down over the concrete lintel and finishing under the planted fascia

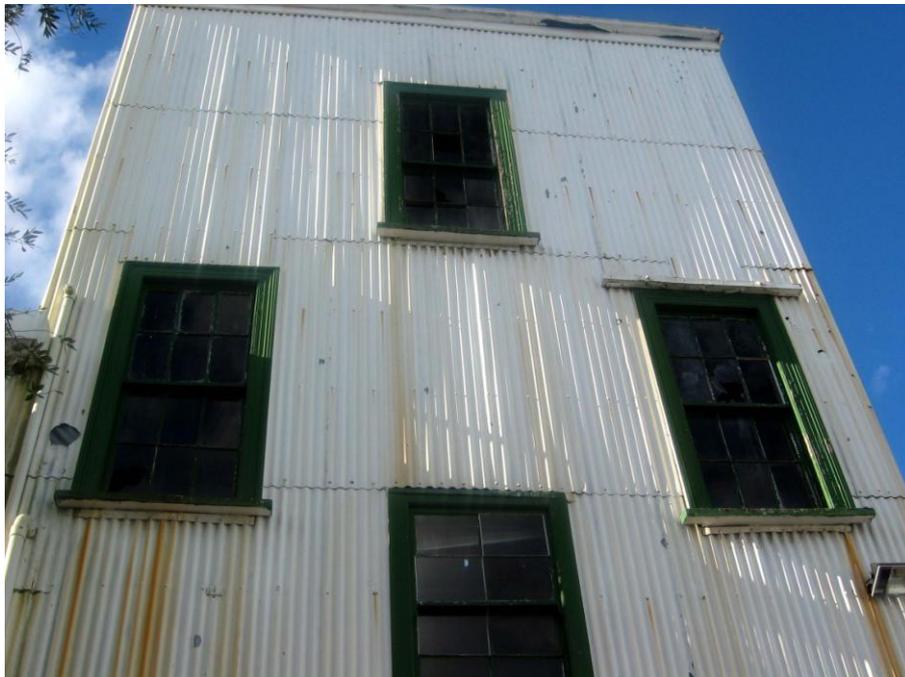
South wall Still Tower, photo Graeme Burgess 2004

There are four double hung windows, two centrally placed, one at the bottom and one at the top, and two at the mid-level set at each side of the tower. The top three windows match. These each have six light sashes. The lowest window has four light sashes. The facings around the upper windows are moulded. The facings of the lower window are plain. The fascia is planted and the spouting is quarter round metal on metal brackets. There is no downpipe. On the eastern return face of the still tower the ground is stepped up. An opening has been made for a doorway and a concrete ramp poured up to it. The door is plain sheet material. The opening has been weathered by broad facings. There are a number of services pipes and wires fixed to the exterior.

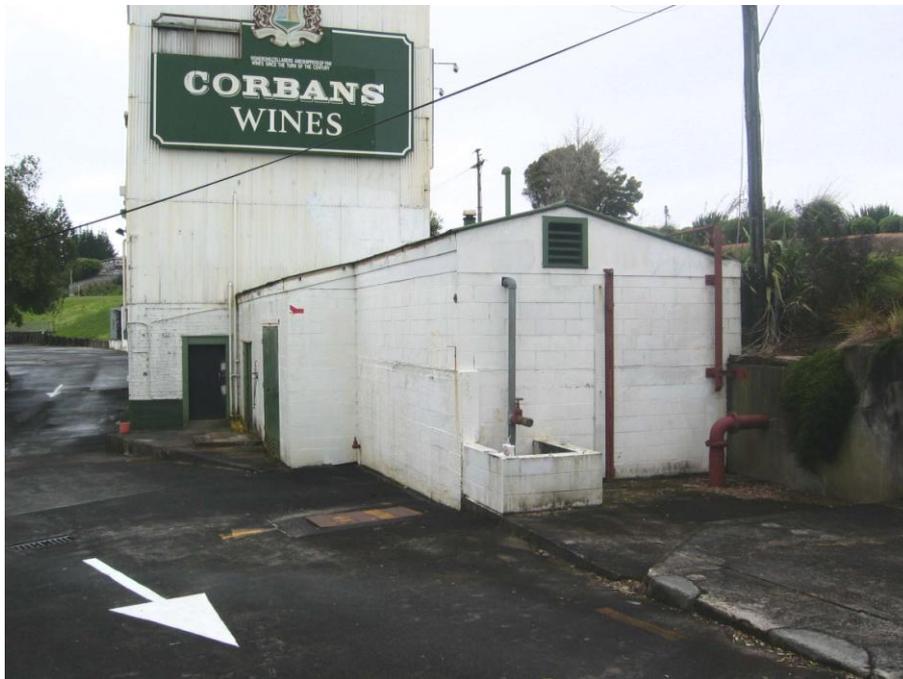
Eastern end of Distillery Buildings, boiler room, photo Graeme Burgess 2004

The final section of the building, the boiler room, is an eccentrically gabled concrete block structure which butts into the still tower and the boundary. The end section of this building steps in to the boundary in plan and has no openings. The first section, next to the still tower, has two door ways, a pair of sheet-metal doors to the left and a single doorway to the right. The gable end of the boiler room is flat sheet panel. There is a louvre panel beneath the peak of the gable. This end of the building has been used for oil storage and the pipe work associated with this, pipes in and out, and a charming indicator panel, remain on the exterior of the building.

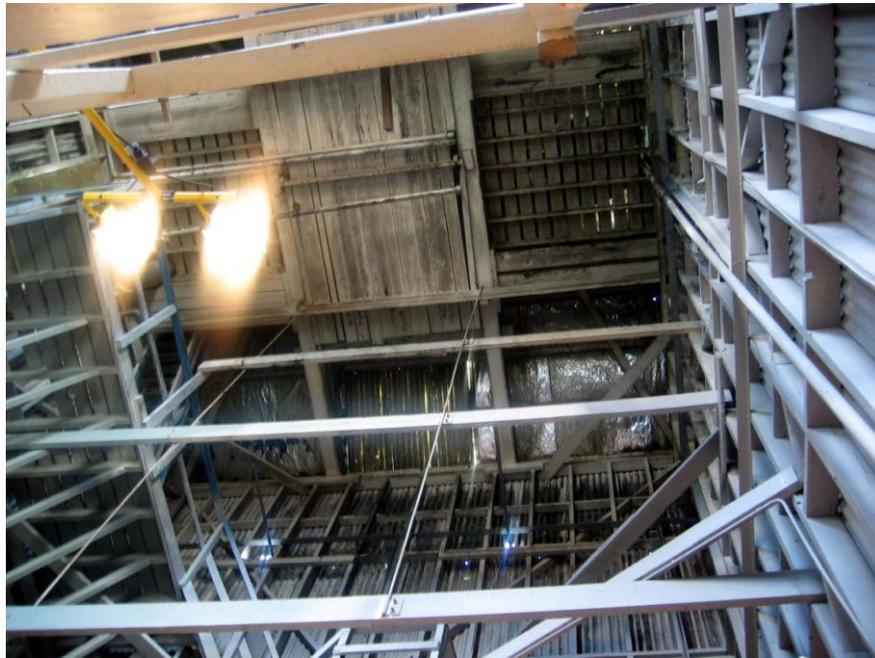
Distillery tower structure, Corban Estate. Photo Graeme Burgess 2004

The still tower, a filigree of timber framework, and ladder stairs with corrugated iron cladding, is remarkable. This structure housed the large copper still. A similar structure was built in 1941 at the Government Viticultural Research Station at Te Kauwhata. At the time of writing a conservation plan for that place in 1996, the still was in place.

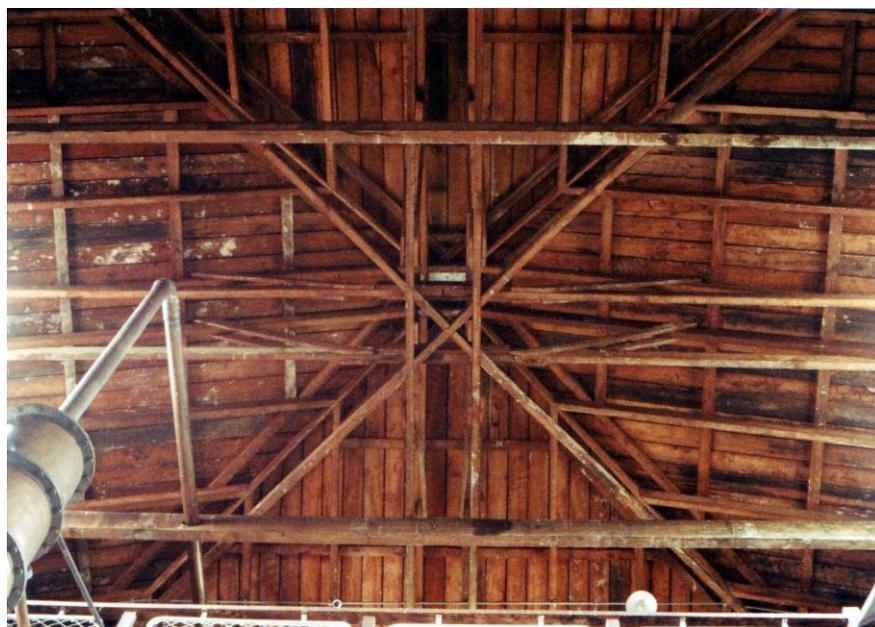
Distillery tower roof structure, Te Kauwhata Viticultural Research Station. Photo Graeme Burgess 1995

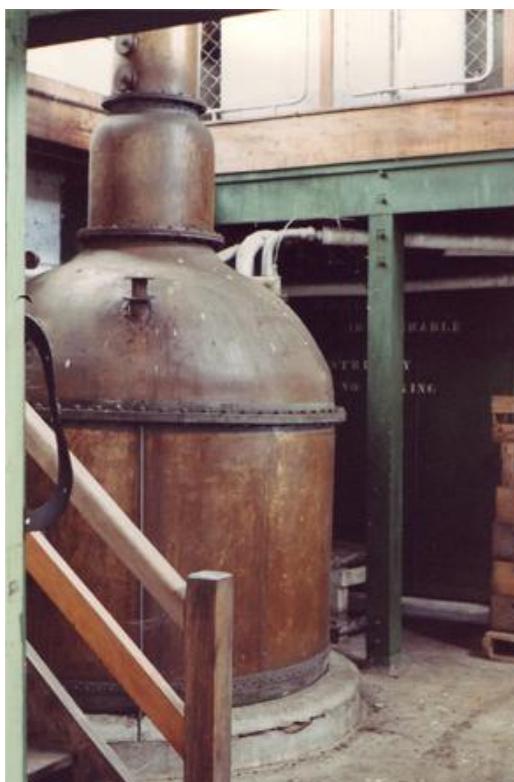
Copper still, distillery tower Te Kauwhata Viticultural Research Station. Photo Graeme Burgess 1995

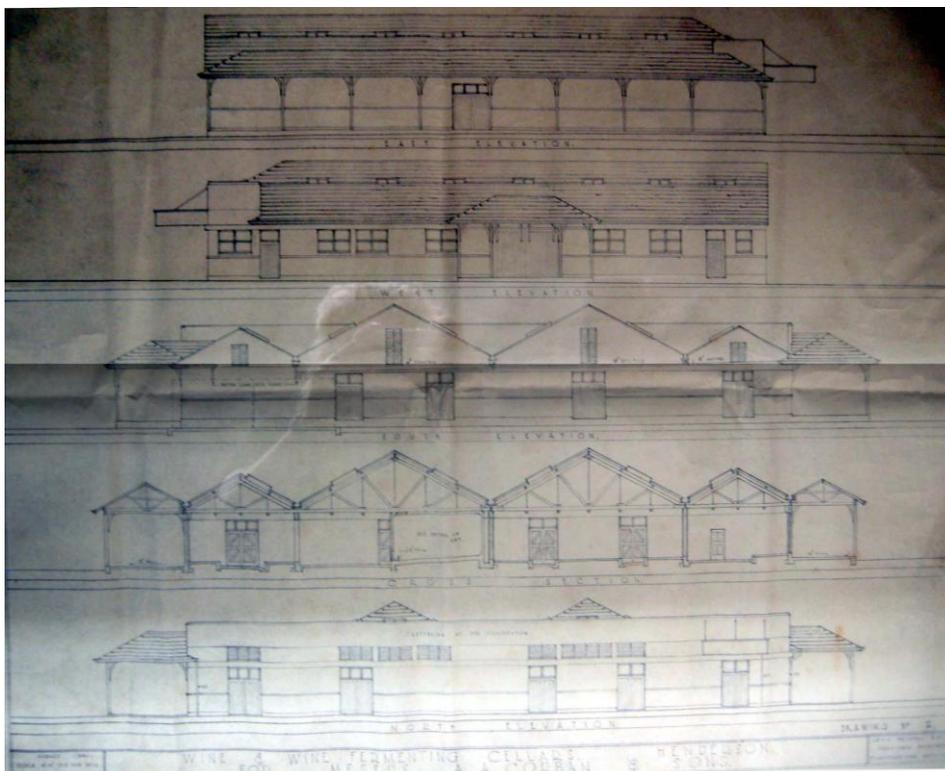
New Winery permit application 1941, elevations and section, Waitakere City property file #10095

The building was designed by the architect Lewis Walker. It was built beside the stables to the west, and covered a larger area than the Old Cellar complex. There are four long gables running north to south. The side gables are narrow, the centre gables are wide. These gables are expressed at the southern end of the building. On the northern frontage the roof is concealed behind a parapet. The parapet wraps back for a short distance at each end. The side roofs are gabled at this end and the central roofs are hipped. At the centre of the western wall was a hip-roofed verandah portico. This covered the entry to the building from the vineyard, and was where the harvest arrived for processing. This element was removed some time after 1960. A second hip-roofed verandah ran the length of the eastern side of the building. This has since been enclosed. The posts supporting the verandah roofs were six inches square, with elegant elongated brackets between the posts and the roof beams. The two verandahs, and the western gable were roofed in concrete tiles, the main roofs of the building were

made of corrugated profile roofing, with large fixed skylights fitted to the western face of each gable. The tiled roof remains over the eastern verandah. The walls of the building are reinforced concrete post and beam with brickwork panels between. The exterior surface is plastered in some areas and has been left exposed in others. There are exposed brick panels at the eastern end of the northern wall, and the southern gable ends of the wide gables are brickwork. By 1960 a long lean-to element had been built across the southern face of the building and a parapet built across the curtailed south end of the long verandah. This was removed before 1963 by which time the barrel storage warehouse had been built.

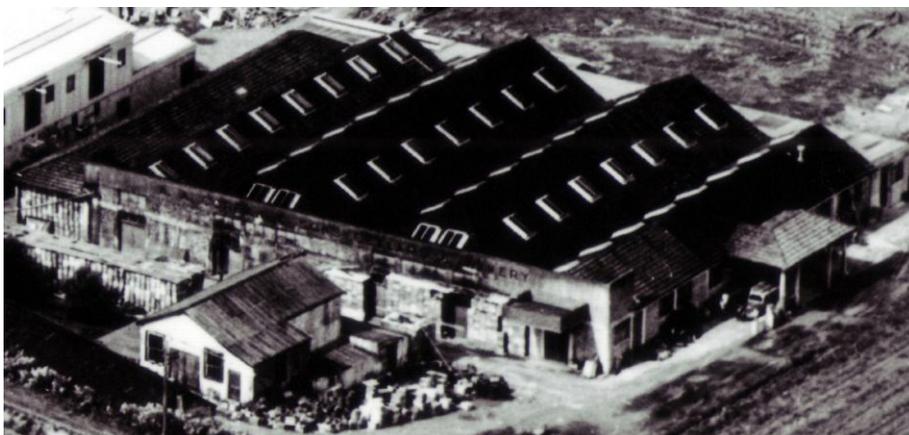
*North & West of the Gables Building, note roof lights and portico
Detail Whites Aviation Aerial oblique photo #51430, 1959*

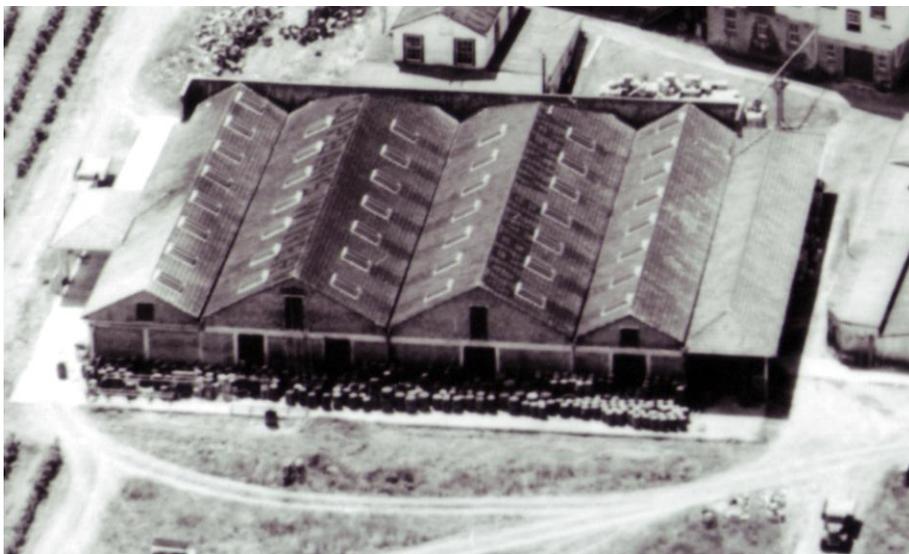
*South of the Gables Building, note the open loggia to the east
And the roof signage.
Detail, Whites Aviation Aerial oblique photo #34781, 1954*

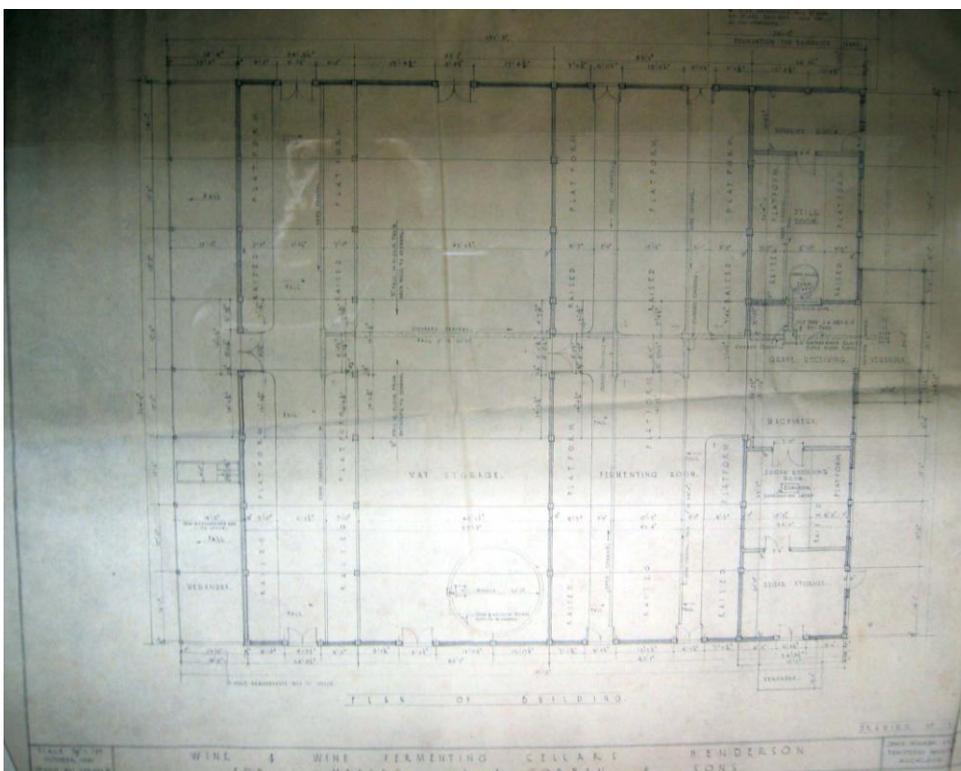
New Winery permit application 1941, plan, Waitakere City property file #10095

The interior of the Gables Building is plain. The floors incorporate platforms for vats, and are laid to fall to drains. The primary structure is reinforced concrete post and beam. The roof is supported by timber trusses. Formerly, the western most bay of the building was divided into a sugar storage room at the northern corner with a sugar dissolving room adjoining. There was also a double door from the northern side of the building, and a single door from the western side of the building into the sugar storage, and double doors from the dissolving room to both the sugar store and into the adjoining grape receiving area. There was a raised platform on the western wall of the sugar dissolving room. The grape receiving area was open to the fermenting room in the next

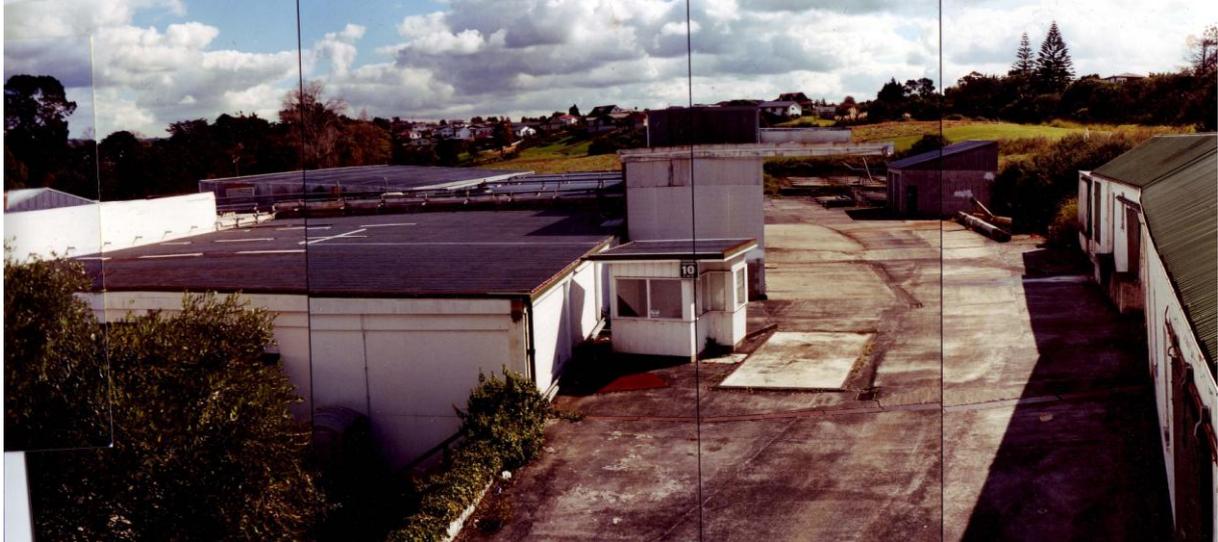
Corban Estate view to the west over the 1966 winery, 1997, Photo Graeme Burgess

In 1966 a new winery was designed by the architect Richard Hillary. This winery building was built to the west of the Gables Building (1941 winery) and up towards the railway. It was a reinforced concrete structure on two levels, with a single pitch roof. Extensions joining this building to the Gables Building were carried out in 1970 and 1972. The building was demolished in 2001 (Tanya Wilkinson).³⁴

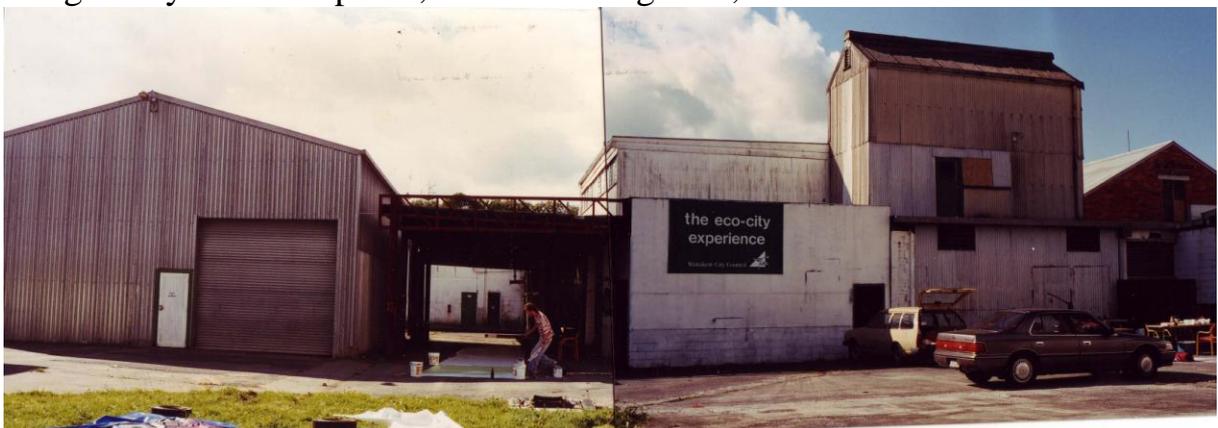
Corban Estate behind the Gables Building (1941 winery), 1997, Photo Graeme Burgess

The first of the new warehouses was the barrel store built at the back of the Gables Building (1941 Winery) at some time between 1960 and 1963. This building is a plain gabled industrial shed, the predominant form of the buildings remaining on the site. In the early 1960s a number of Nissen Huts were brought on to the property to provide additional storage. These were sited in a row across the front of the new barrel store. Nissen Huts are barrel vaulted metal barns designed as the most economical form of relocatable shelter for use during the Second World War. All the Nissen huts have been removed.
