Corban Estate Winery

426 Great North Road
Henderson

CONSERVATION PLAN
July 2005

BURGESS & TREP ARCHITECTS

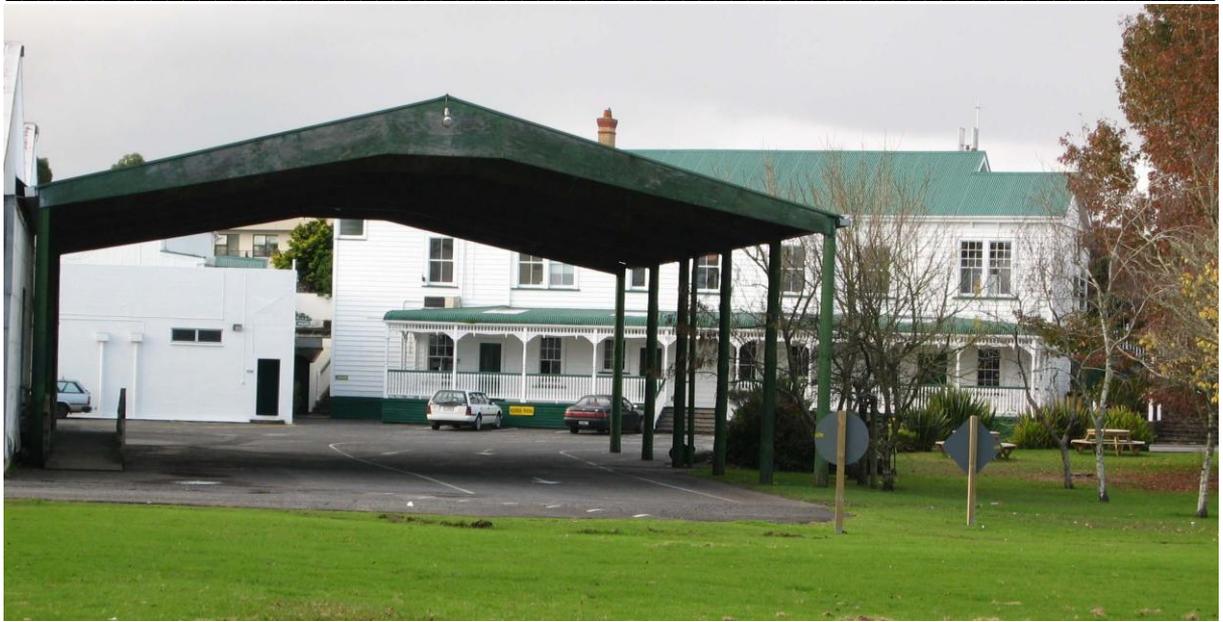
Portico outside the 1970s warehouse buildings, photo Graeme Burgess 2004

The large warehouse beyond the barrel store at the back of the property was built around 1970 and extended in 1974. The timber pole portico outside this, designed by John Chapman, Structural Engineer, was built in 1987.

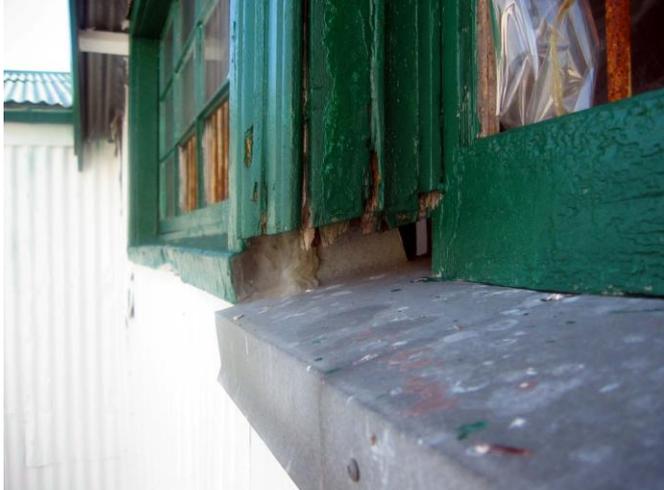
*Missing section of window cill. Rear of Boxing Rooms
Photos Graeme Burgess 2004*

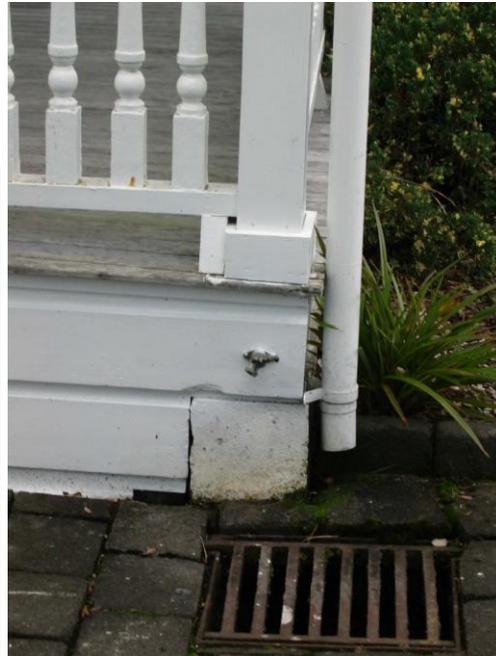
*North east porch, note d.p. spills to ground
Corner post & weatherboards repaired.*

Building work has been carried out on the homestead very recently. There are some areas of the house which need attention nevertheless. The cladding runs down to the ground across the northern frontage. The new concrete paths built against the building will harm the timberwork. The concrete stair down the western wall of the house may also cause long term damage to the building. At the eastern verandah a hose tap has been fitted against the structure of the verandah.

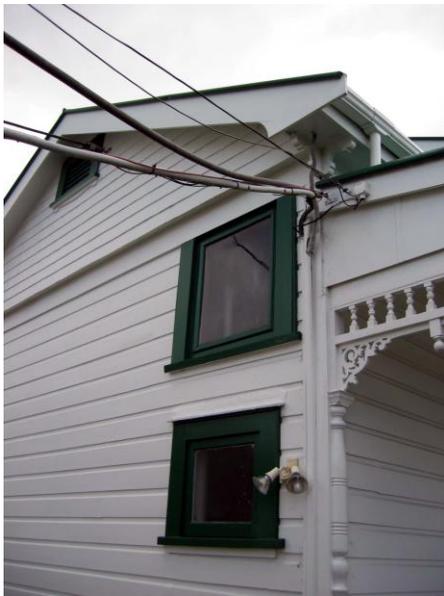
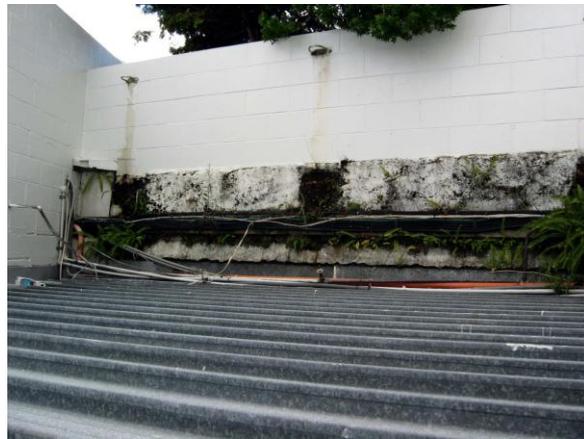
*Left: power lines from homestead to garage Right: services cables across roof to Old Cellar
Photos Graeme Burgess 2004*

Recommendation: Services: All services on the property, power, telephone, gas, stormwater and sewerage, should be surveyed and checked.

Policy 22: Services: A plan should be prepared to rationalise all services to remove redundant elements and to achieve a more elegant solution to the problem of ill placed and unsightly services.

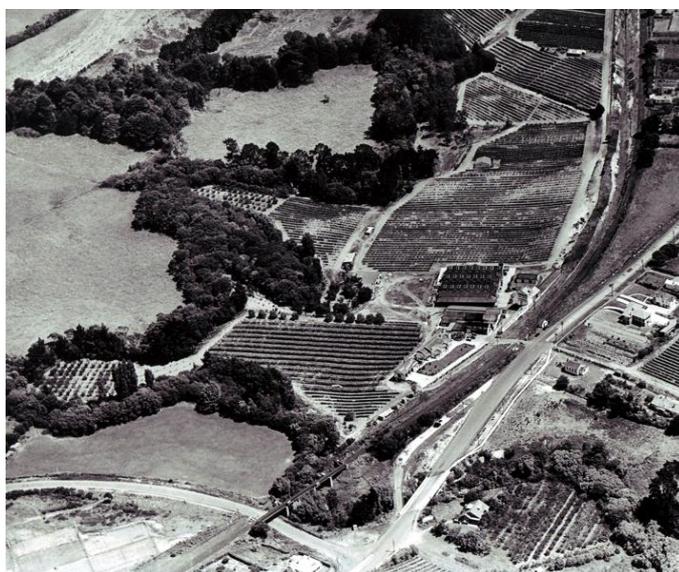
Whites Aviation Photo #26530, 1951

*Detail, Whites Aviation photo #26530, 1951
Note the wedge shaped lean-to opposite the Old Cellar in the foreground
And the use of the walls and walls for advertising.*
