CONSERVATION PLAN

OMANAIA MARAE + OMANAIA WESLEYAN CHURCH

BURGESS & TREEP ARCHITECTS 2012

Omanaia Marae + Omanaia Wesleyan Church Omanaia Road Hokianga, Taitokerau

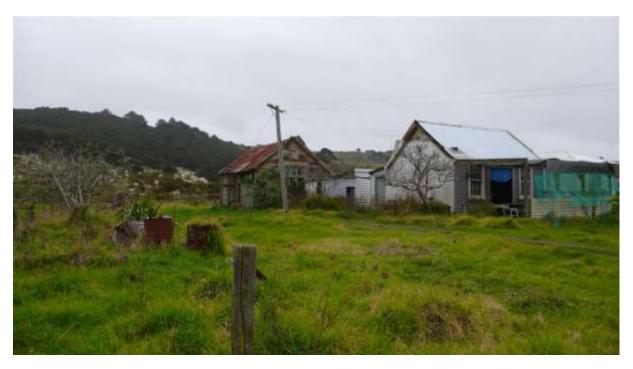
The native school house and teachers residence as it stands currently in its relocated position in Omanaia.

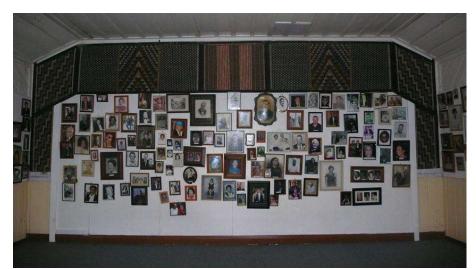
Southern interior wall of the Wharenui at Omanaia Marae. Photograph Burgess & Treep 2012

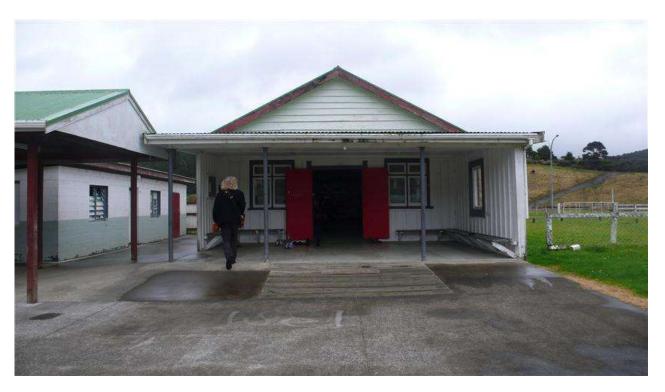
Barge boards non original second grade timber with knots and cracks. All flashings and spouting require possible replacement. The whole exterior of building needs repairs to the cladding and should be cleaned down and painted following repair. Generally windows and facings are in ok condition in the undercover porch area. The concrete pad which had been built directly up against the timber cladding needs attention as the two materials are in contact and this is where rot to the timber can occur.

Wharenui North Elevation. Photograph Burgess & Treep 2012

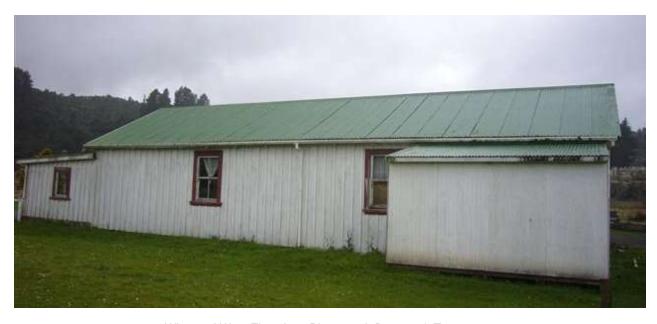
The down pipes and spouting are all non original PVC and all spouting require attention and potential replacement. There are two cases where the downpipe is broken and discharging onto the side of building or straight into the ground.

There is inadequate ground clearance on the eastern side especially where concrete path is in contact with the timber cladding causing areas to become rotted out. There are many areas where the boards are split and battens broken. The whole exterior of the building needs repairs to the cladding and should be cleaned down and painted following this. The non original lean-to additions are clad in plywood which is also in bad repair. They should really be demolished as they have no relationship to the original heritage fabric of the building and are of poor construction.

With regards to the openings, in most cases the window frames and sills are broken and rotten and in general the windows and facing as are in very bad condition and need full replacement or immediate repairs. There is no flashing over the porch window on the western facade. On the eastern facade the end of the porch lean-to barge is open. Above this the corner between the side wall and the gable end is not covered. The first sash window in on this side has severe case of rotten timber at intersection of sill and frame.

Wharenui West Elevation. Photograph Burgess & Treep 2012

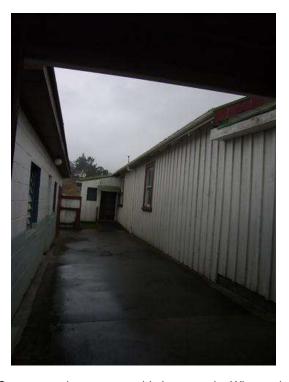
Concrete path on eastern side between the Wharenui and the wharepaku looking south, note concrete has been built up against the cladding

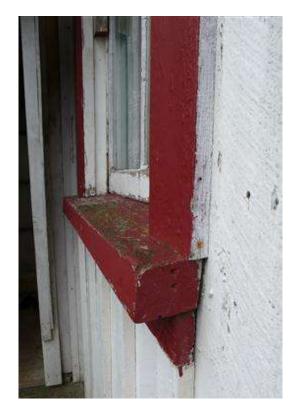
Sash detail on eastern facade Burgess & Treep, July 2012

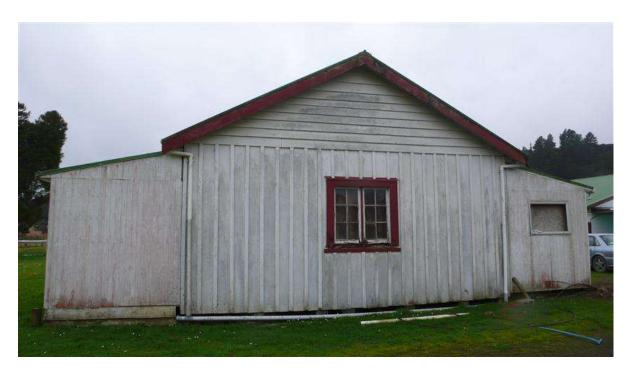
Claddings need the same superficial treatment as all other facades. The window is in very bad condition with the sill section and the bottom rail of the sash almost completely rotted away. Barge boards are non original made from second grade timber and feature numerous knots and cracks. The weatherboards under the gable are butted together and not flashed. The ply sheets used on the cladding of the non original lean-to structures are also butted without and visible flashings. The spouting needs attention there is a down pipe which runs along the ground. This does not comply with conventional practice. The end of the soffit has rotted out on the south eastern corner.

Wharenui South Elevation. Photograph Burgess & Treep 2012

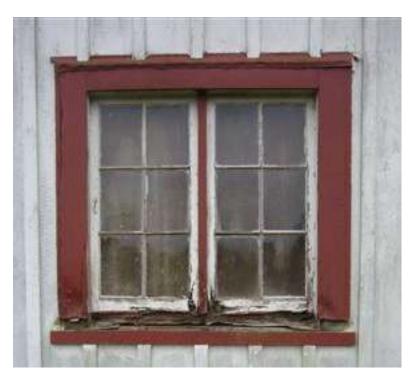
South window detail with rotted frame, sill and facings.
Burgess & Treep 2012

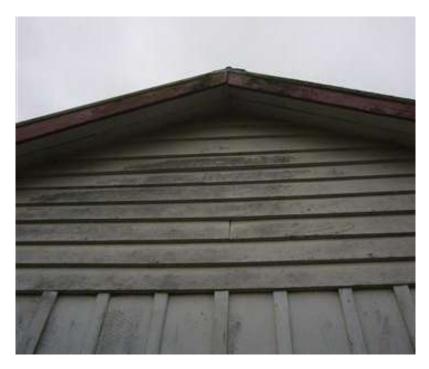
Weatherboards on southern gable end. Note the lack of flashings on butted boards Burgess & Treep, July 2012

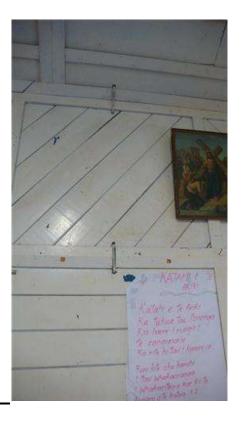
Electrical wires exposed on interior Burgess & Treep, July 2012

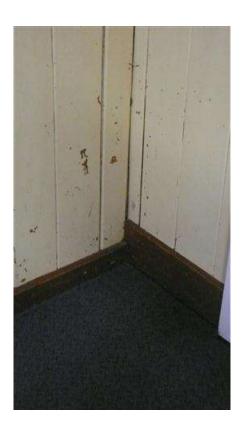
Corner detail showing uneven skirting, and split boards Burgess & Treep, July 2012

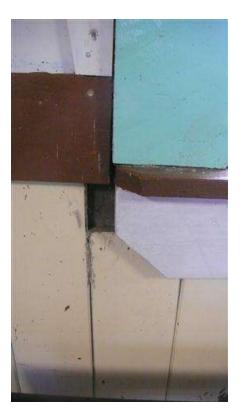
Rough junction between boards around window Burgess & Treep, July 2012

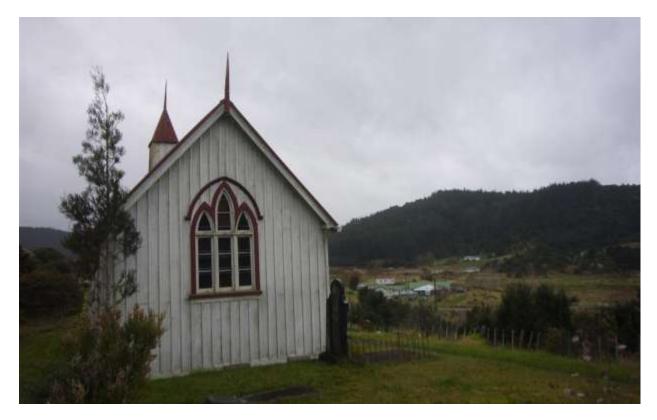
Some of the decorative mouldings around the windows have been lost and architectural detailing on the bell tower, spire and finial are in a state of disrepair. Generally windows and facings are in very bad condition although there are no broken glass panes. All flashings and spouting's require attention. There are areas where the soffit has fallen away and needs to be replaced.

South Elevation of the Church. The Marae can be seen to the right below. Burgess & Treep, July 2012.

The current makeshift foundations consisting of concrete blocks on end and paint cans filled with concrete not only unsightly but extremely dangerous. They should be replaced immediately with timber block foundations. The joists and bearers have been replaced relatively recently and the original floor boards have been replaced with particle board.

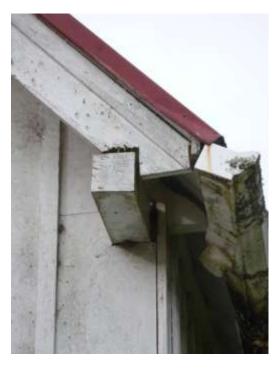
North western corner showing top plate of the wall framing.
Burgess & Treep July 2012

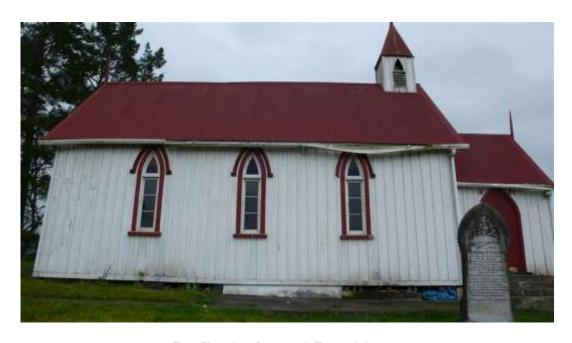
East / West Elevation

In some areas the boards have split and the battens broken and the condition of the baseboard needs to be assessed. In general the windows and facings are in bad condition. The facing on the central window on the western façade has completely disintegrated and on the window to its left the hood moulding had broken off at one end. The hood moulding has also broken off on the left hand side of the central window on the eastern elevation.

Concrete steps have been built directly up against the timber cladding causing areas of the boards to rot away over time. The concrete should be removed and the areas of rotten cladding should be repaired and replaced. The concrete path is overgrown and the concrete is cracked and uneven. There is no formal locking system for the church and the doors are held closed by a small timber latch and a pile of bricks placed in the front. This needs to be addressed for security reasons. There is a modern security light located to the right of the entrance doors it detracts from the heritage value of the porch and should be removed.

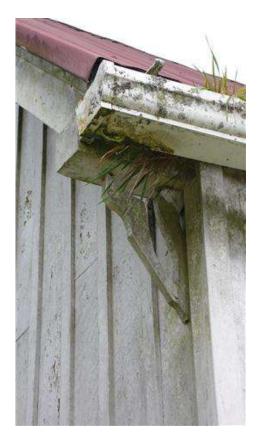
Roof edge detail. South East corner Burgess & Treep, July 2012

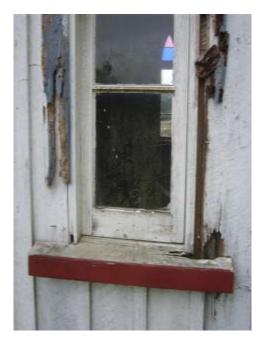
Facing completely rotted away western facade Burgess & Treep, July 2012

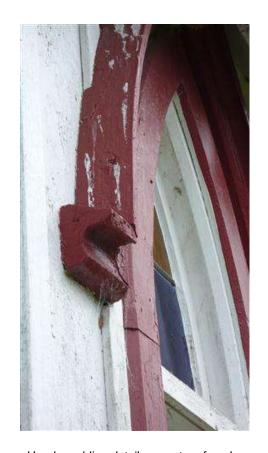
Hood moulding detail on eastern facade Burgess & Treep, July 2012

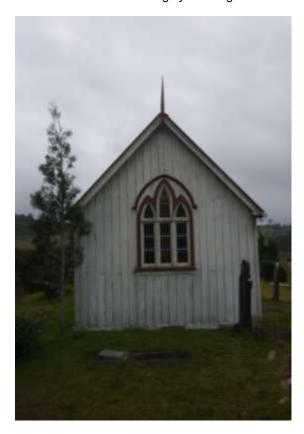
South Elevation

In some areas the boards have split and the battens broken. The decorative timber bracket which details the eave has become detached on the right had side and is hanging upside down, the other is still in place on the left. On the southwestern corner the boards have completely come away and there is no batten covering the junction, a gap is exposed and there are protruding nails visible.

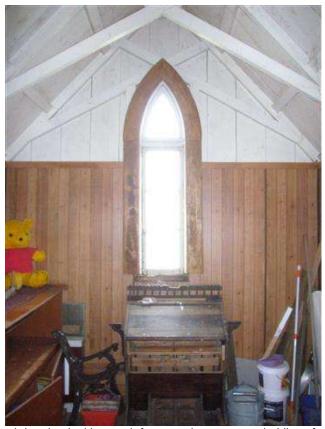
Church Interior, looking north from porch, note over cladding of walls Burgess & Treep, July 2012

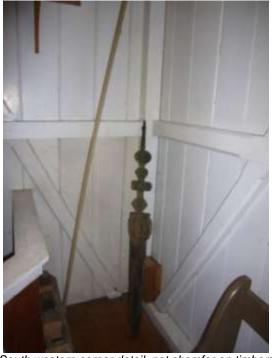
South western corner detail, not chamfer on timbers Burgess & Treep, July 2012
